Stucco Relief from Structure XIX, Palenque

by: Marcia Valle Rangel and Juan Alfonso Cruz Becerril

Research Year: 1999

Site: Palenque, Group of the Cross

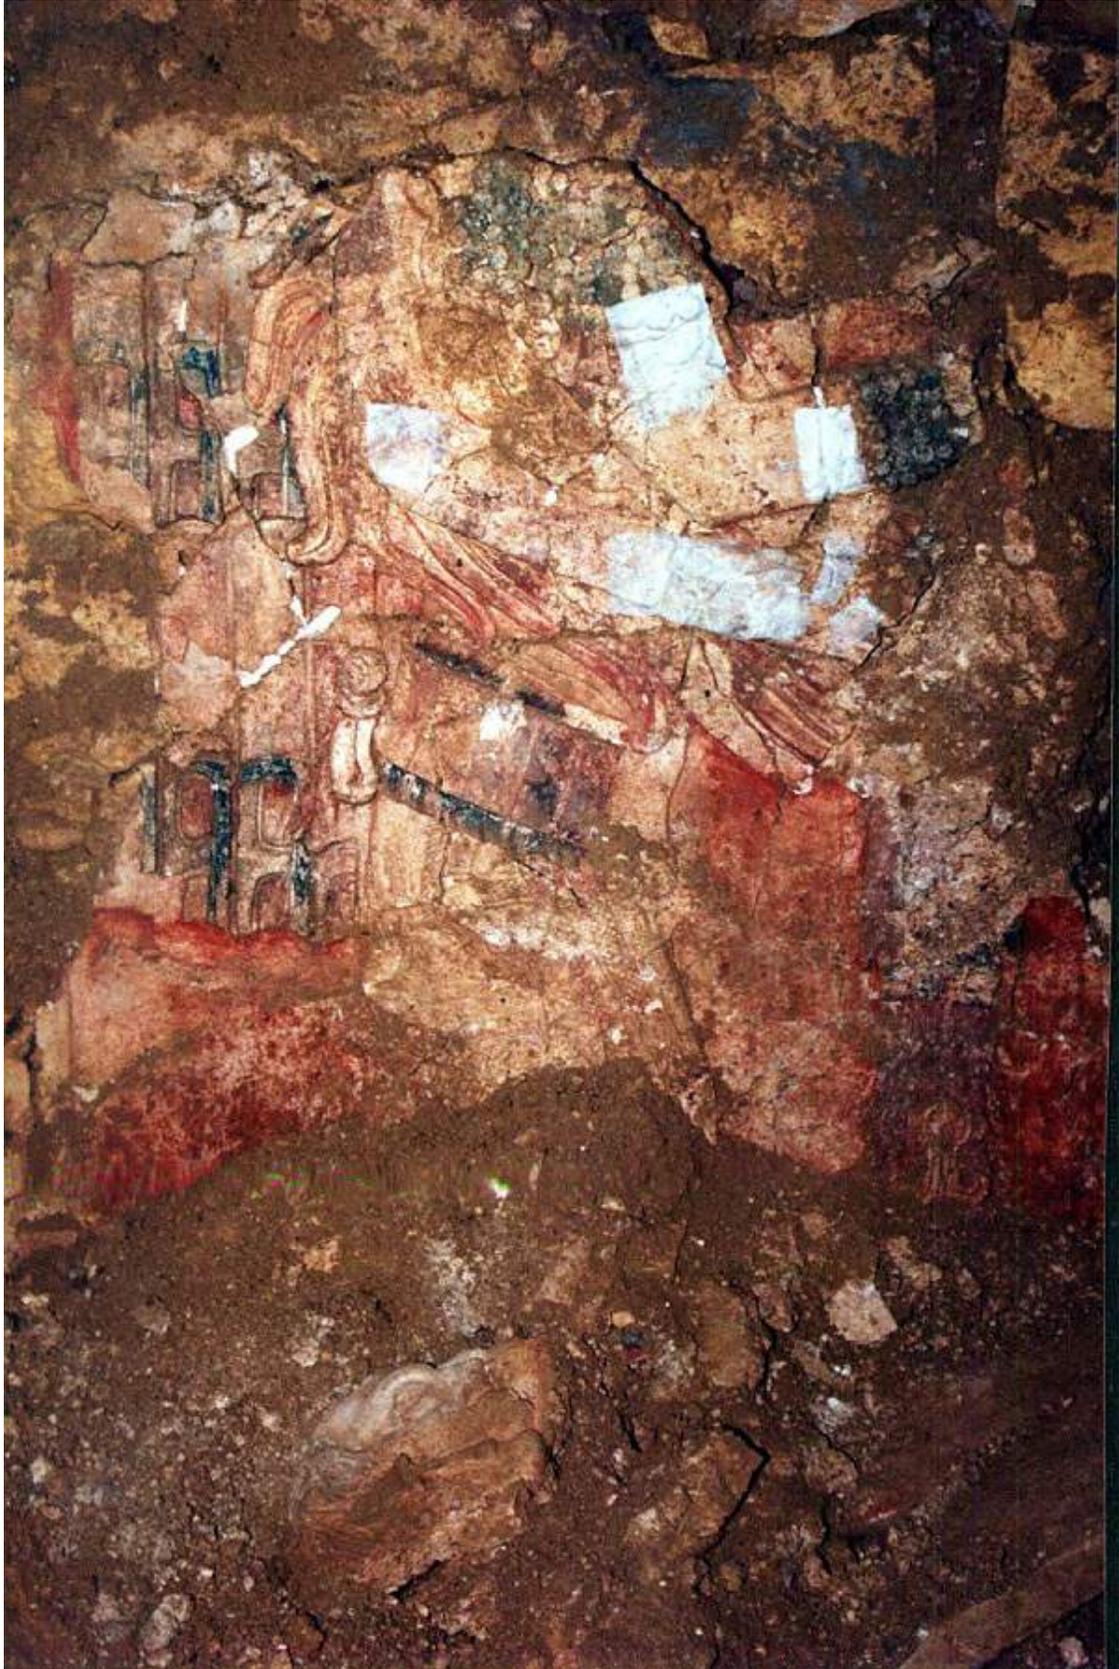
The relief attached to the pilaster had an interior filling of earth and clay, alien to the original support, which were gradually deposited by sliding and filtration caused by rainfall, thus creating deformations and convexities in the stucco, as well as flaws and fissures, while some edges presented exfoliation and pulverization (see [photo 9](#)).

Photo 9. State of preservation of the relief

Because Structure XIX is still in the process of study and structural consolidation, and because the temple lacks a cover of its own, thus making the stucco relief vulnerable to environmental conditions and climatic changes that are at times extreme, in order to prevent the endangering of the physical integrity of the stucco as a consequence of vandalism and looting, as this temple lacks any appropriate security measures, not to mention the lack of maintenance and the passing of time, the restoration team proposes to release the relief still fixed to the wall and move it to the preservation workshop to accomplish all the necessary preservation and restoration procedures the piece requires, and later place it at the site museum for exhibition.

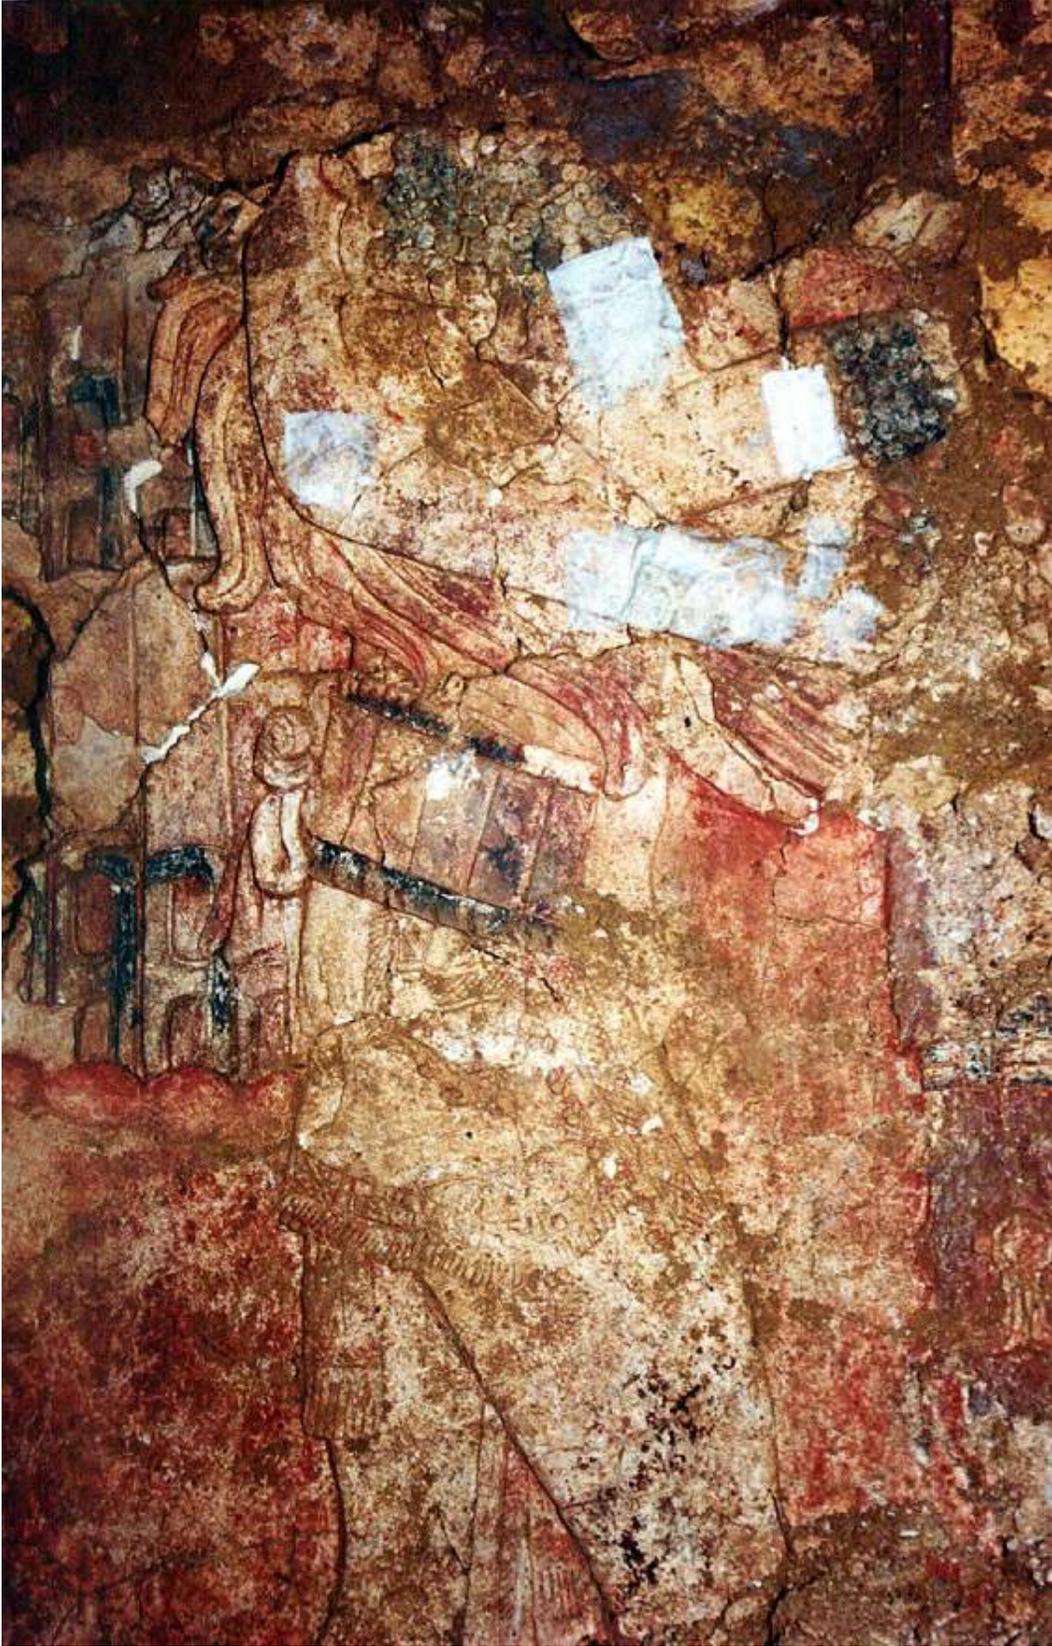
Photo 10. Area covered with Japanese paper

- Fixation of the pictorial layer: The pigment was fixed using Paraloid B72H, in a 5% concentration, applied by sprinkling.
- Partial covers: Loose fragments were partially covered with Japanese paper, using Paraloid B72H, in a 5% concentration, with acetone as the adhesive agent (see [photo 10](#)).

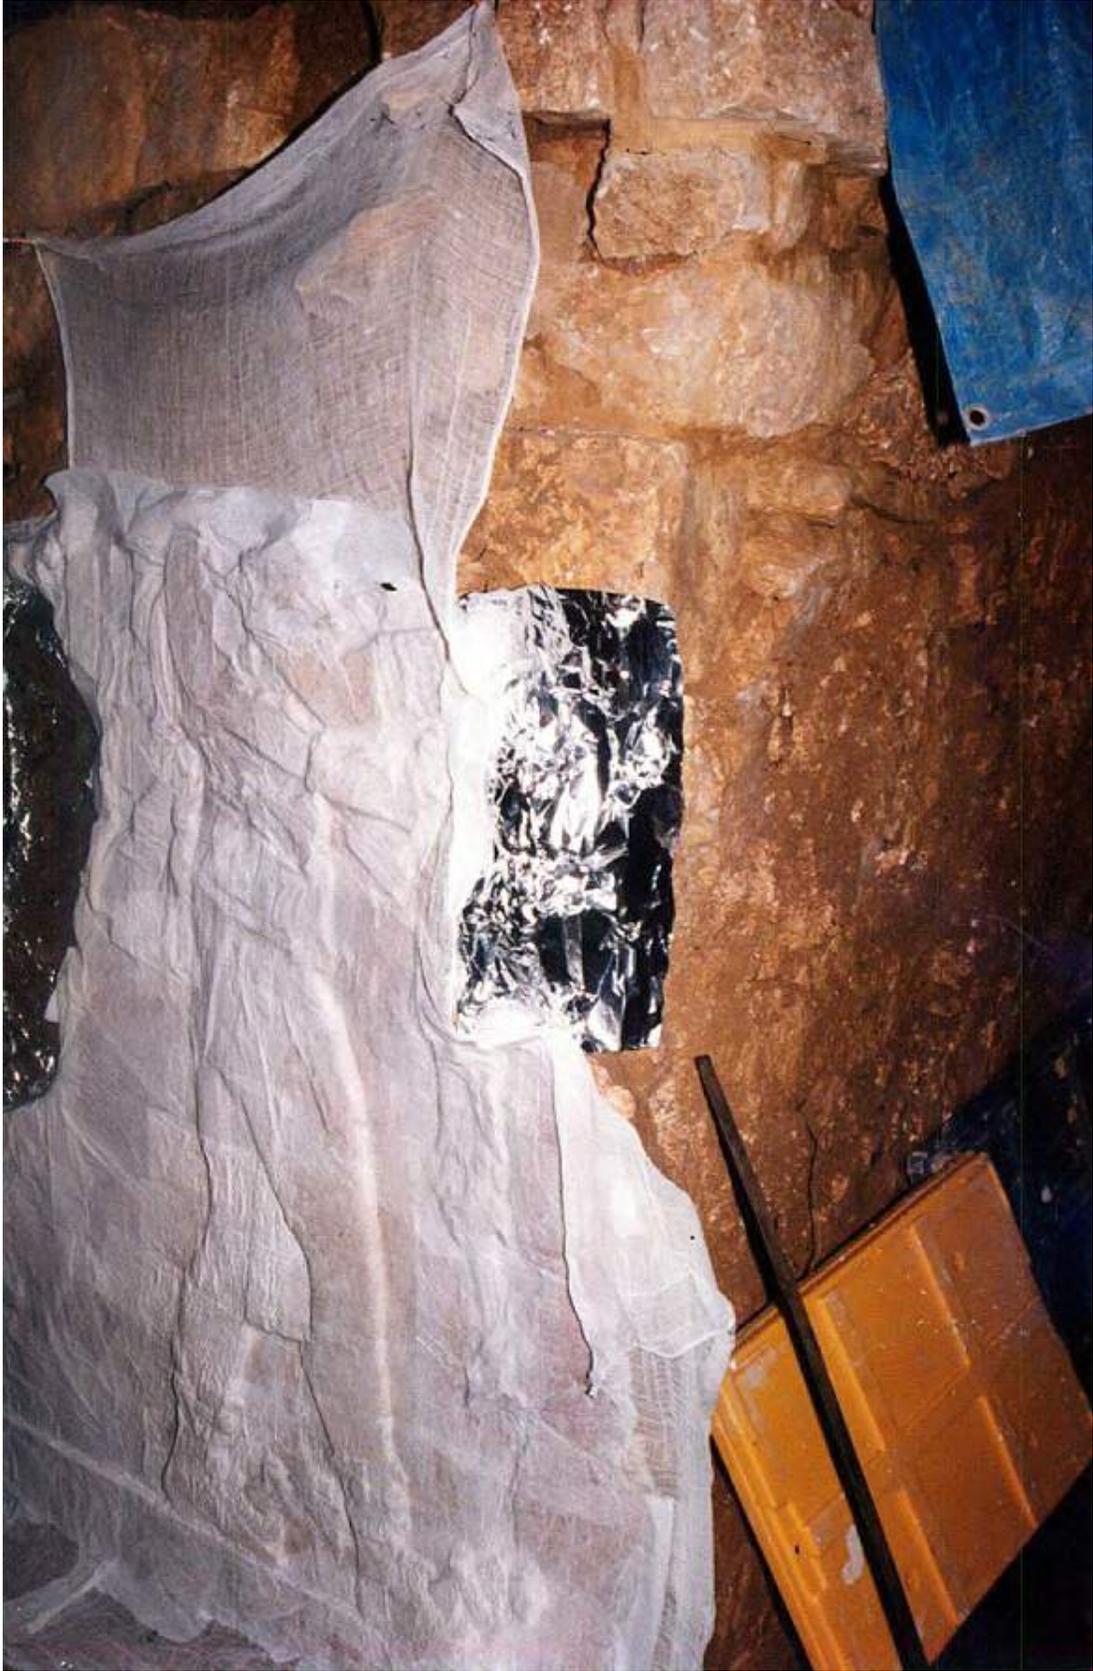
Photo 11. Overall protection covers

- Protection cover: This procedure was carried out by using a first insulating layer of a cheesecloth cover adhered with Paraloid B72H at a concentration of 3% in acetone, and by further placing another layer of China paper using Paraloid B72H at a concentration of 5%, to stick it together (see [photo 11](#)).

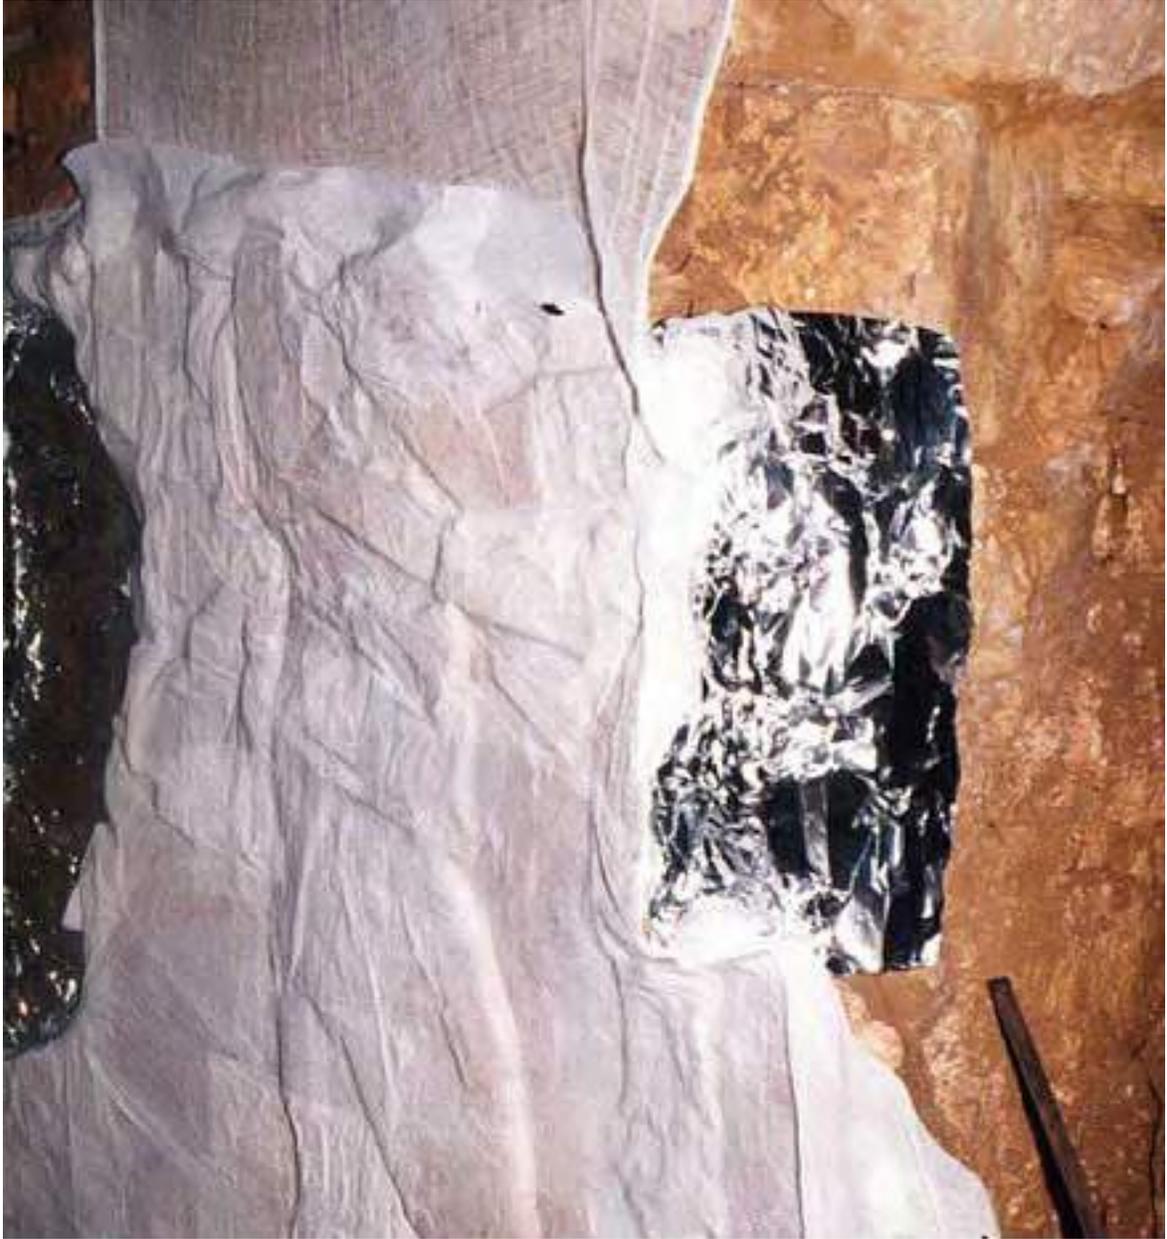
Photo 12. Preparing the stucco relief for detachment

- Insulating layer: Aluminum foil was used as an insulating layer on the entire relief surface, after verifying that the foil was free of perforations (see [photo 12](#)).

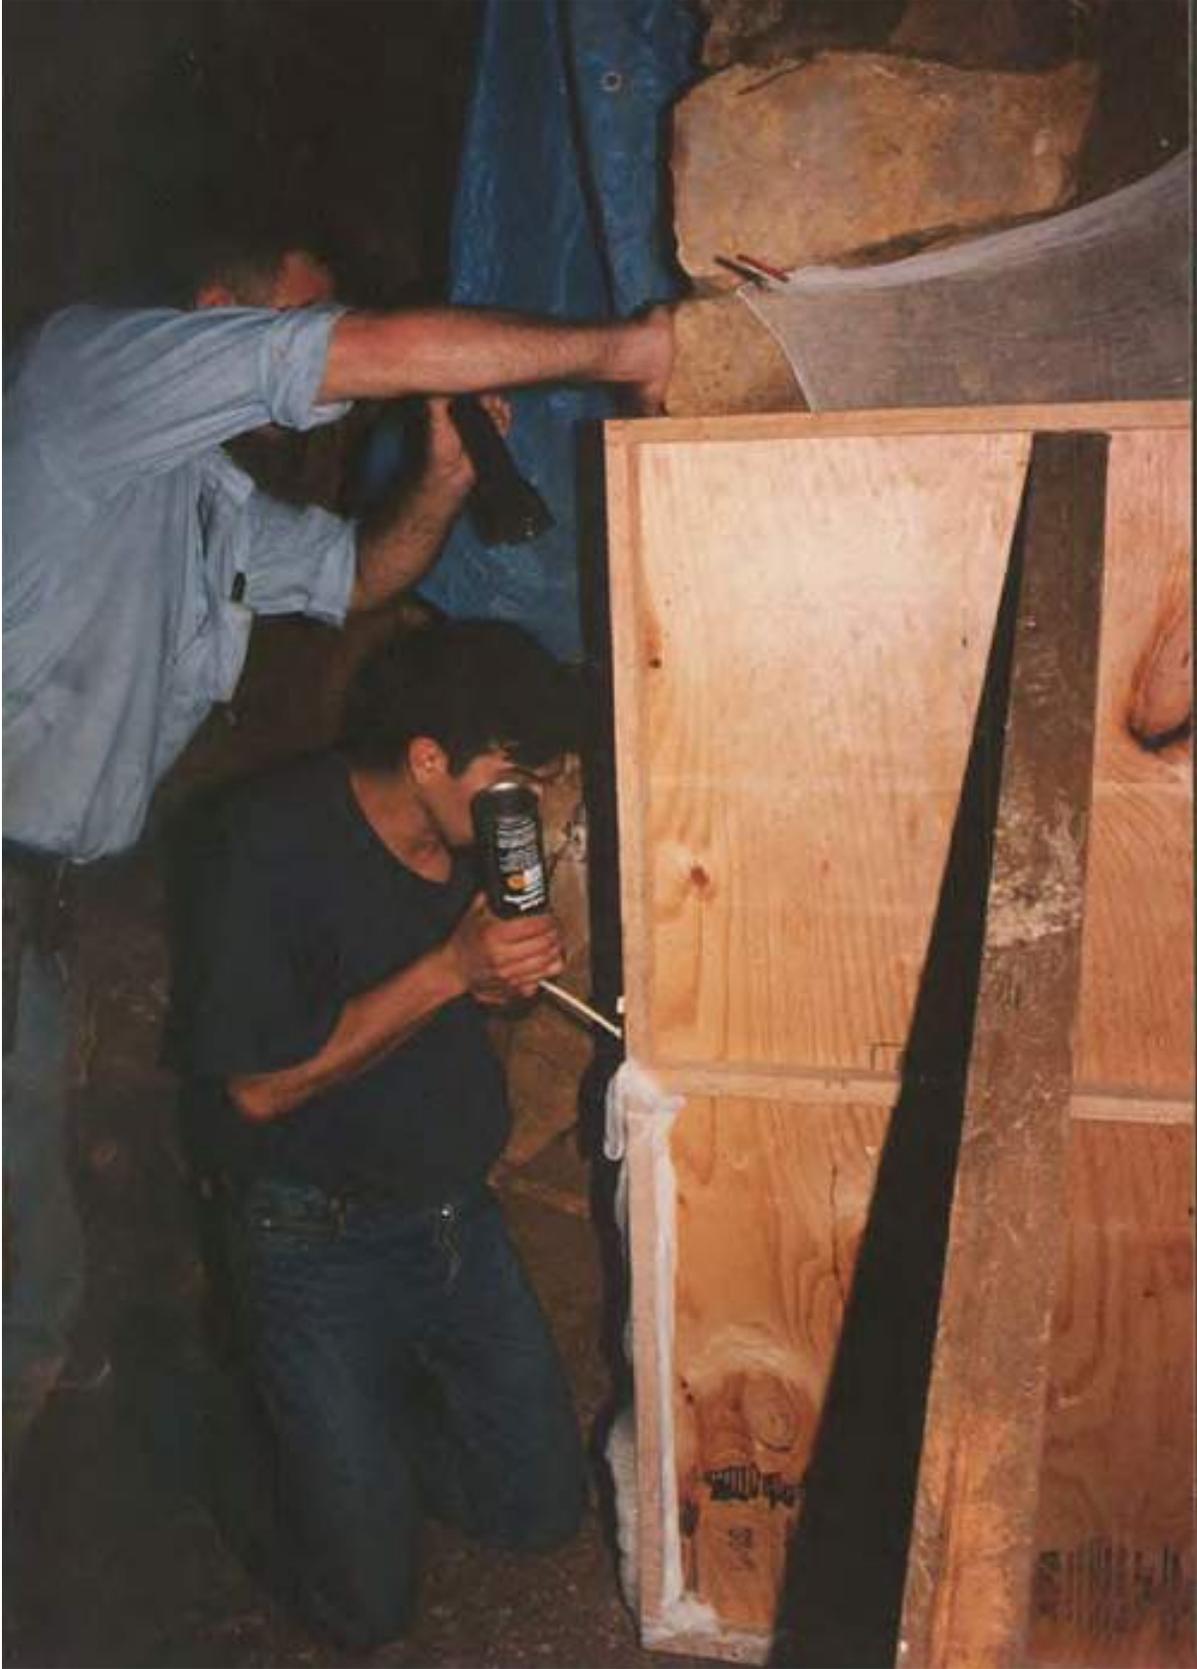
Photo 13. Injection of polyurethane foam

- Provisional support: The provisional support consisted of a rigid layer of polyurethane foam which was injected between the stucco and a wooden frame so that the support would acquire the shape of the relief, thus preventing any movement during its transportation to the restoration workshop (see [photo 13](#)).

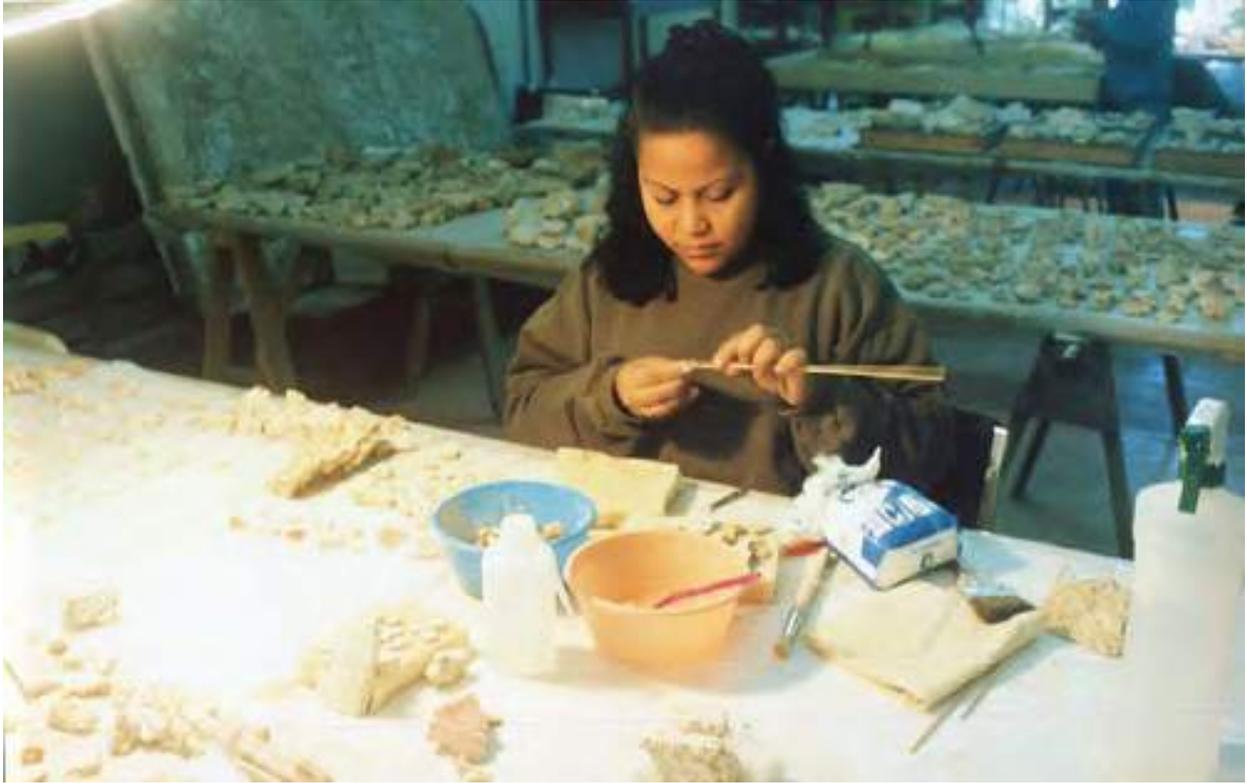
Photo 21. Chemical cleaning of fragments found in rubble

- In the next step, a chemical cleaning was carried out on the fragments recovered from the rubble using a 1:1 solution of water and alcohol, applied with smooth hyssops to eliminate clay and soluble salts (see [photo 21](#)).

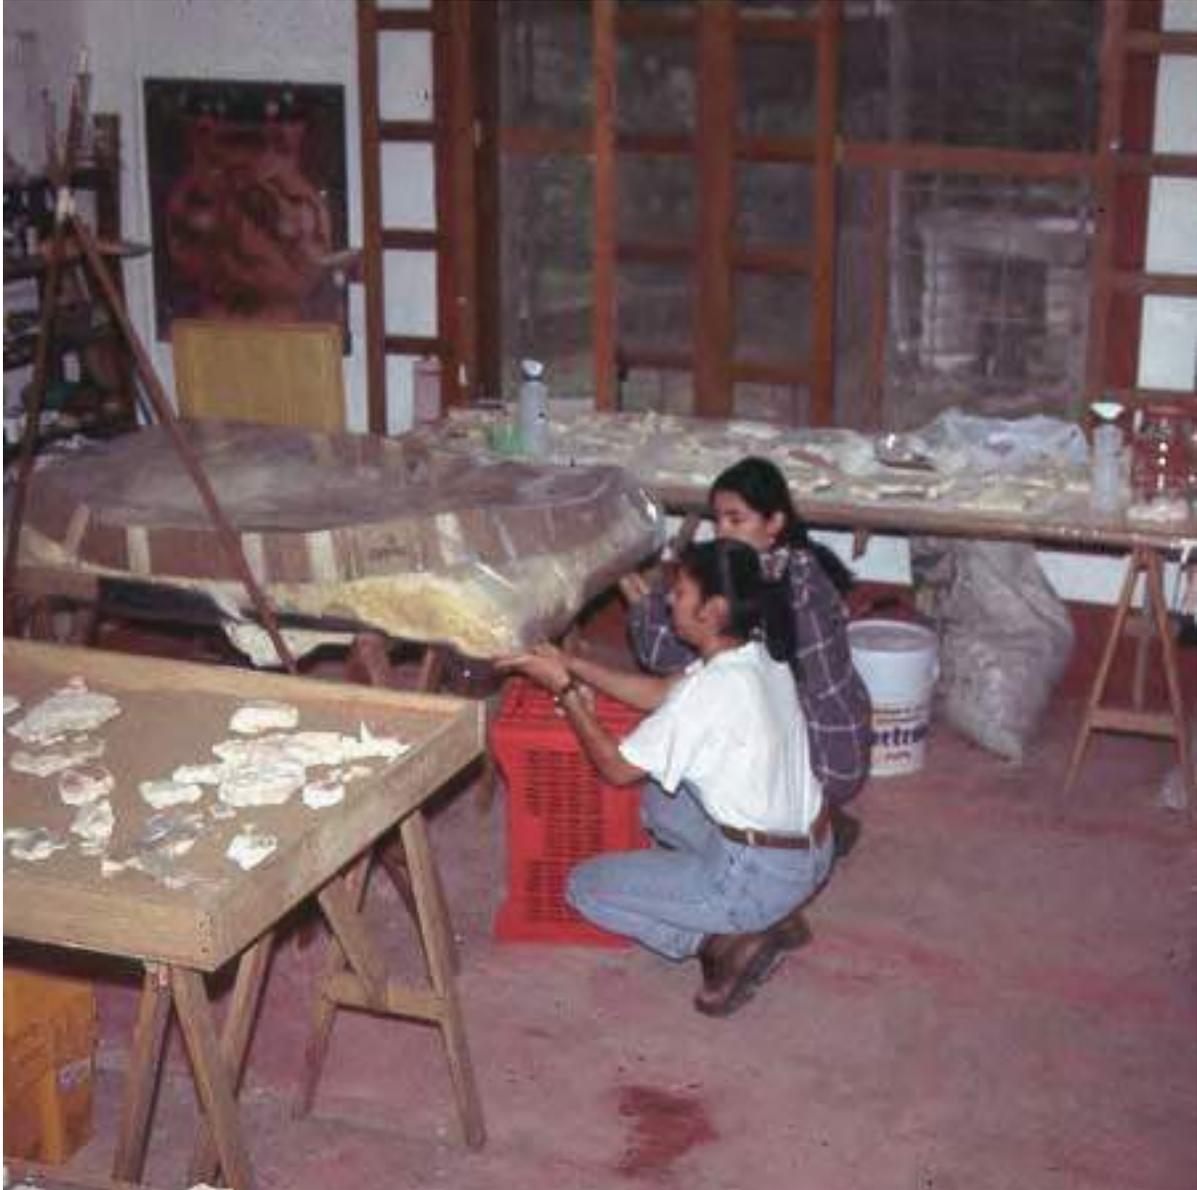
Photo 22. Consolidation of fragments

- Fragments found within the rubble: This process was applied only to the most degraded fragments. Paraloid B72H was used at a concentration of 3%, dissolved in thinner and applied by dripping.
- Detached fragment: The consolidation process of the stucco support was done using Paraloid B72H, at a concentration of 3% in thinner, by dripping through venoclysis, and then with the application of sprinkled alcohol to disrupt the surface tension, inside a slow-dryer chamber (see [photo 22](#)).

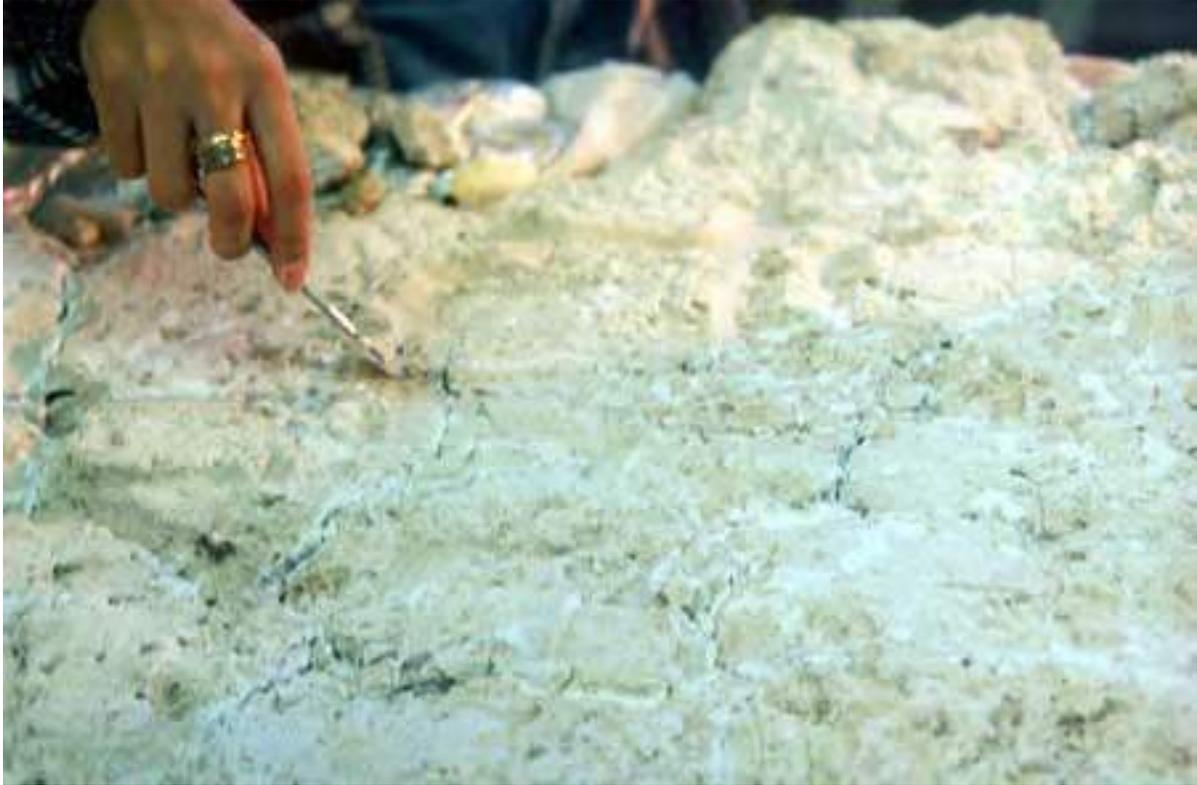
Photo 23. Consolidation of cracks and fissures on the reverse of the detachment

- A solution of calcium caseinate was injected on the reverse of the fragment detached from the jamb of the pilaster (see [photo 23](#)).

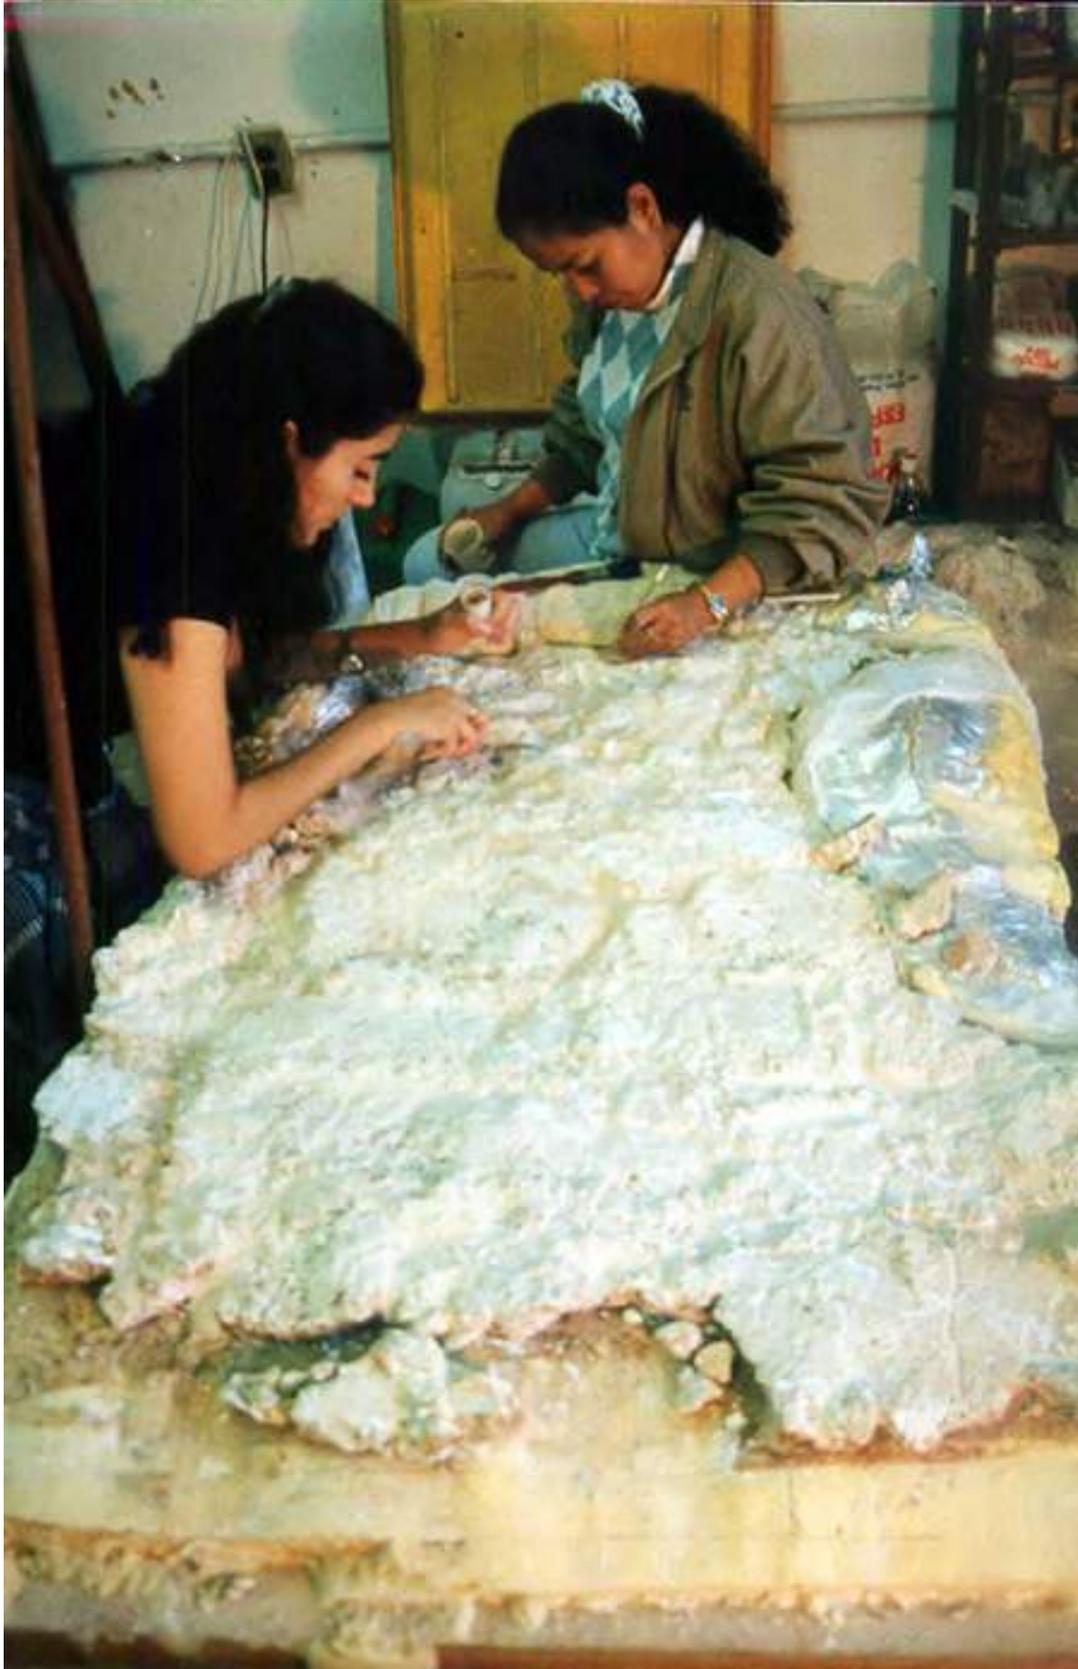
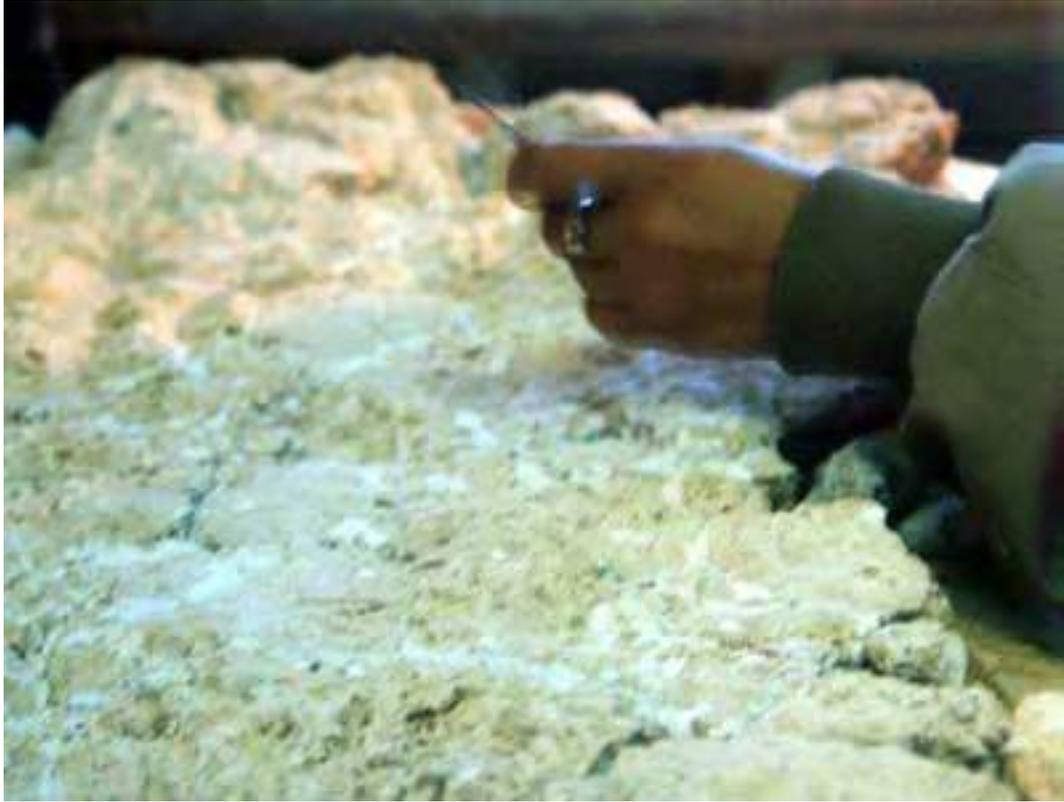
Photo 24. Repair on the reverse of the detached fragment

Photo 25. Repair on the reverse of the detached fragment

- With the surgical knife, the back side of the detached piece was leveled, lowering the most pronounced protuberances in order to obtain a surface as uniform as possible; then, the cracks, fractures and fissures were repaired with a repairing paste made of lime and fine limestone powder in a proportion of 1:2 (see [photo 24](#) and [photo 25](#)).

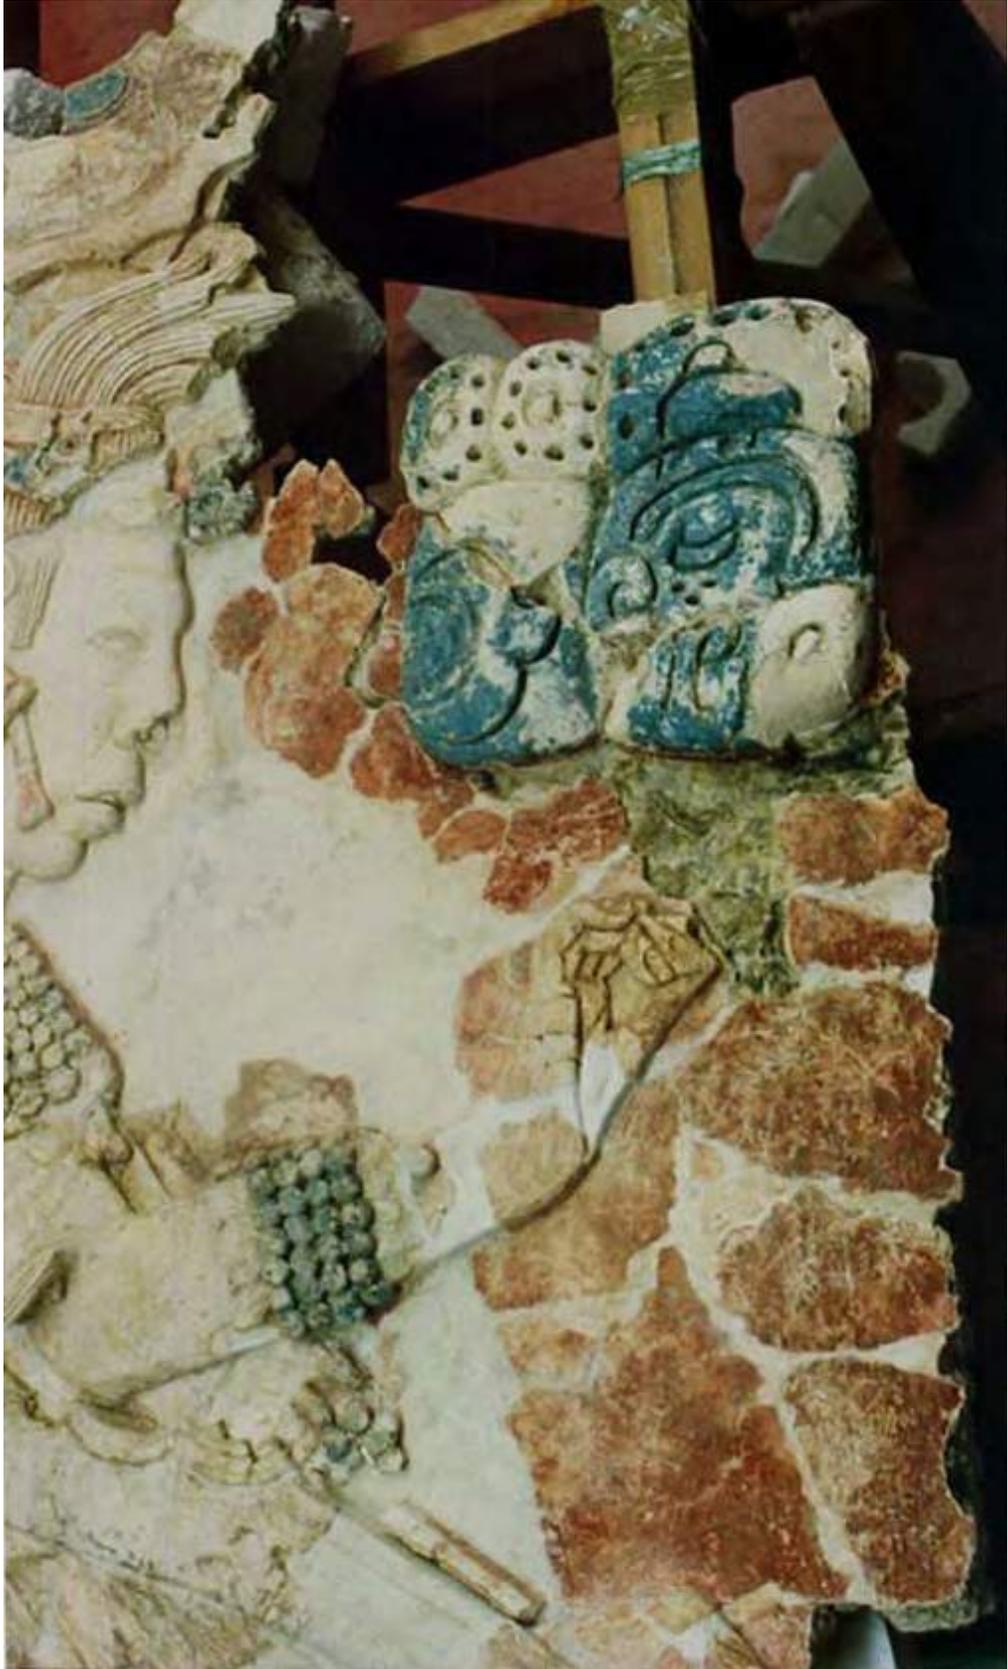
Photo 57. Repairs with ribs paste in the front

Repairs with ribs paste were accomplished in the fragments that were being assembled, both in the joints and the space between fragments (see [photo 57](#)), considering that this paste, when melted with a soldering iron, provides a greater resistance for movements as well as a greater flexibility (see [photo 58](#)).

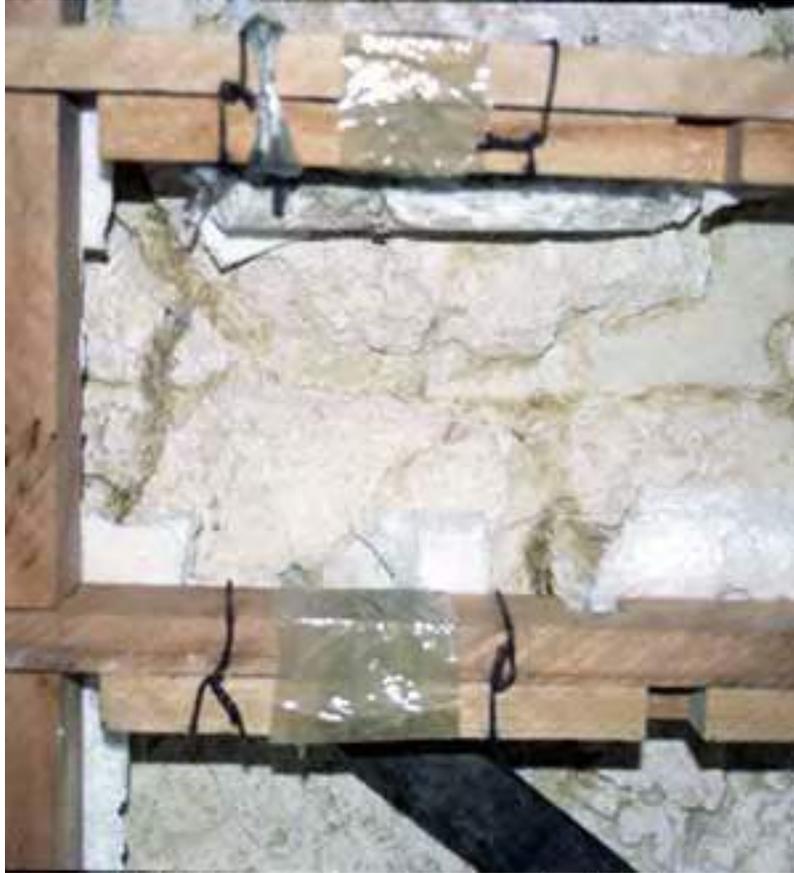
Photo 58. Repairs with ribs paste in the back

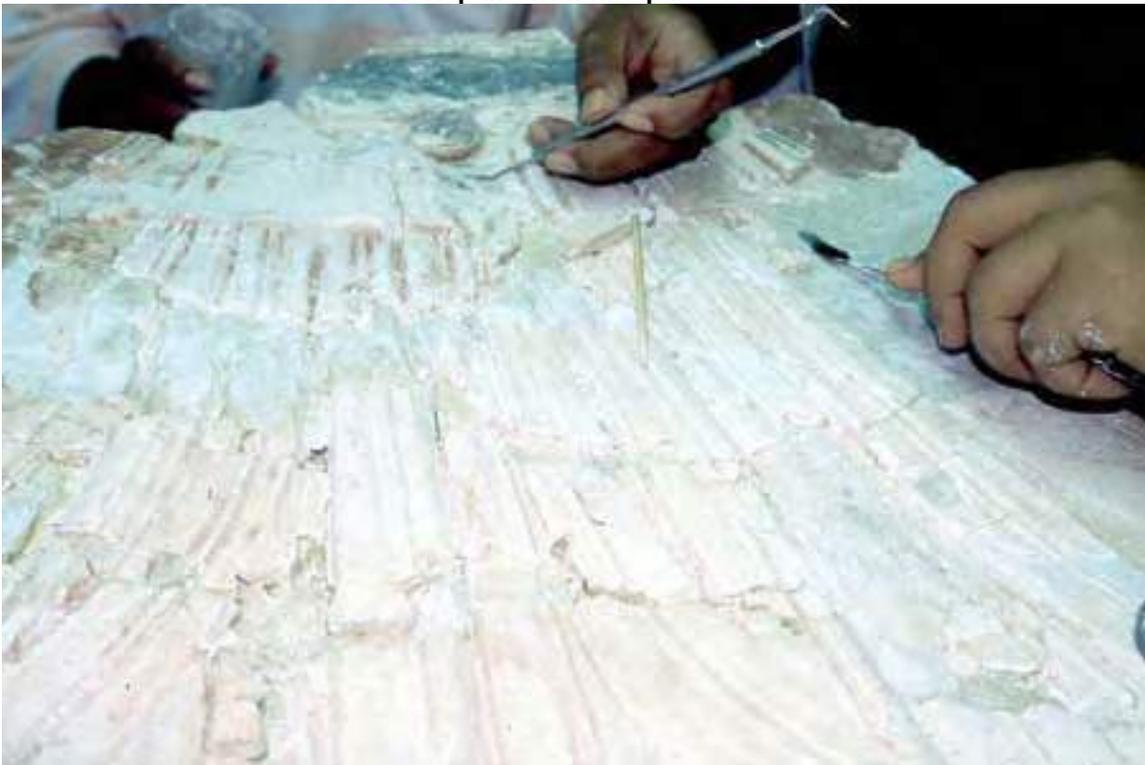
Photo 59. Repairs in joints with ceramic paste

Once repairs with ribs paste were completed, we proceeded with fine repair using a ceramic paste (see [photo 59](#)); this paste was also used to complete a number of forms (see [photo 60](#) and [photo 61](#)).

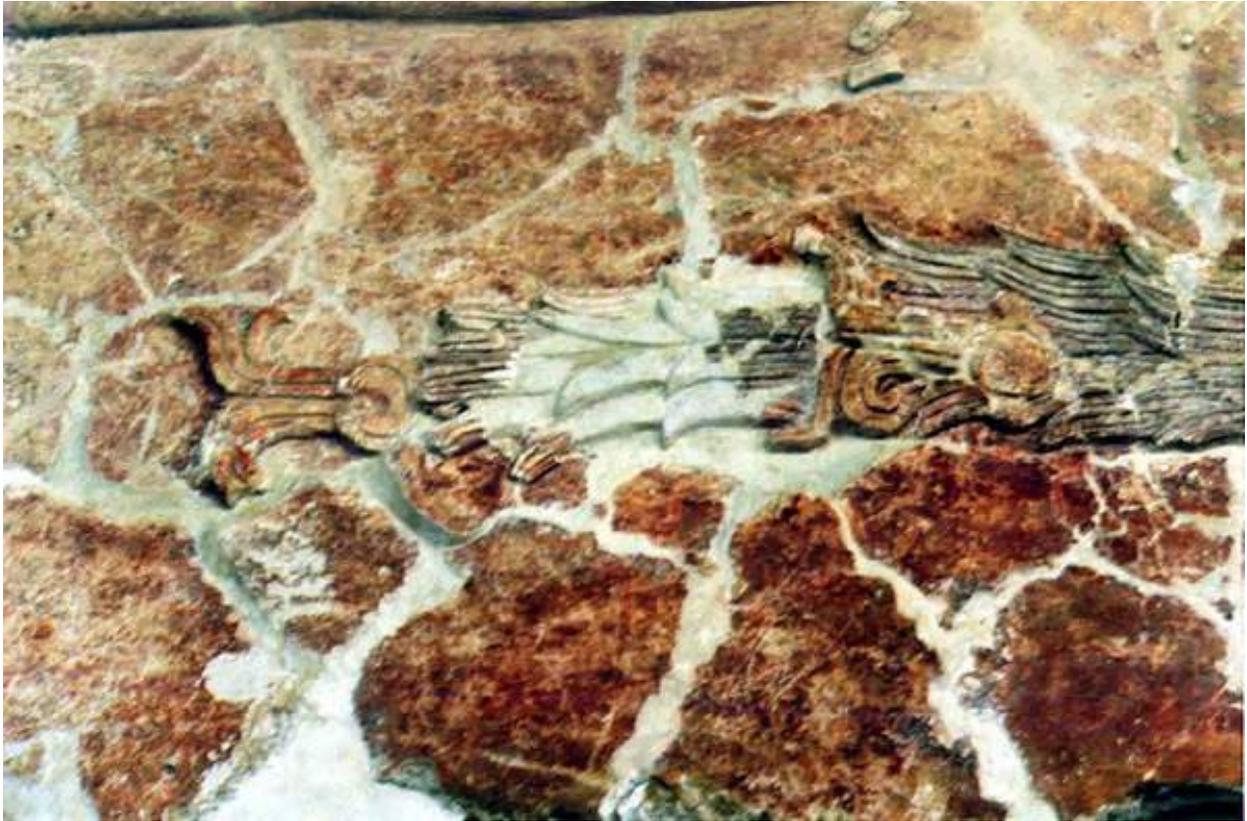
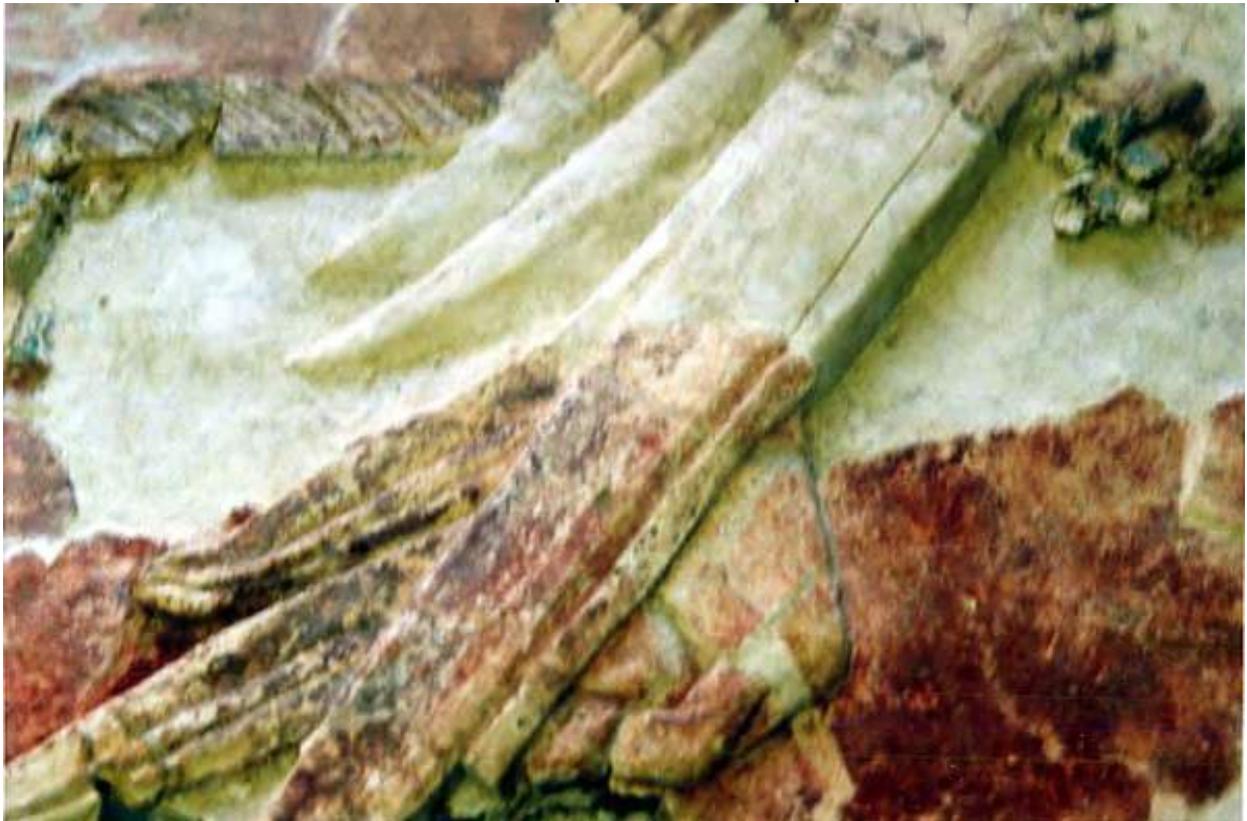
Photo 60. Repairs with ceramic paste

Photo 61. Repairs with ceramic paste
