Stucco Relief from Structure XIX, Palenque

by: Marcia Valle Rangel and Juan Alfonso Cruz Becerril

Research Year: 1999

Site: Palenque, Group of the Cross

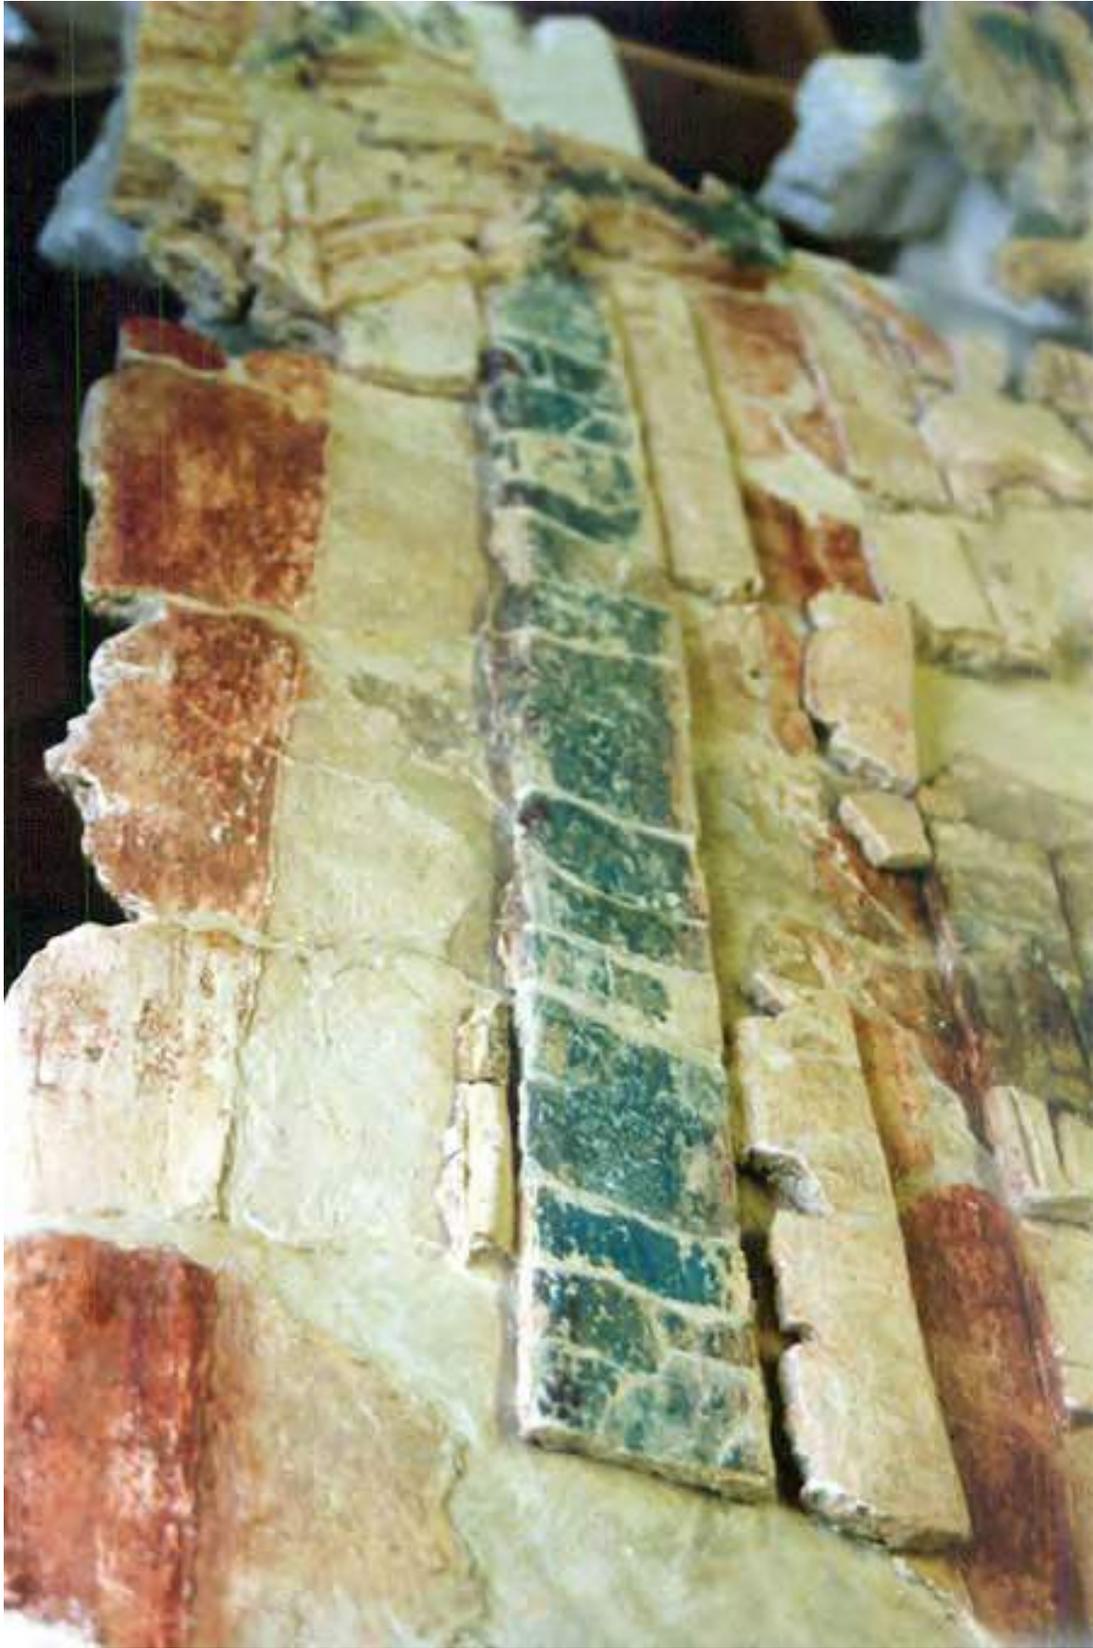
Photo 62. Joining of the *pastillaje*

Parallel to the process of repairing with the ceramic paste, we began with the process of assembling the fragments of embroidered clay (*pastillaje*) by using Mowithal B60H as an adhesive, to later continue the repairs with ceramic repairing paste (see [photo 62](#)).

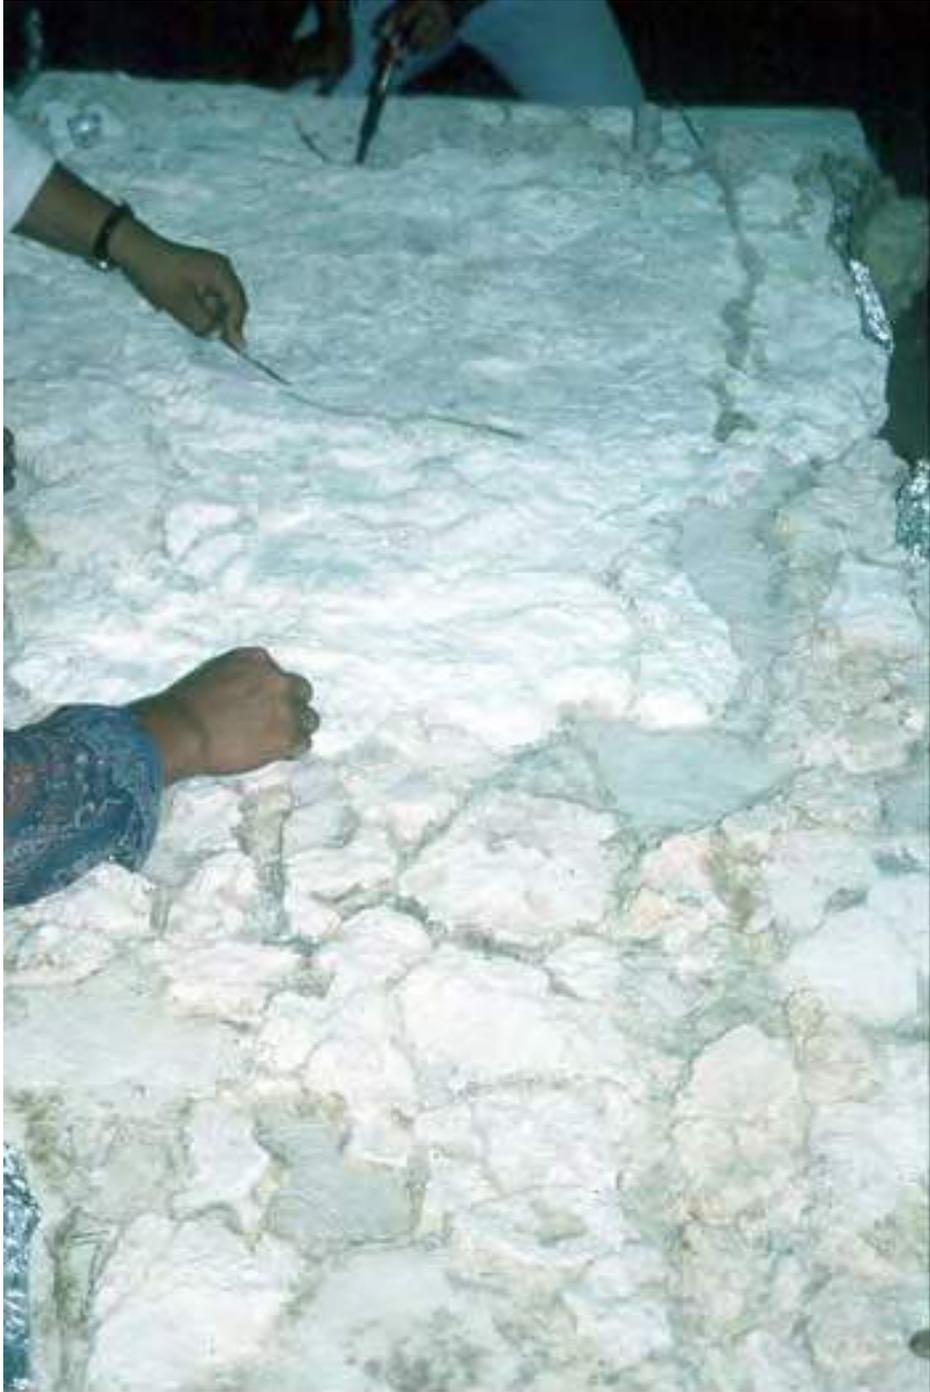
Photo 69. Repairs on the reverse of the stucco panel

With the purpose of obtaining a semi-uniform surface in the back, the largest protuberances were mechanically removed with a surgical knife; later, the cracks and fractures were repaired with ribs paste, heating the largest ones with a soldering iron, and treating in the same way every small hole observed in the stucco (see [photo 69](#)).

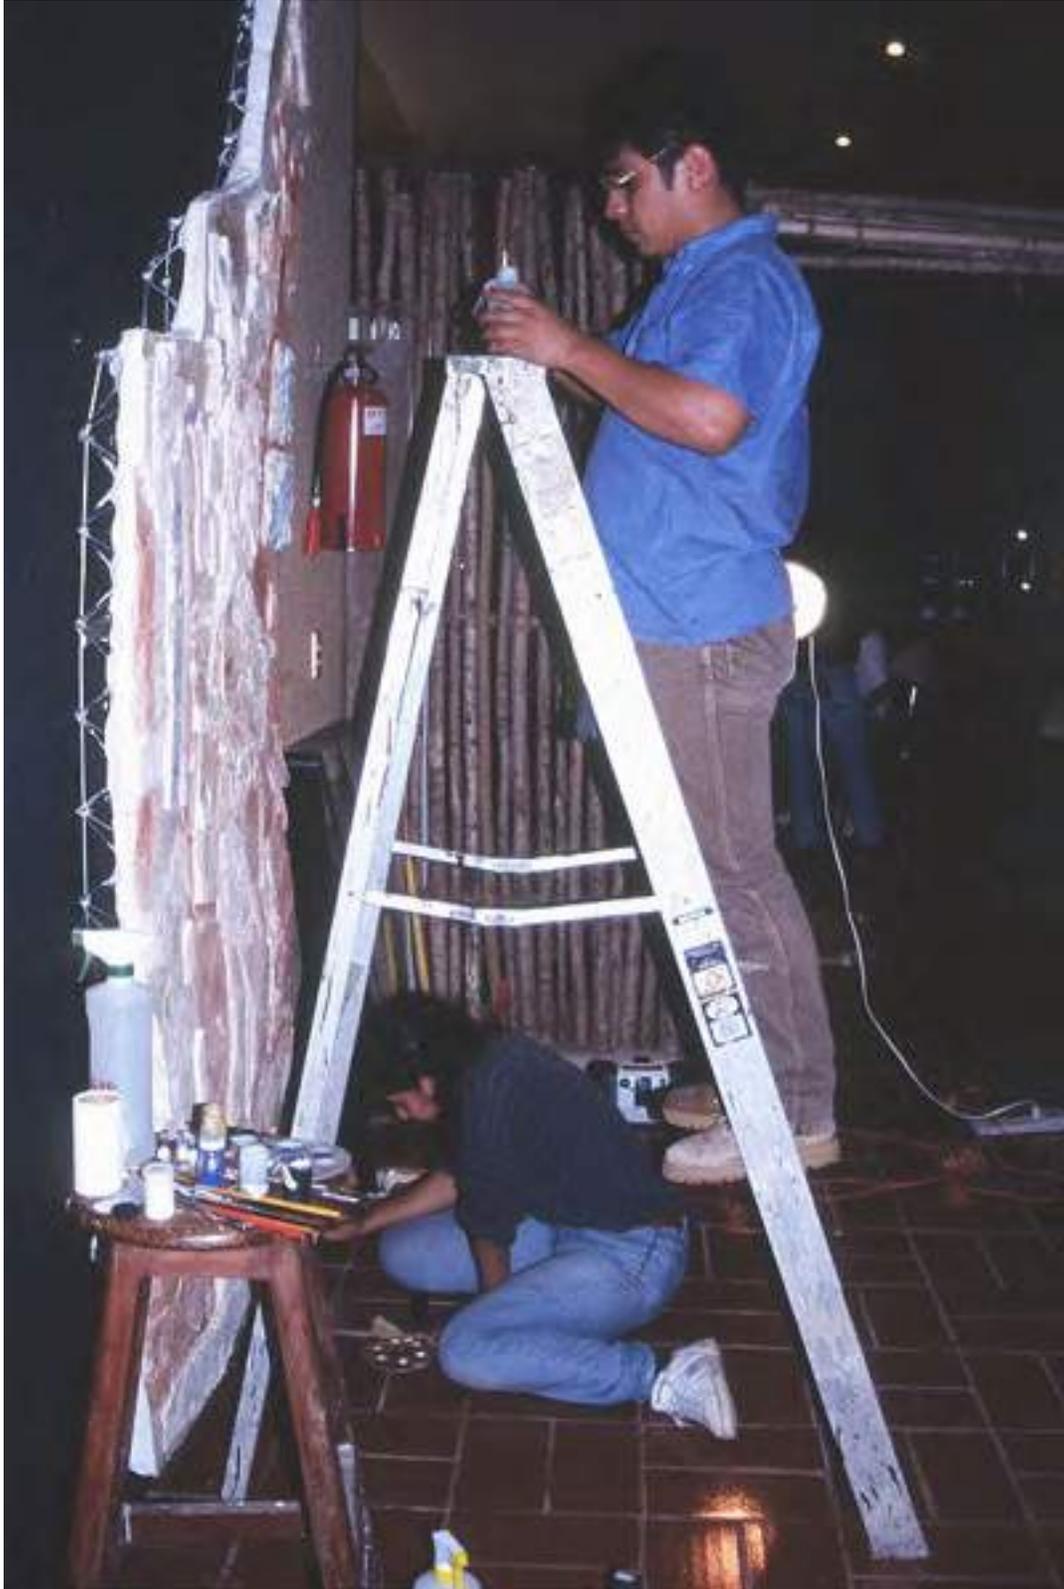
Photo 76. Color reintegration

Mineral pigments were used to attenuate the visibility of the repairs so that they would not be obvious to the eye (see [photo 76](#)).
