Stucco Relief from Structure XIX, Palenque

by: Marcia Valle Rangel and Juan Alfonso Cruz Becerril

Research Year: 1999

Site: Palenque, Group of the Cross

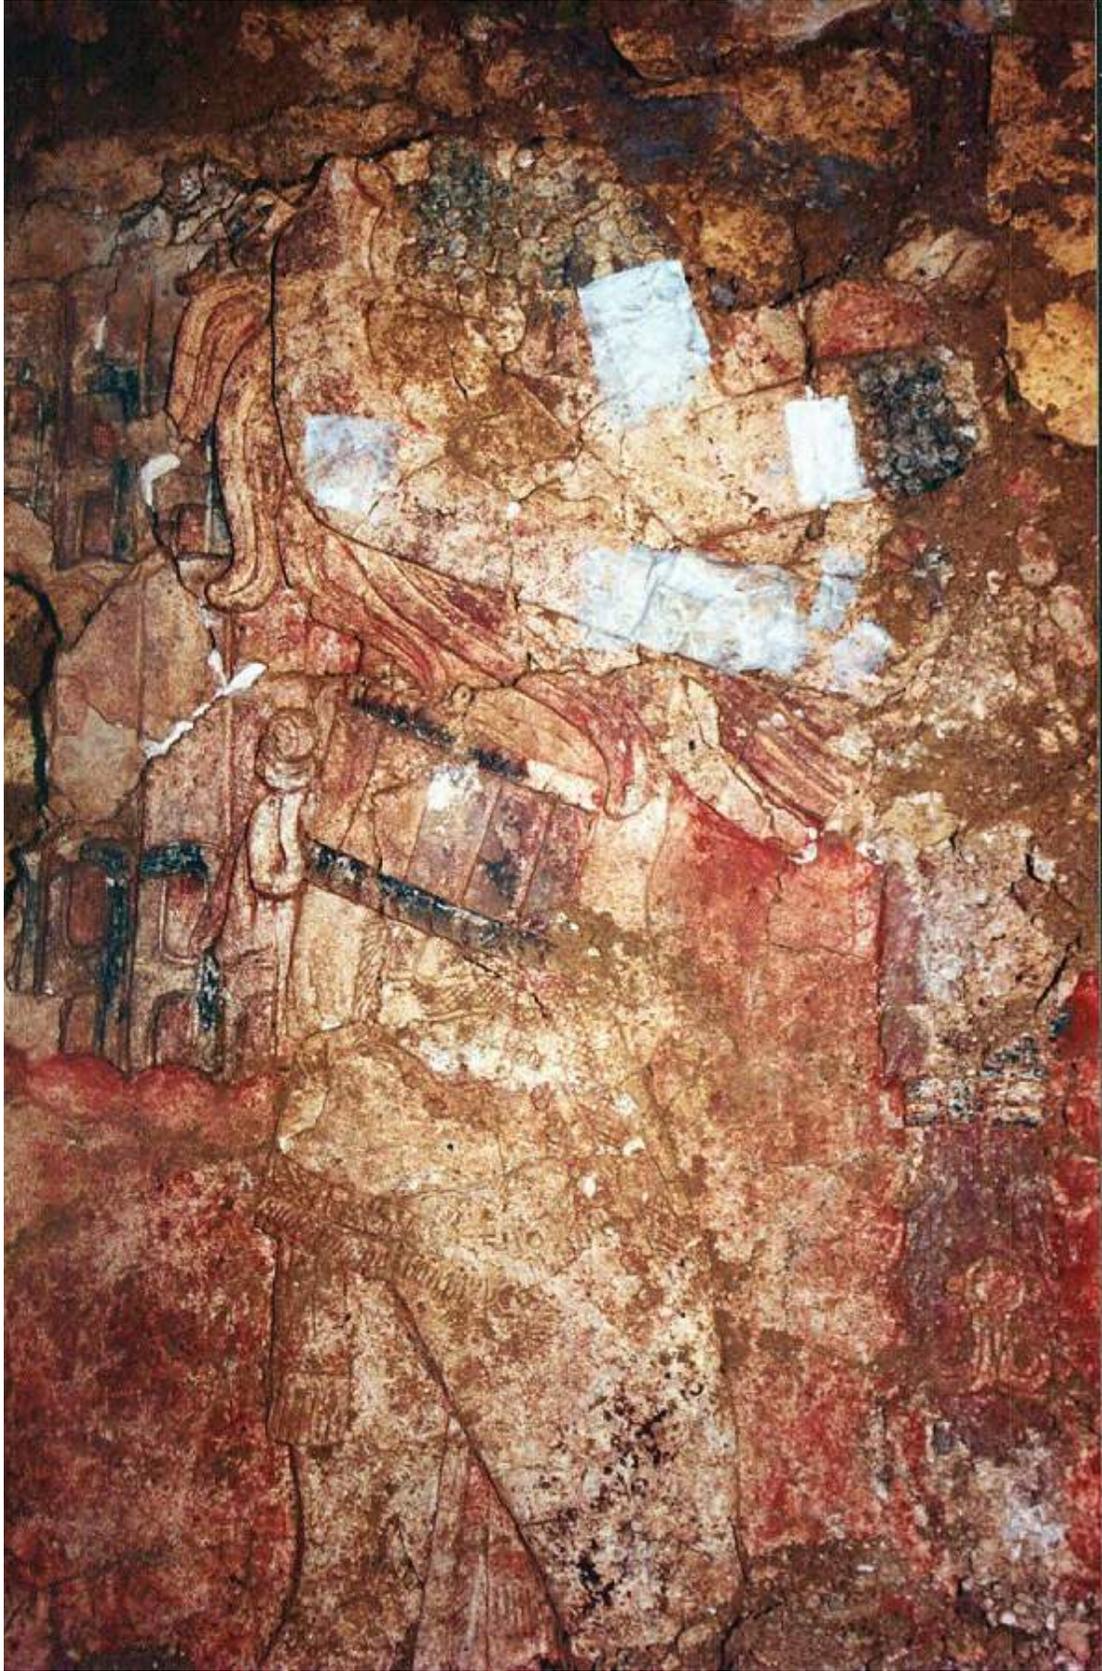
As the excavation work progressed, the remains of a molded stucco relief were uncovered, attached to the jamb of the central pilaster (see [photo 6](#)). Once the pilaster was completely liberated, we were able to fully appreciate the magnitude of this relief and its state of preservation (see [photo 7](#), below). Finally, upon the full liberation of the pilaster it was inferred that the approximate portion of the stucco relief in situ amounted to 40%, while the rest of it was mixed with the rubble (see [photo 8](#), shown below).

Photo 7. Stucco relief attached to pilaster

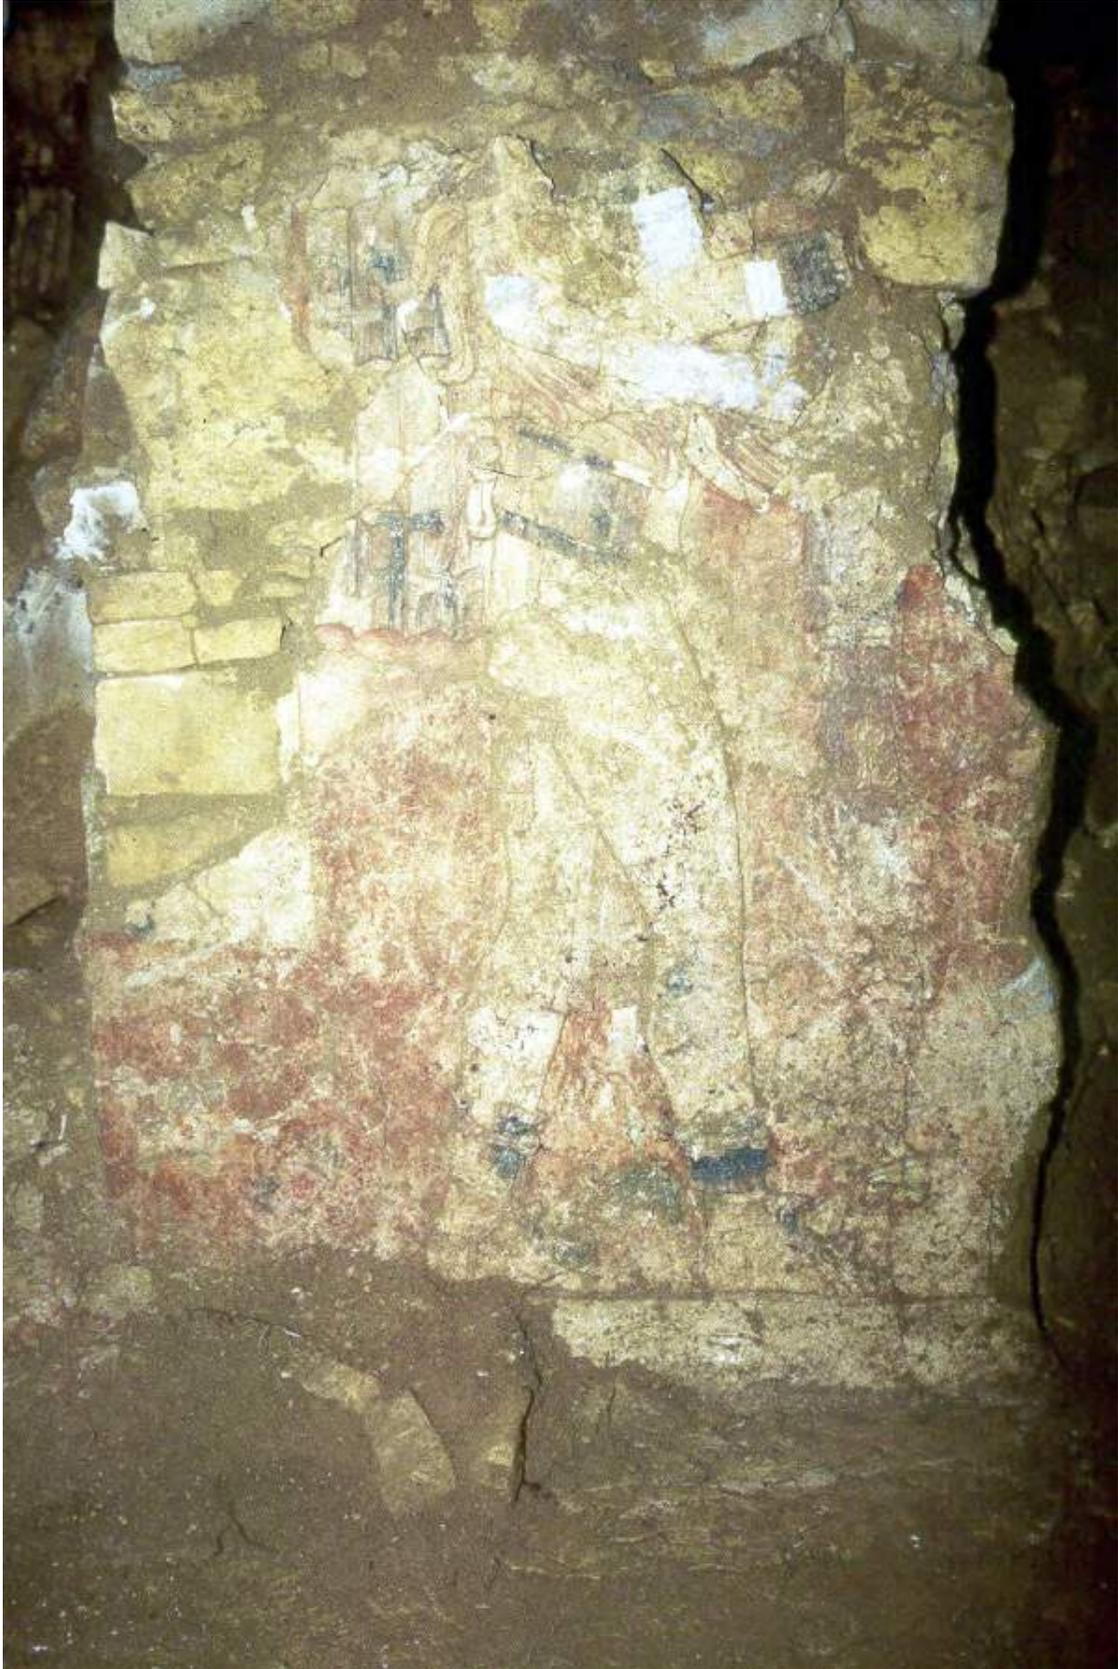
Photo 8. Stucco relief attached to pilaster

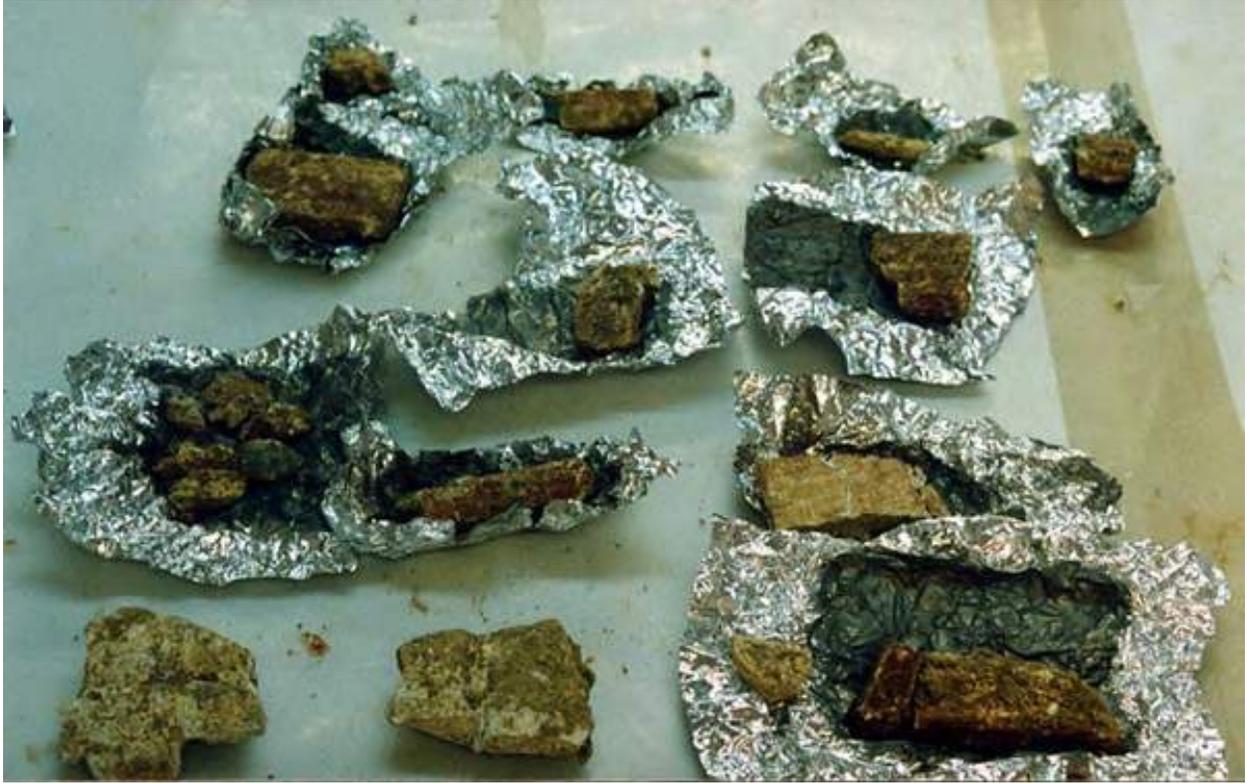
Photo 14. Stucco found in the rubble

- Once all the materials were taken to the lab, they were sorted according to their point of origin, separating those that were found among the rubble (see [photo 14](#), and [photo 15](#)), and the fragments detached from the pilaster (see [photo 16](#)); then, according to this classification the processes of cleaning, consolidation and assembly of the fragments was undertaken, according to the requirements of each piece. Later, a separation and preliminary grouping of materials was carried out depending on shapes, colors, paste types and their thickness (see [photo 17](#), and [photo 18](#)).

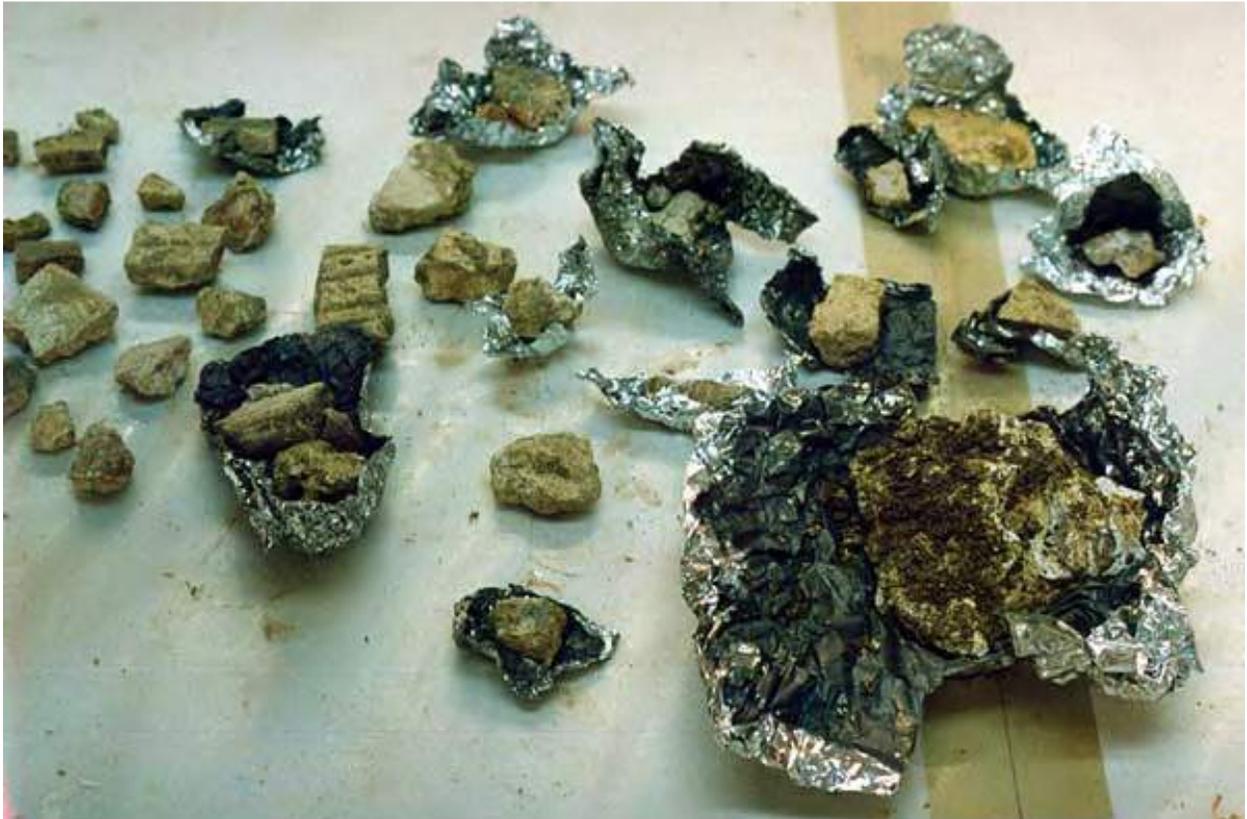
Photo 15. Stucco found in the rubble

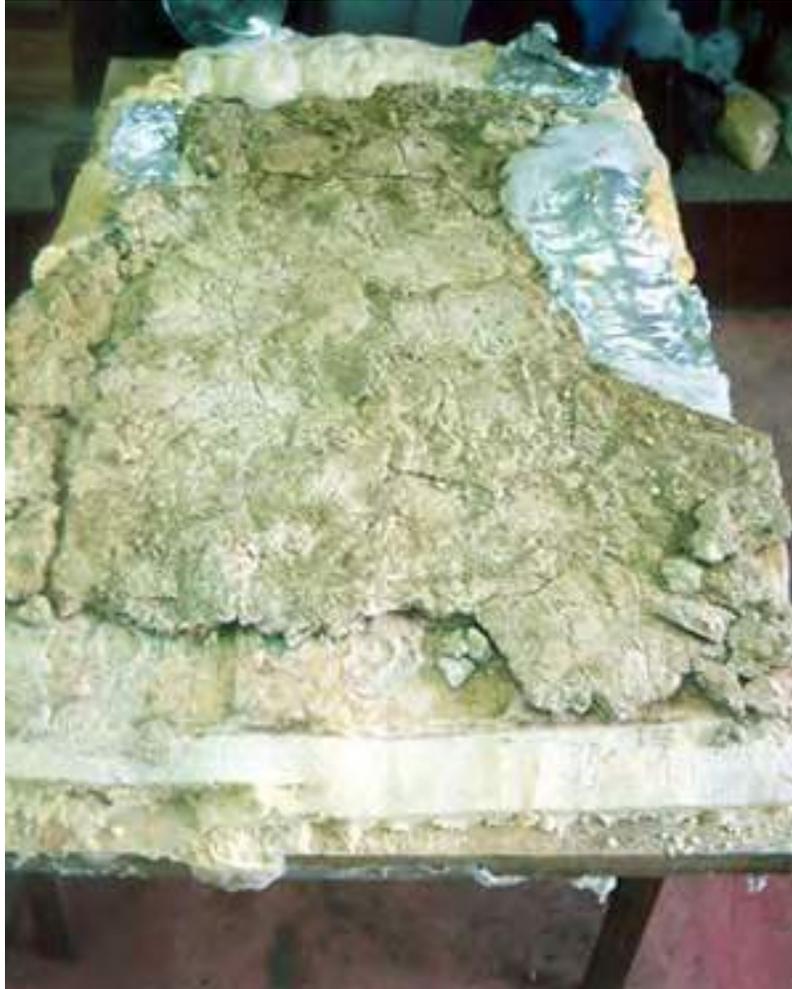
Photo 16. Reverse of detached fragment of the stucco relief

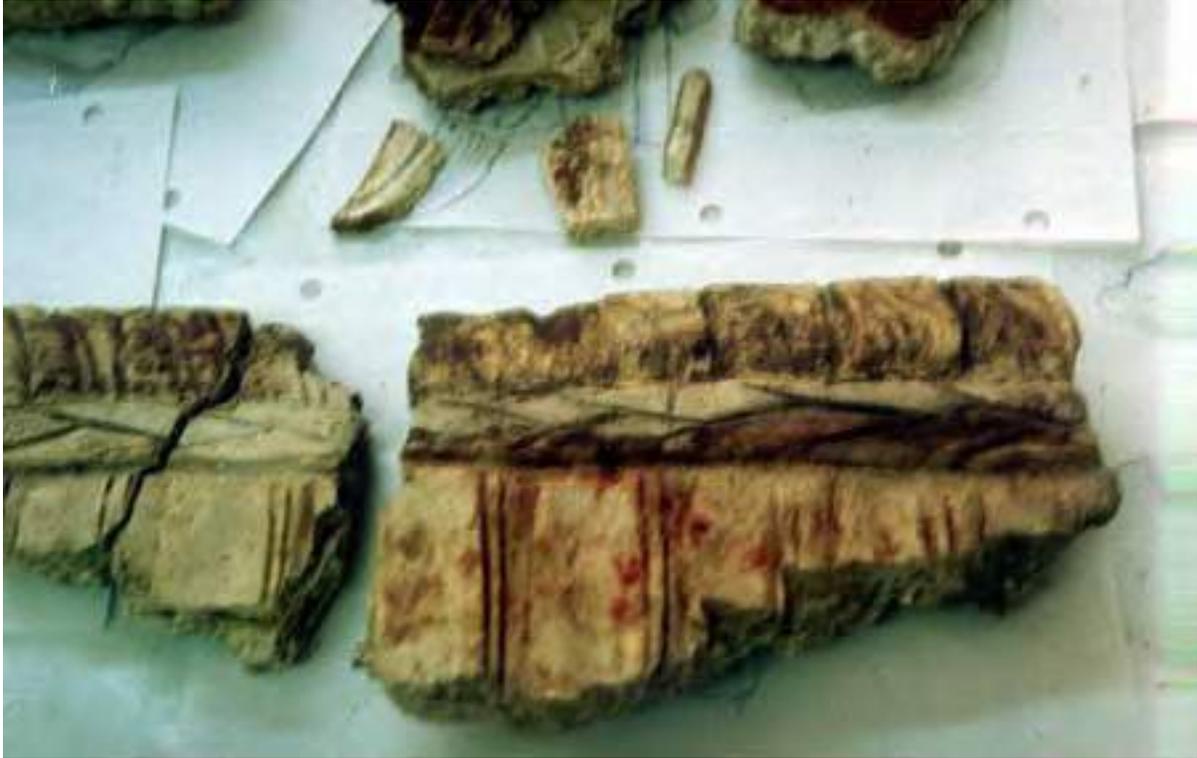
Photo 19. Superficial cleaning of stucco fragments found in rubble

- Stucco fragments found in the rubble: These fragments underwent the superficial, mechanical cleaning processes, by means of soft brushes, small brushes, a surgical knife, a dissection needle and a small pear-shaped air pump to remove clay, carbonates, and organic material remains such as roots (see [photo 19](#)).
- Detached fragment: On the reverse of this fragment a superficial, mechanical cleaning was completed, using soft brushes, small brushes, a surgical knife, a dissection needle and a small pear-shaped air pump to eliminate clay, soluble salts and non-stucco materials, such as organic remains, stones, etc. (see [photo 20](#)).

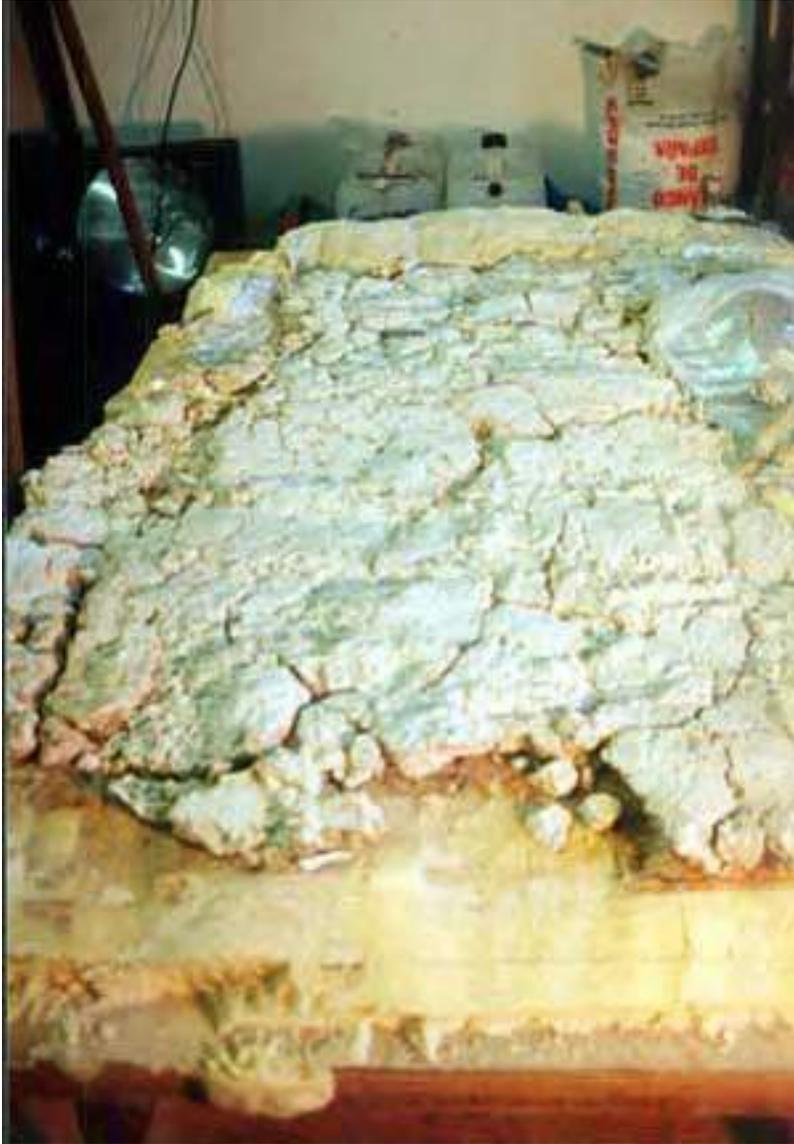
Photo 20. Superficial cleaning of reverse of detached fragment

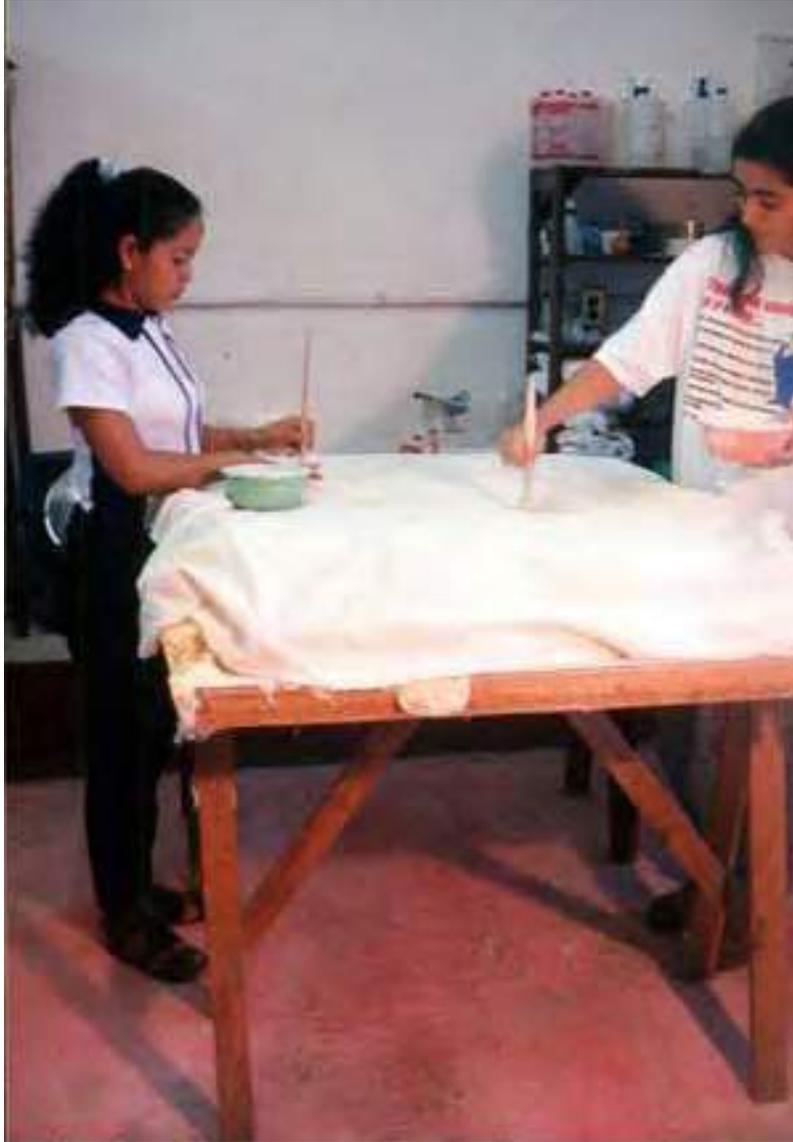
Photo 28. Covering with Guadalajara cloth and calcium caseinate

- 1 covering with a Guadalajara cloth and calcium caseinate: Later, a second covering was accomplished with Guadalajara cloth and calcium caseinate (see [photo 27](#)) applied with a brush, attaching it to the cheesecloth to avoid air bubbles (see [photo 28](#)).

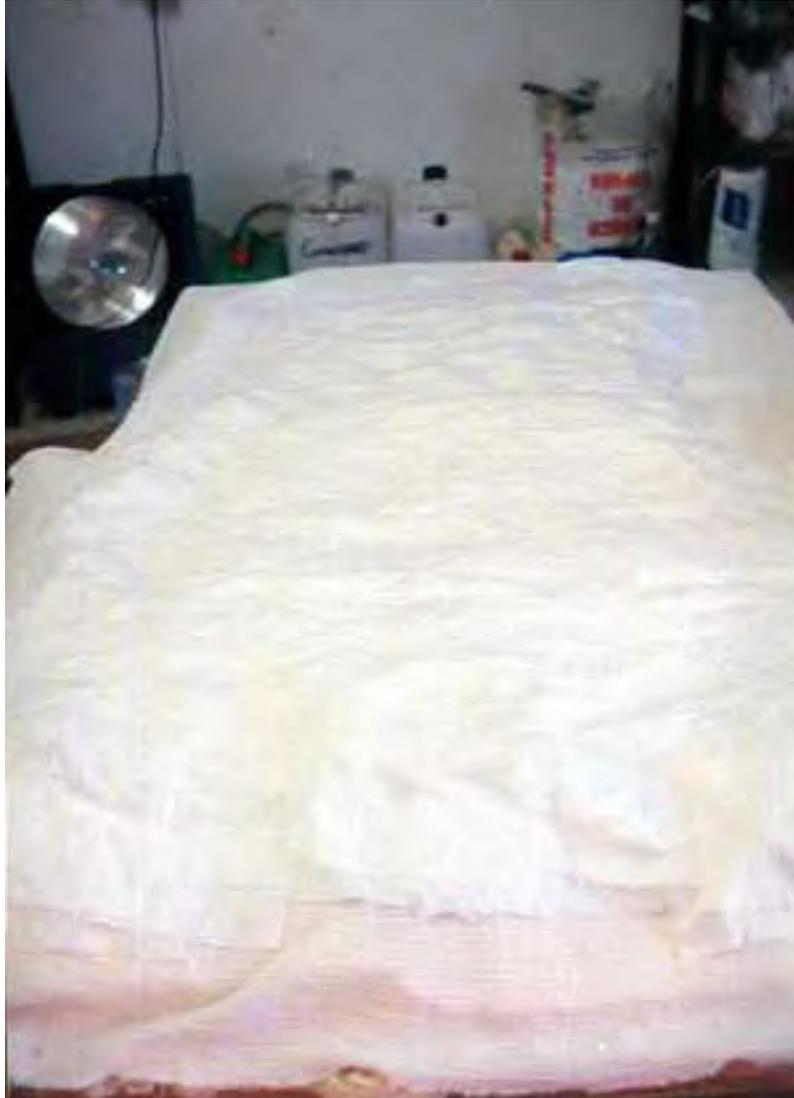
Photo 29. Insulating layers of tissue paper

- 2 layers of folded tissue paper (see [photo 29](#)): Then, a provisional insulating layer of tissue paper was applied, which was adhered by humidity (see [photo 30](#)). Once this layer dried up, cardboard retainers were added to maintain the provisional support in place (see [photo 31](#)).

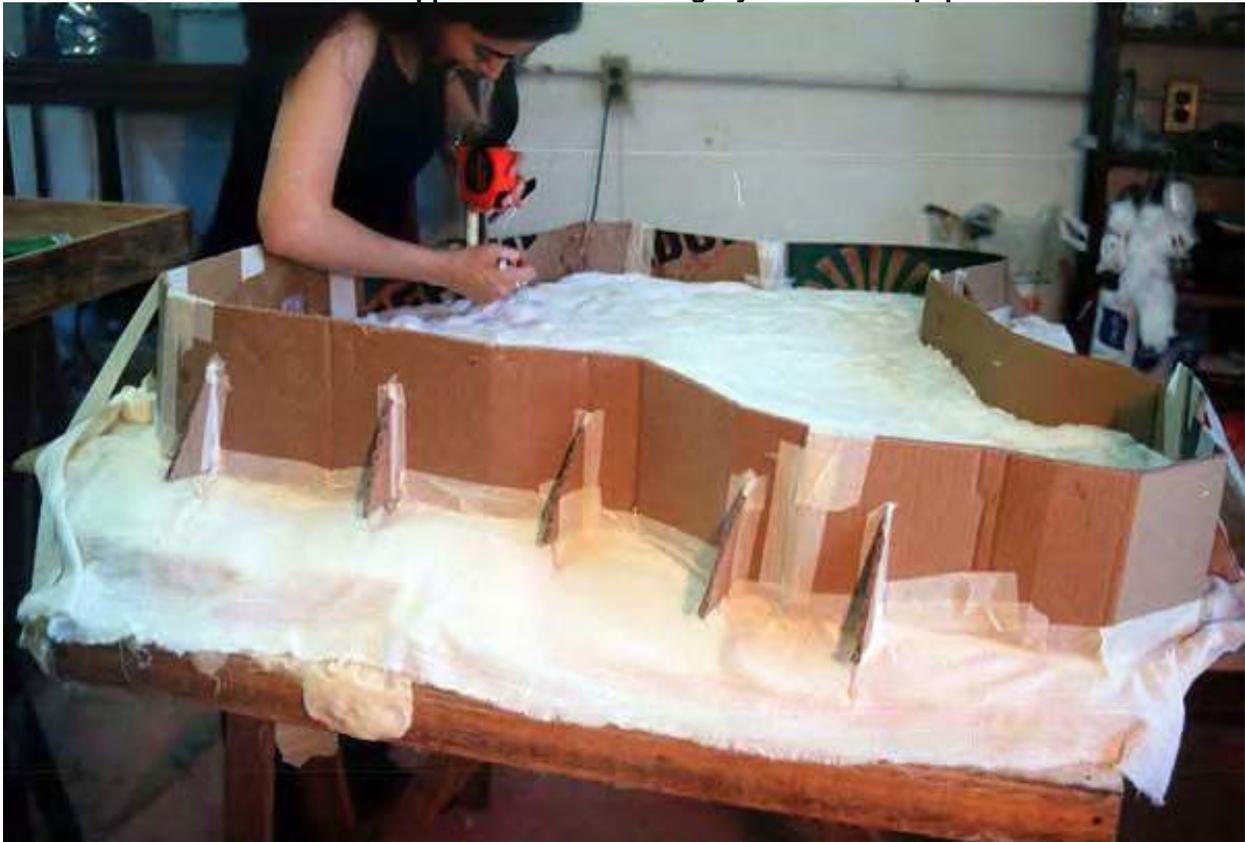
Photo 31. Placement of cardboard retainers to hold the provisional support

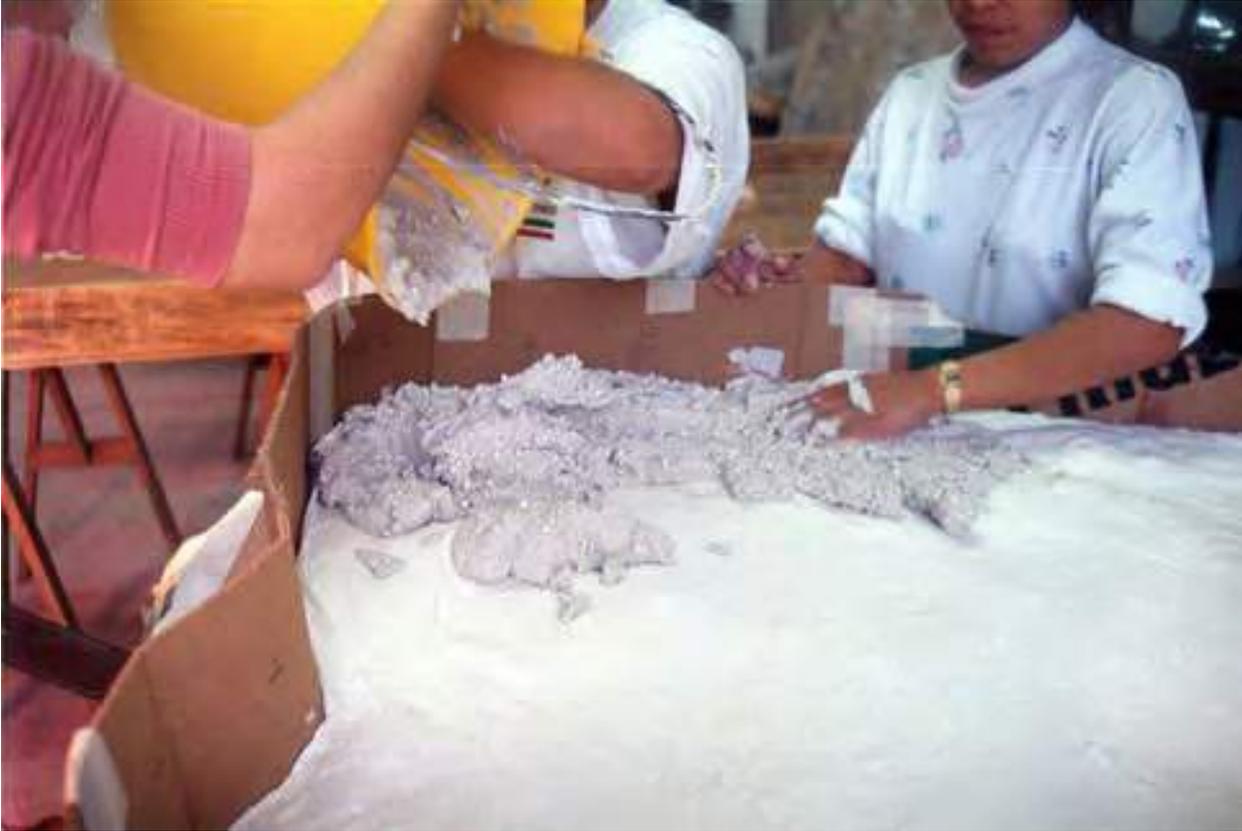
Photo 32. Application of plaster with polystyrene pearls

- Plaster with polystyrene pearls: Once the layer of tissue paper dried up, a plaster layer with a load of polystyrene pearls was applied (see [photo 32](#)) to make this layer lighter, functioning at the same time as a provisional support (see [photo 33](#)).
- Plank in the shape of the stucco: When the plaster dried up, a plank in the shape of the stucco was added, to provide the panel with a greater support (see [photo 34](#)).

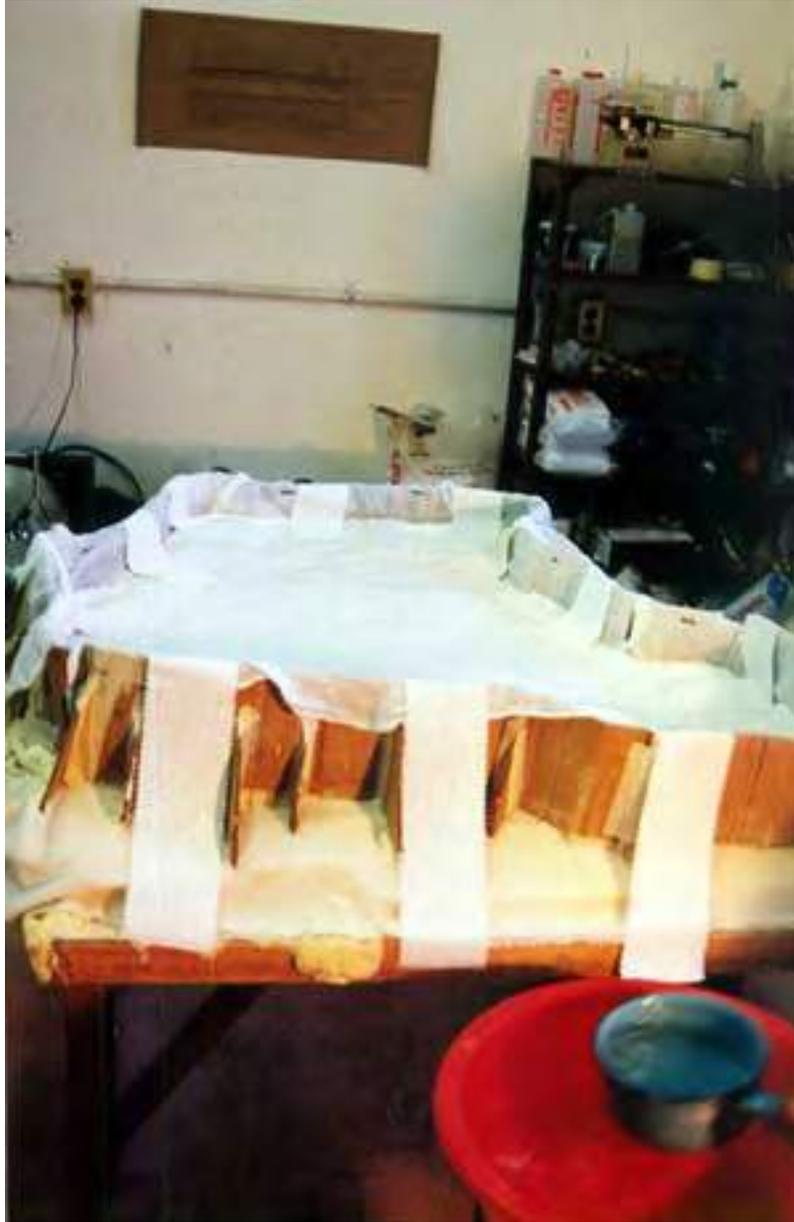
Photo 33. Provisional support

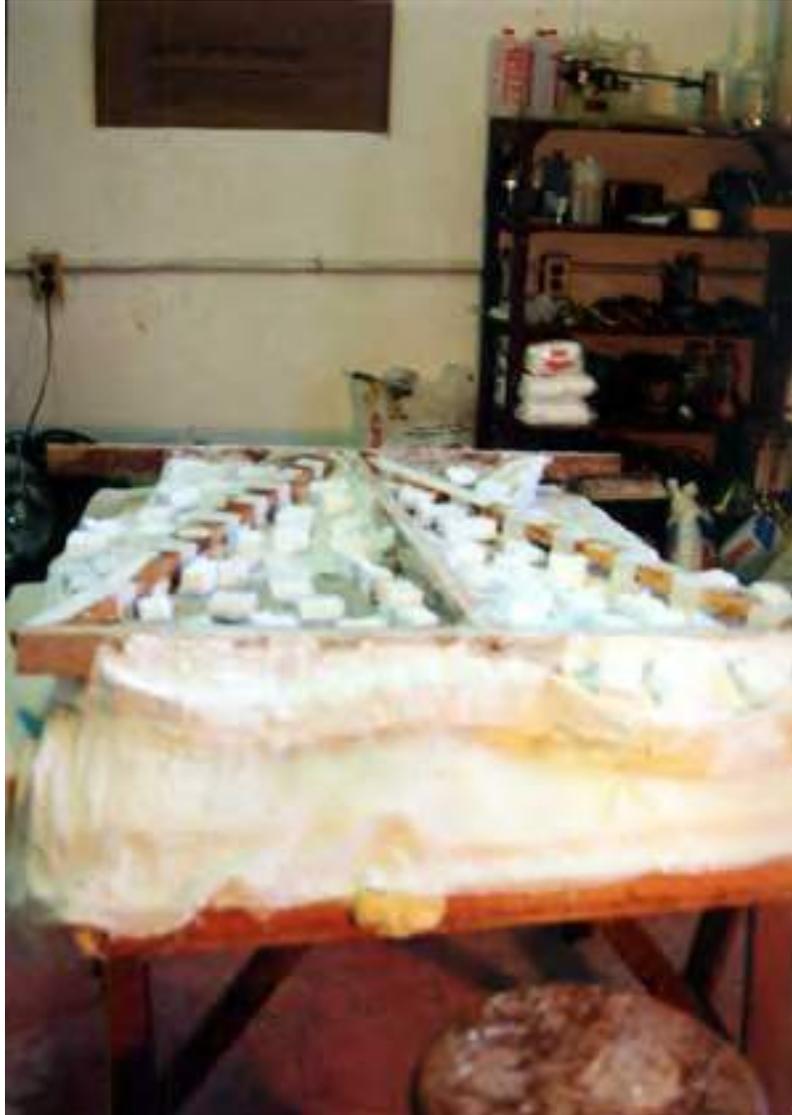
Photo 34. Provisional support and plank with the shape of the fragment

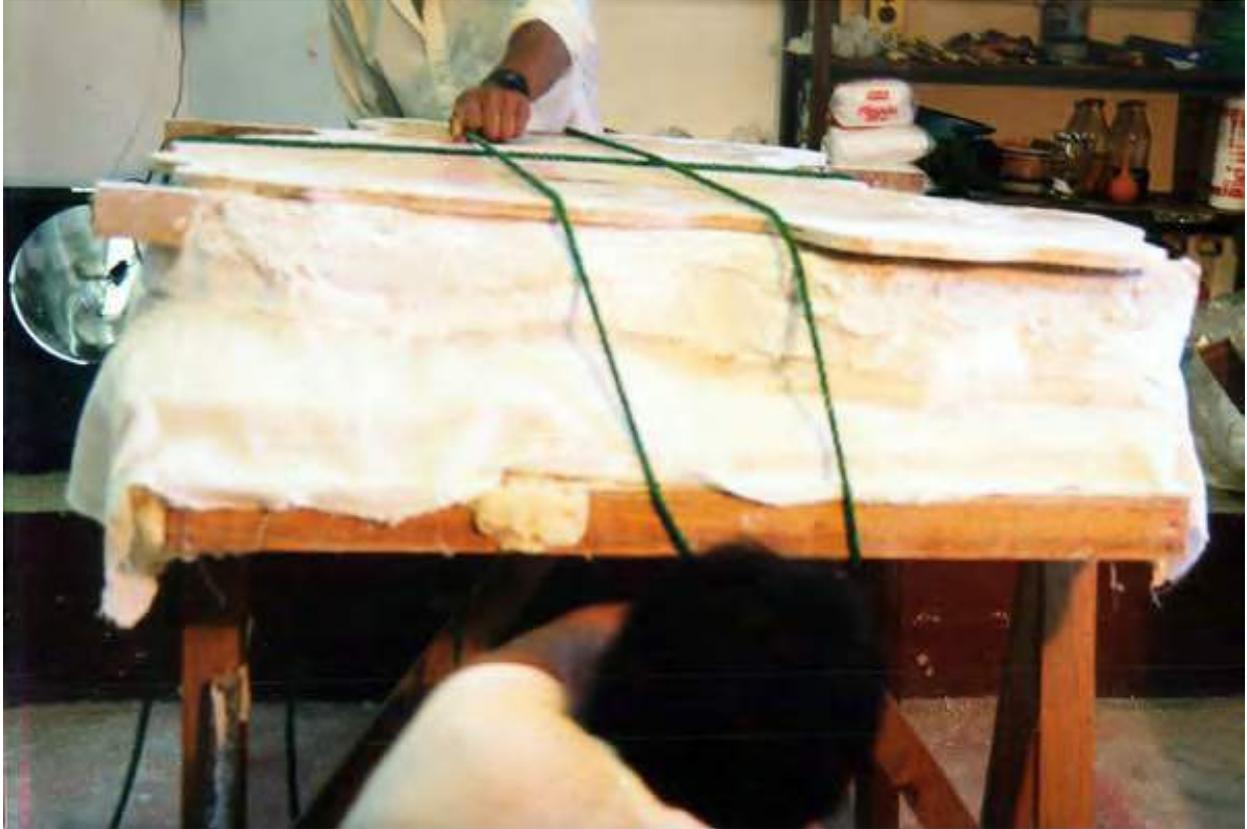
Photo 35. Turning over the fragment detached from wall

Then it was tied up to the plank (see [photo 35](#)) and turned over (see [photo 36](#)), and we proceeded to remove the insulating layers with which the stucco relief was detached from the pilaster of Structure XIX (see [photo 37](#)), which were as follows:

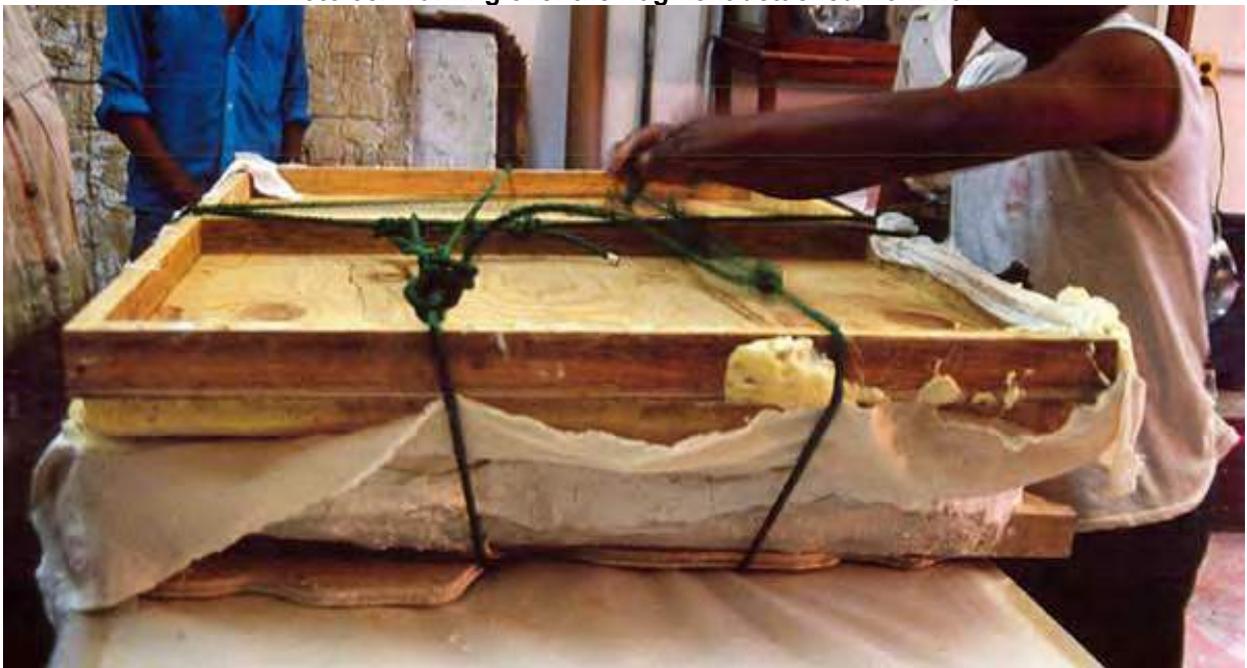
Photo 36. Fragment of stucco relief detached from wall, front

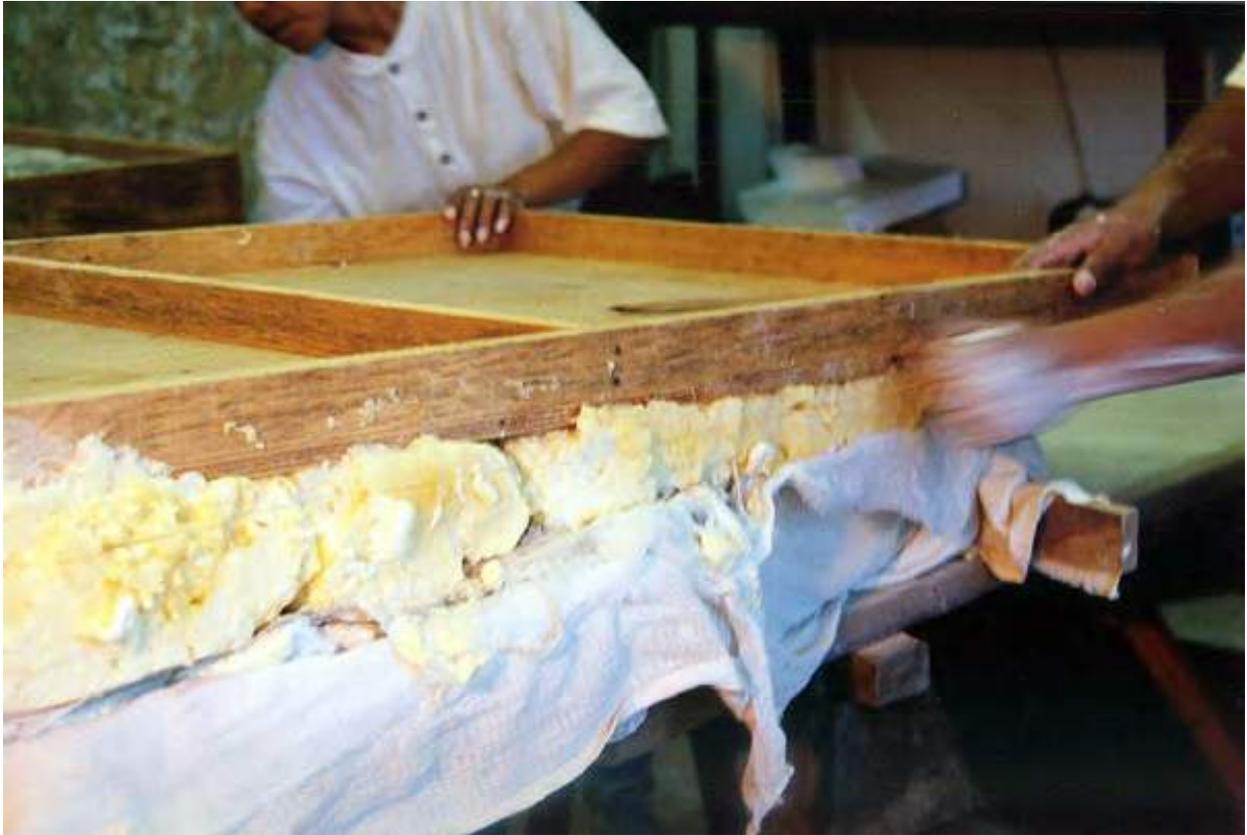
Photo 37. Removal of insulating layers from the detachment

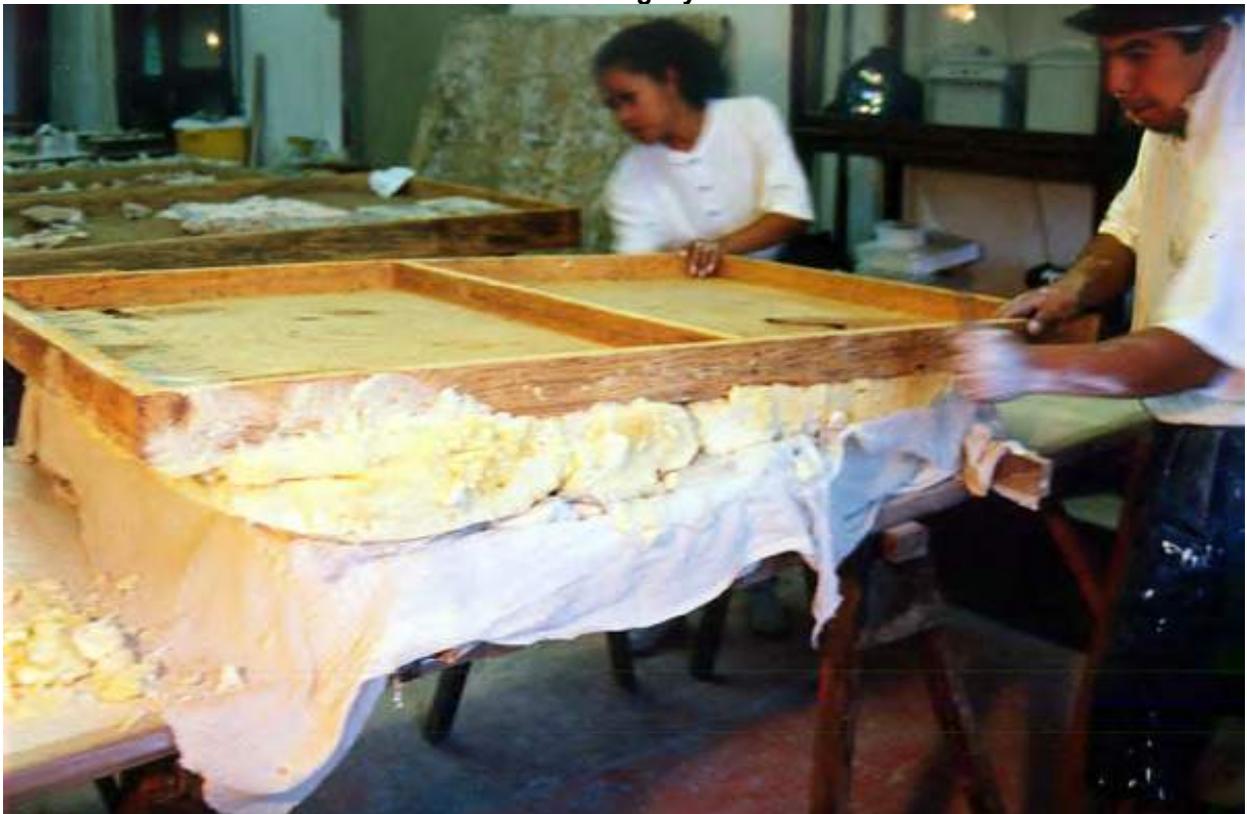
Photo 38. Removal of supporting plank of area detached from wall

1. A plank, as a provisional support (see [photo 38](#)).
2. The layer of polyurethane foam (see [photo 39](#)).
3. The layer of tissue paper.

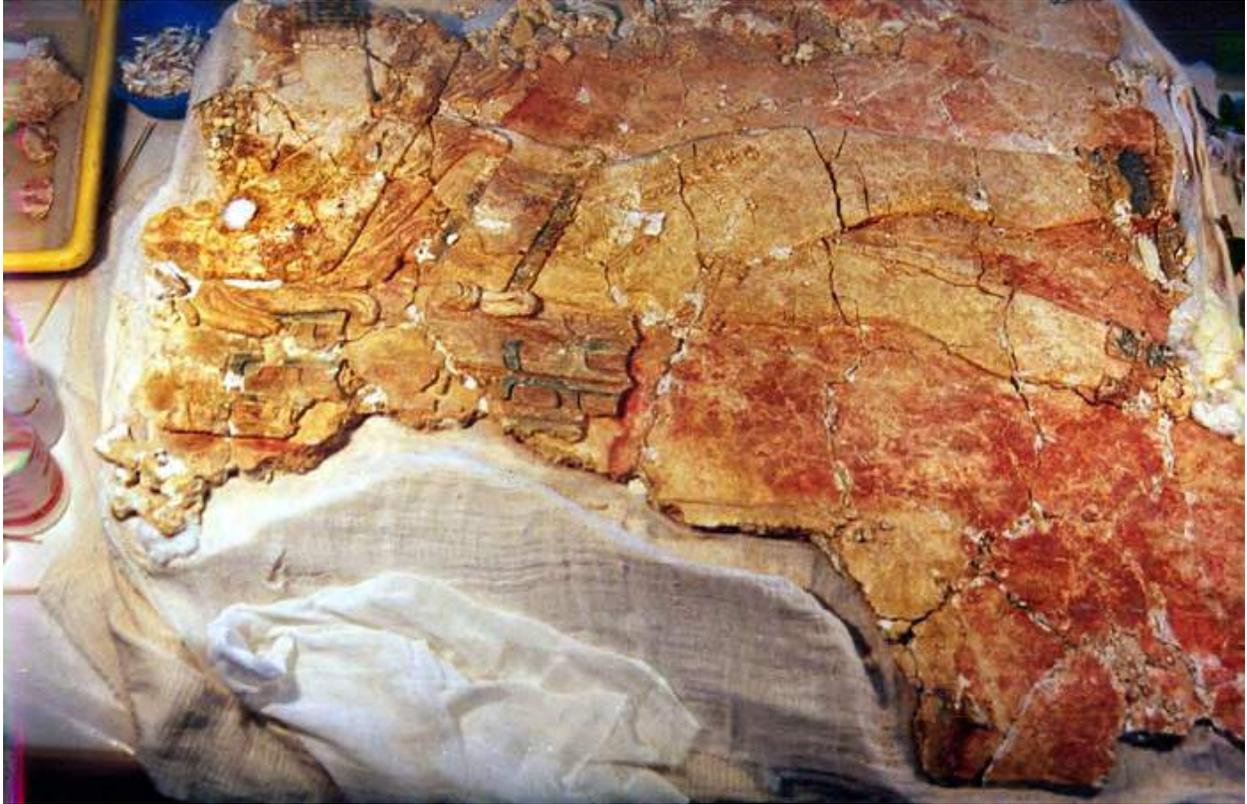
Photo 40. Dry, superficial cleaning of the detached relief

As soon as the layers of the detachment were removed, we proceeded with a superficial dry cleaning using a soft-haired brush to eliminate the powder and the clays on the surface (see [photo 40](#)).

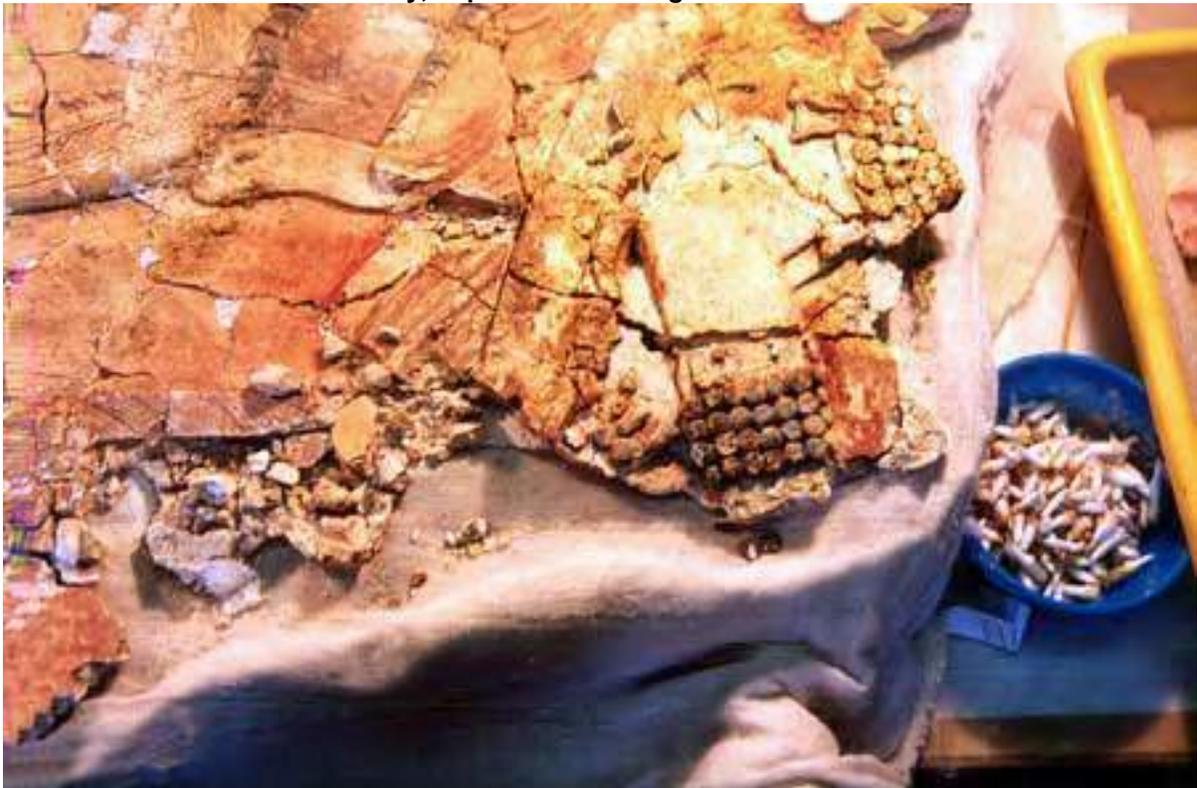
Photo 41. Elimination of partial covers of Japanese paper

Then a chemical cleaning with smooth hyssops while the partial covers of Japanese paper were eliminated (see [photo 41](#)); subsequently, the cracks and fissures were injected with calcium caseinate.
