Stucco Relief from Structure XIX, Palenque

by: Marcia Valle Rangel and Juan Alfonso Cruz Becerril

Research Year: 1999

Site: Palenque, Group of the Cross

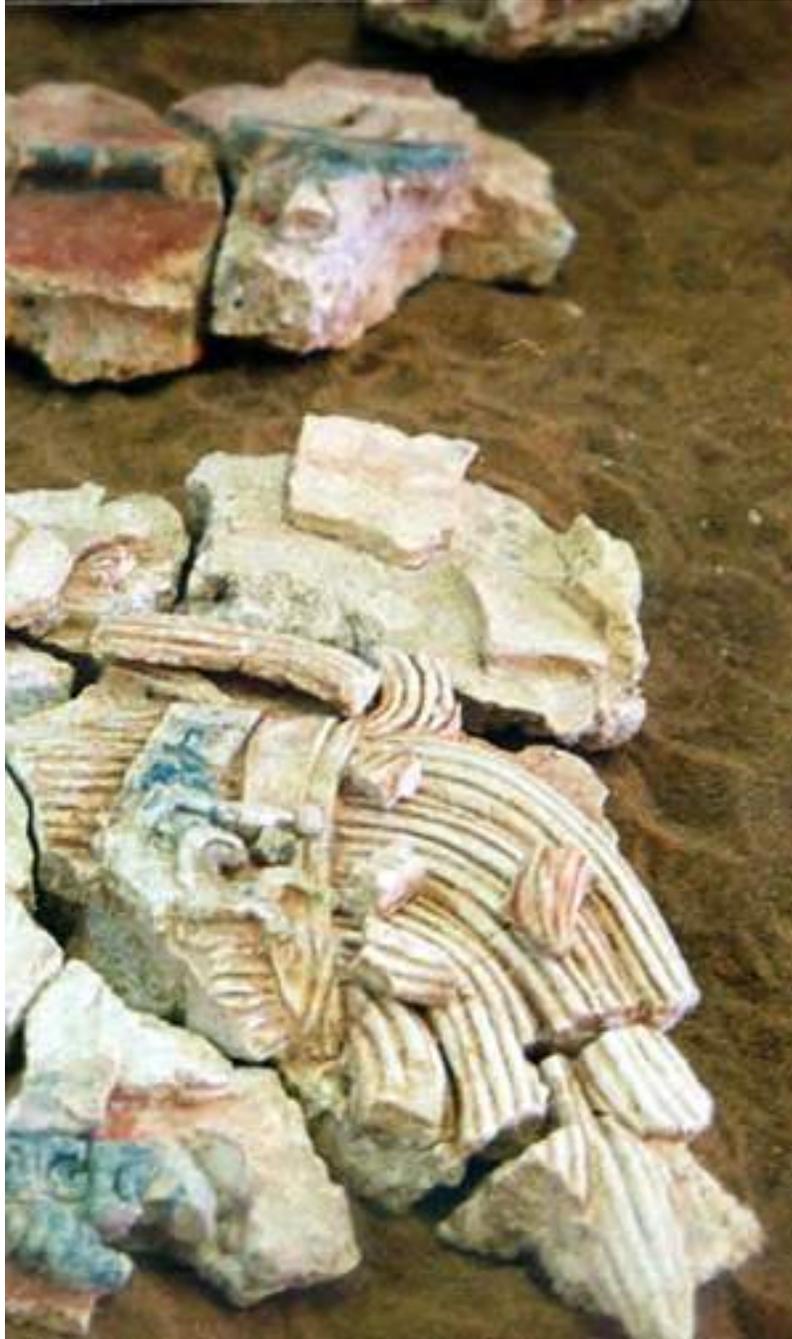
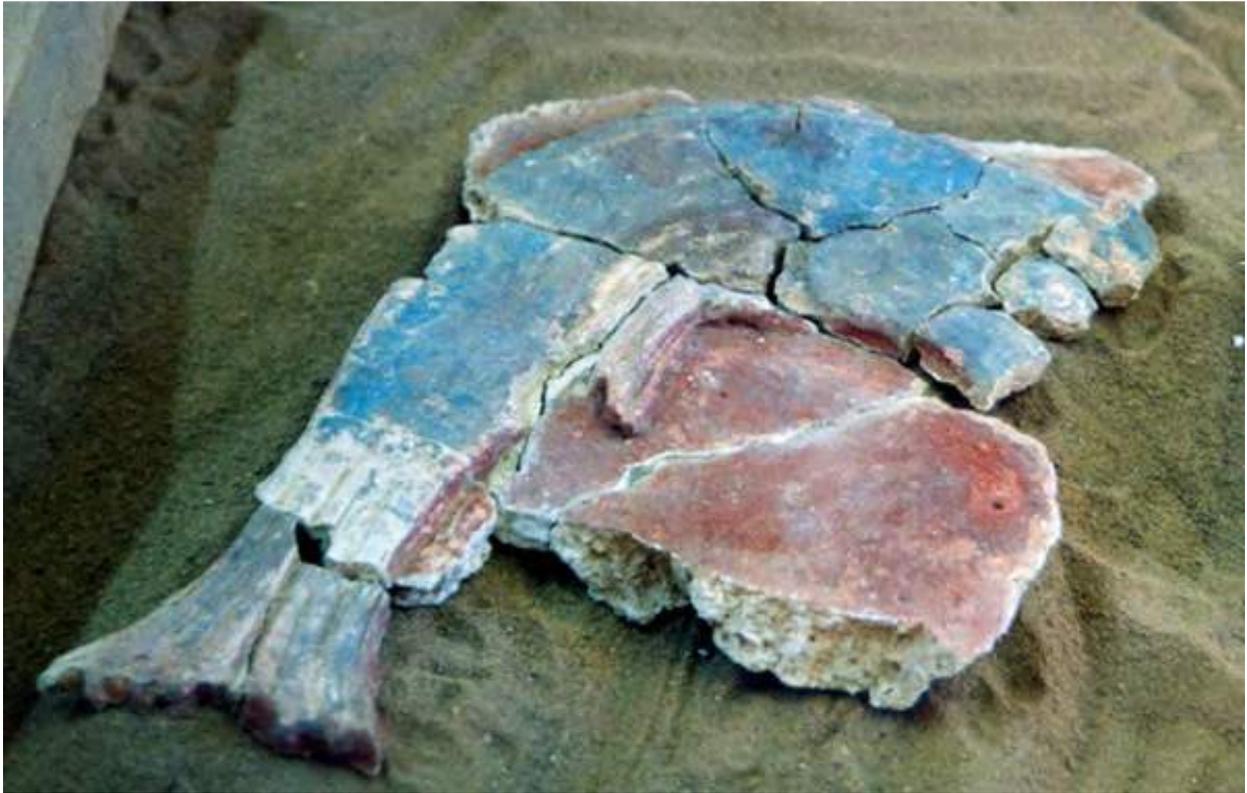
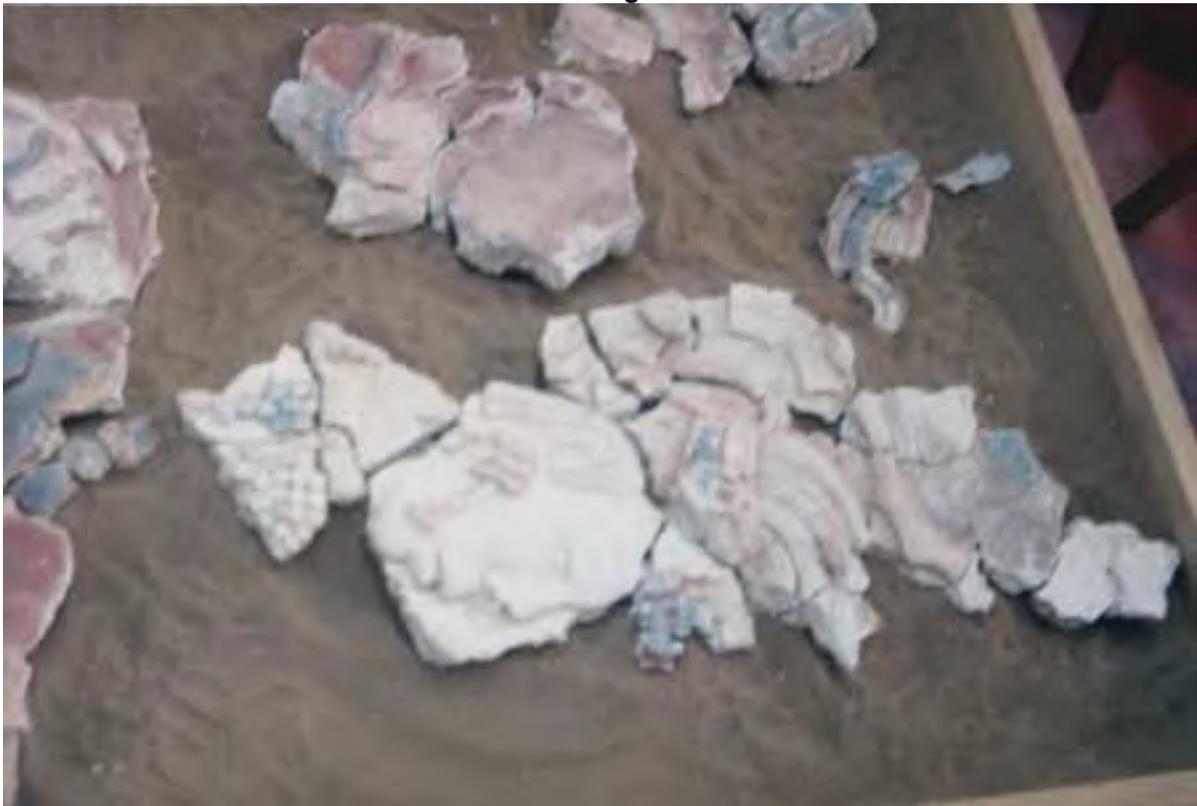
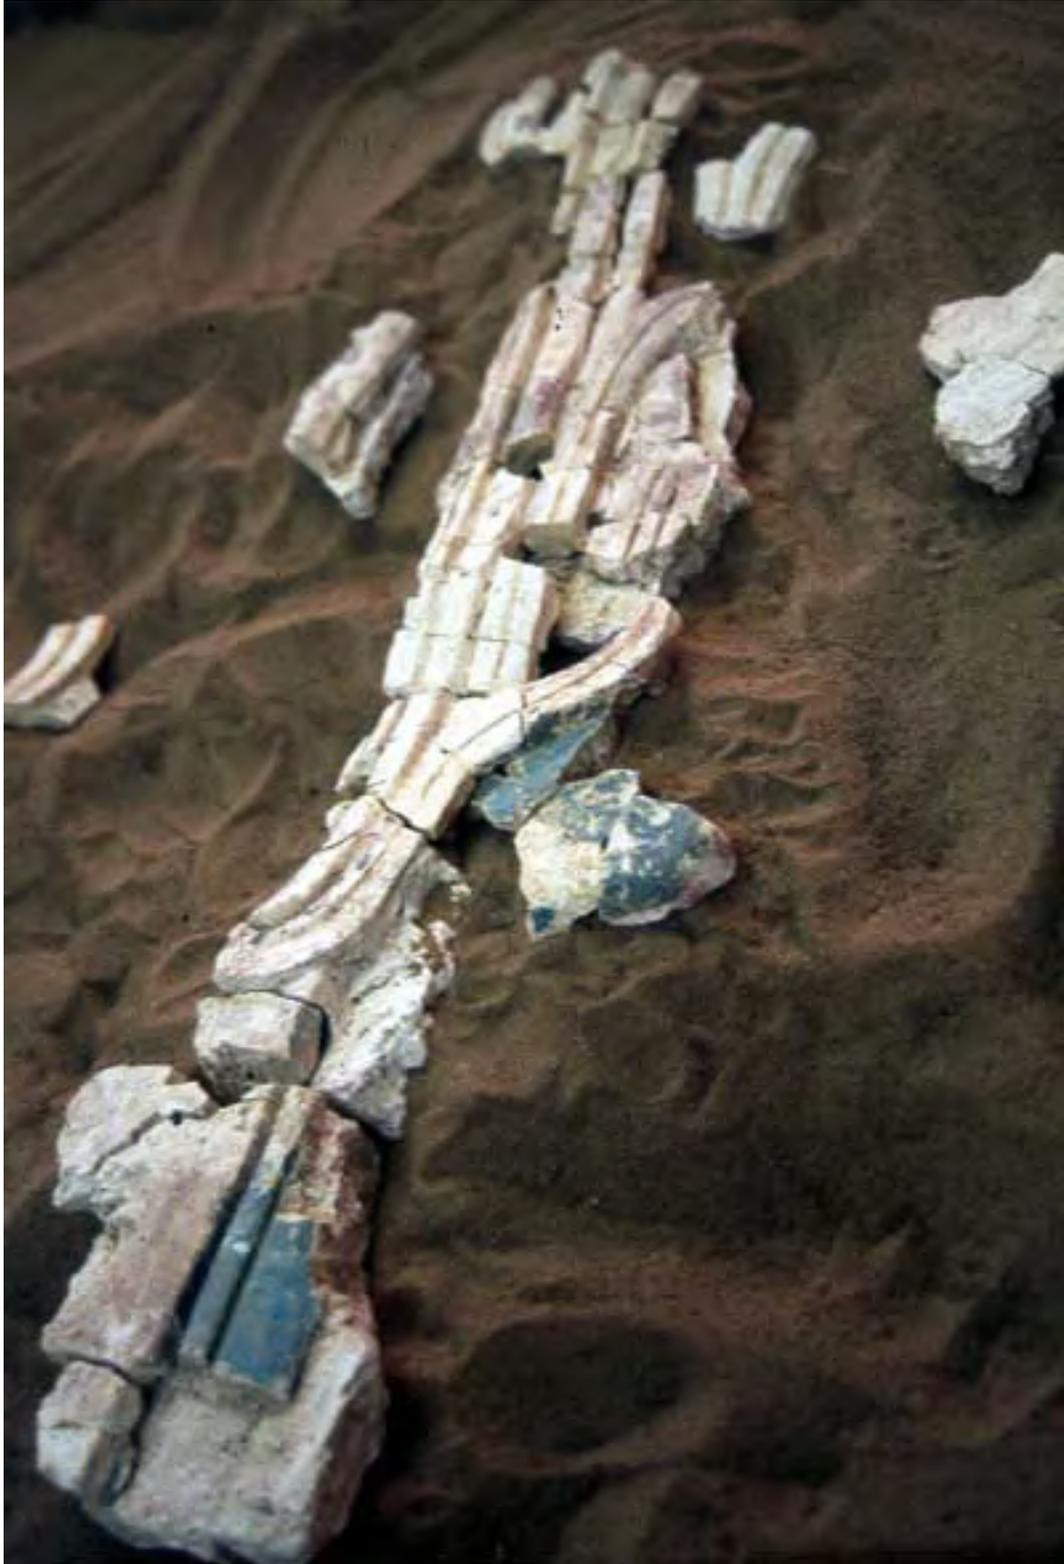
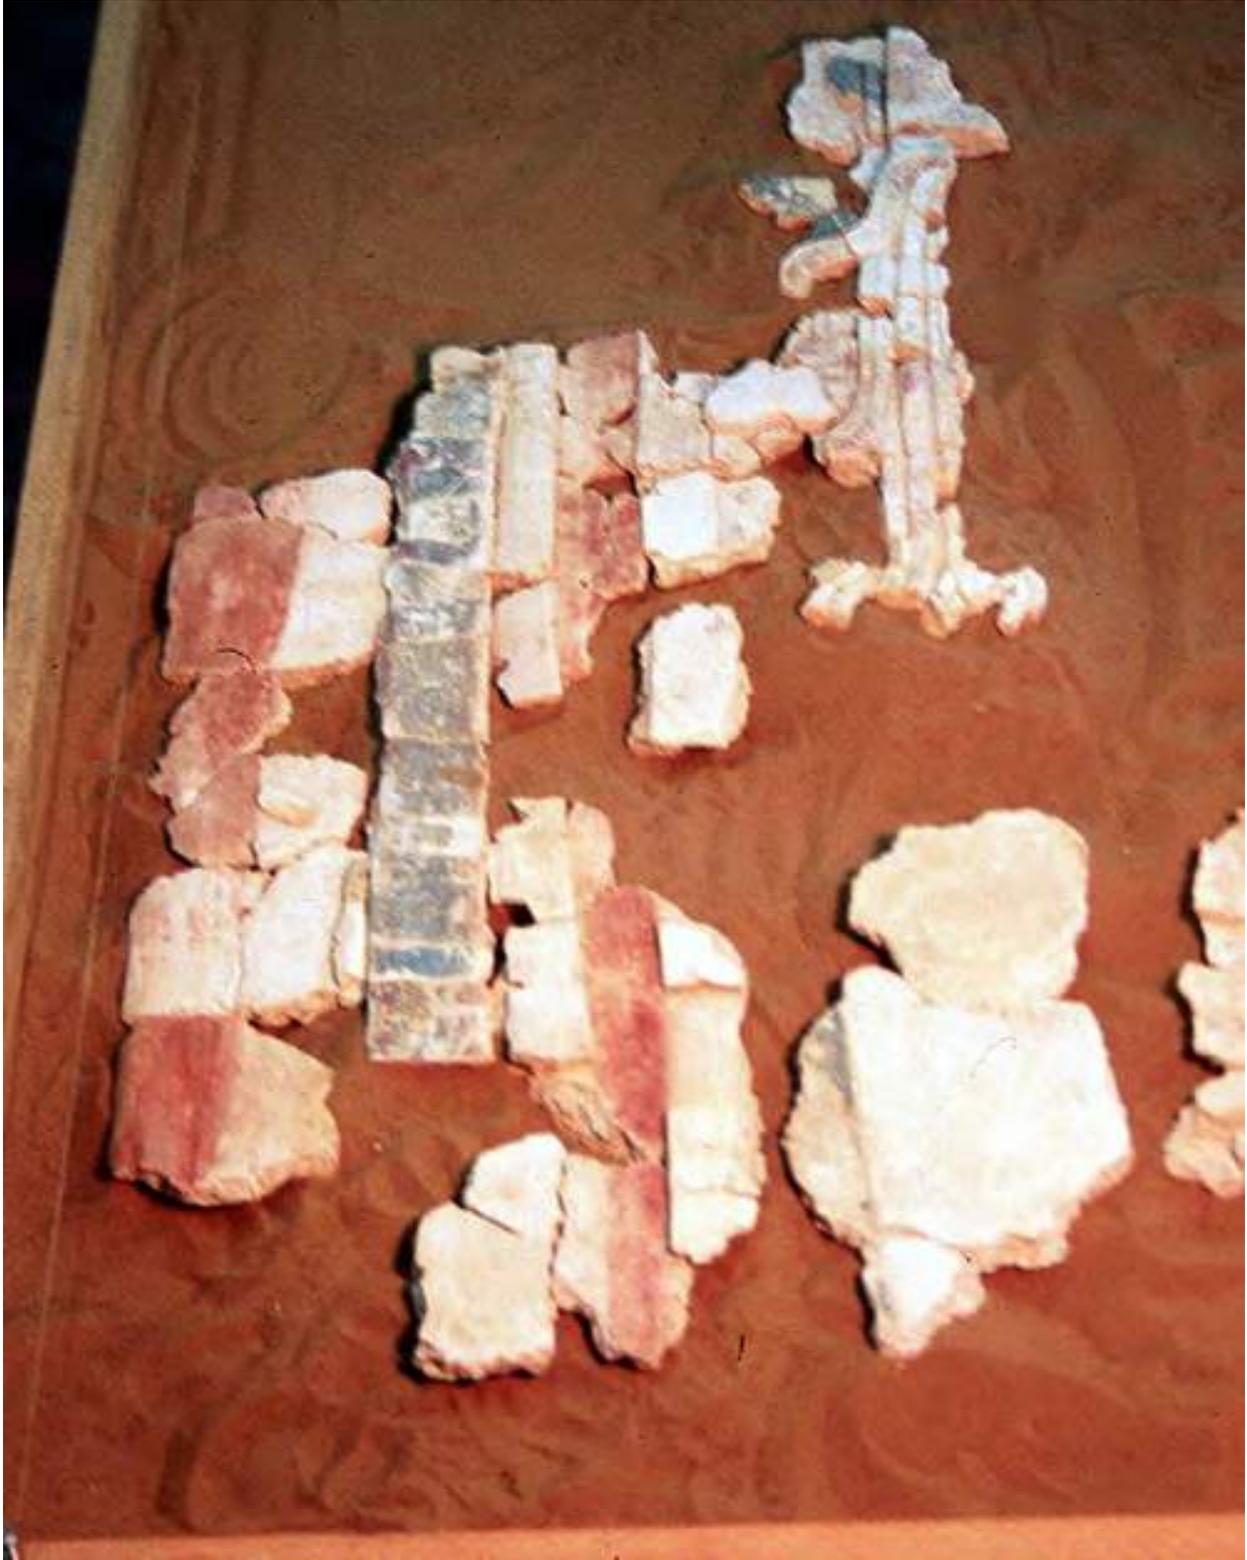
Photo 42. Placement of fragments found in rubble

1. Search for the original location of the fragments (see [photo 42](#)).

We searched for the joints between the fragments to conform elements of a larger dimension (see [photo 43](#)); once the joints were located, the pieces were placed in the sand bed for handling and to obtain the same surface level, as the thickness between one piece and the other was variable and the sand allowed us to handle them without causing damage to the edges (see [photo 44](#), [photo 45](#), [photo 46](#) and [photo 47](#)).

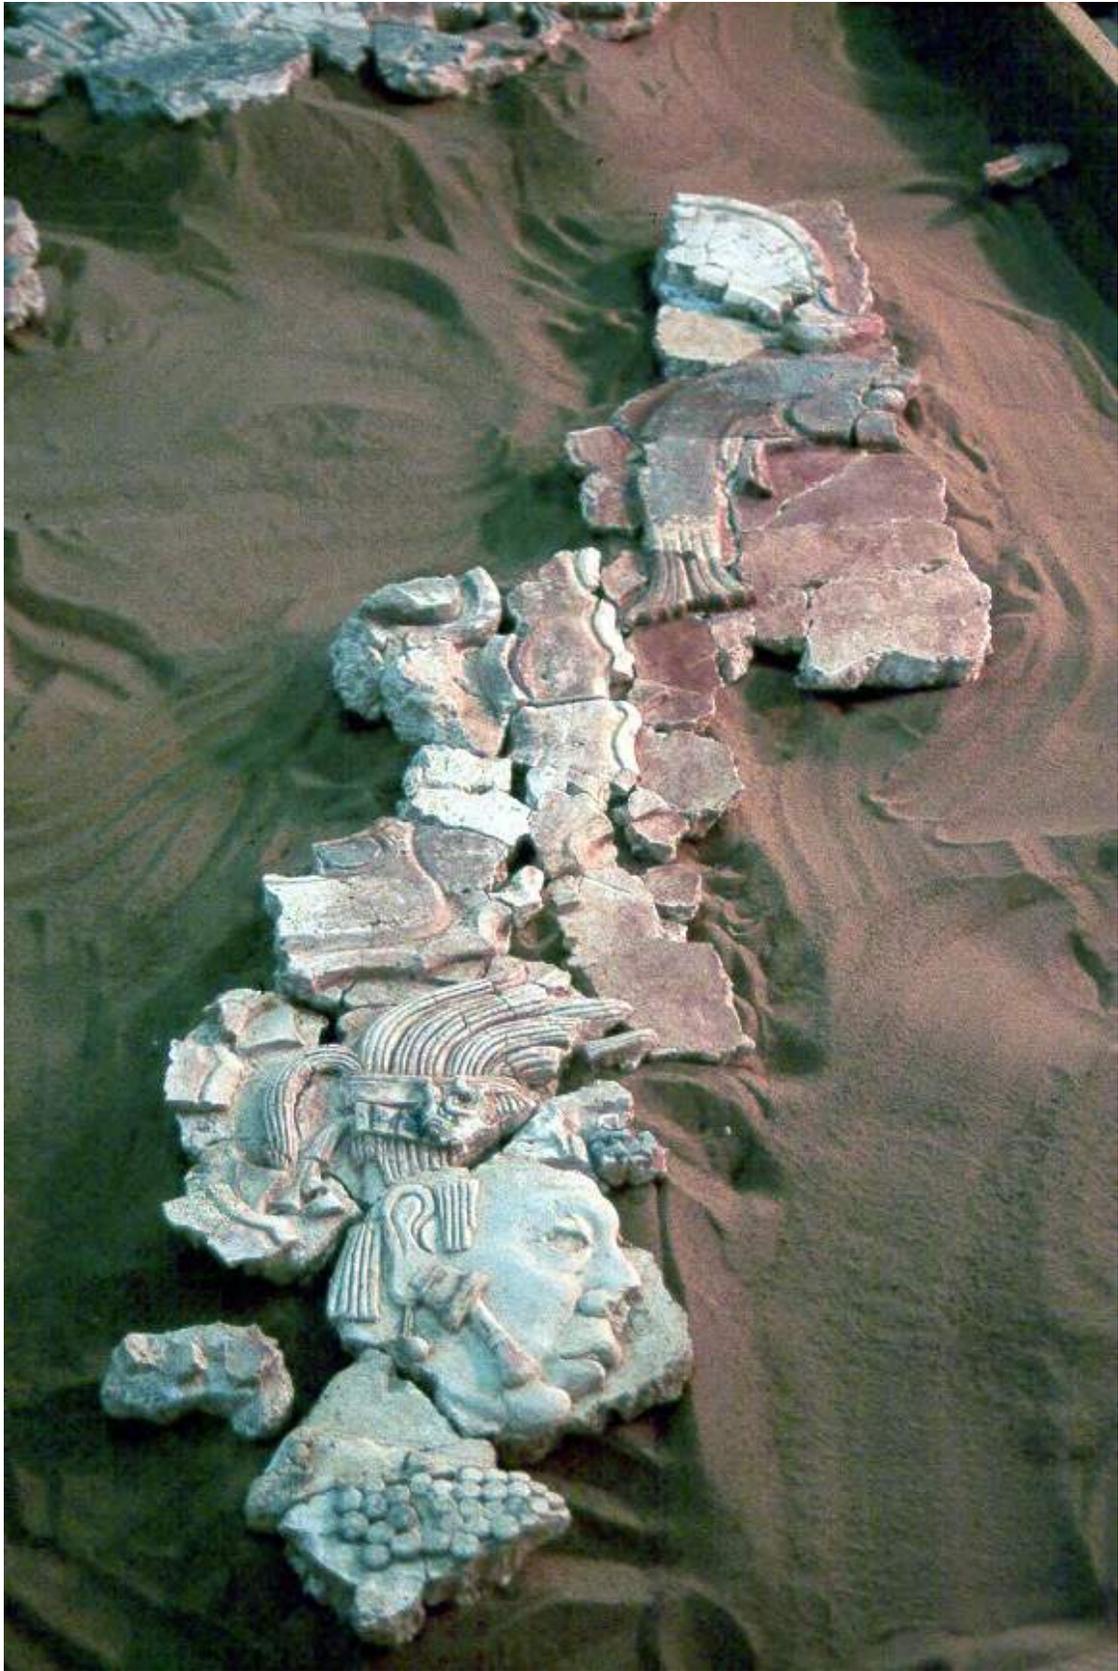
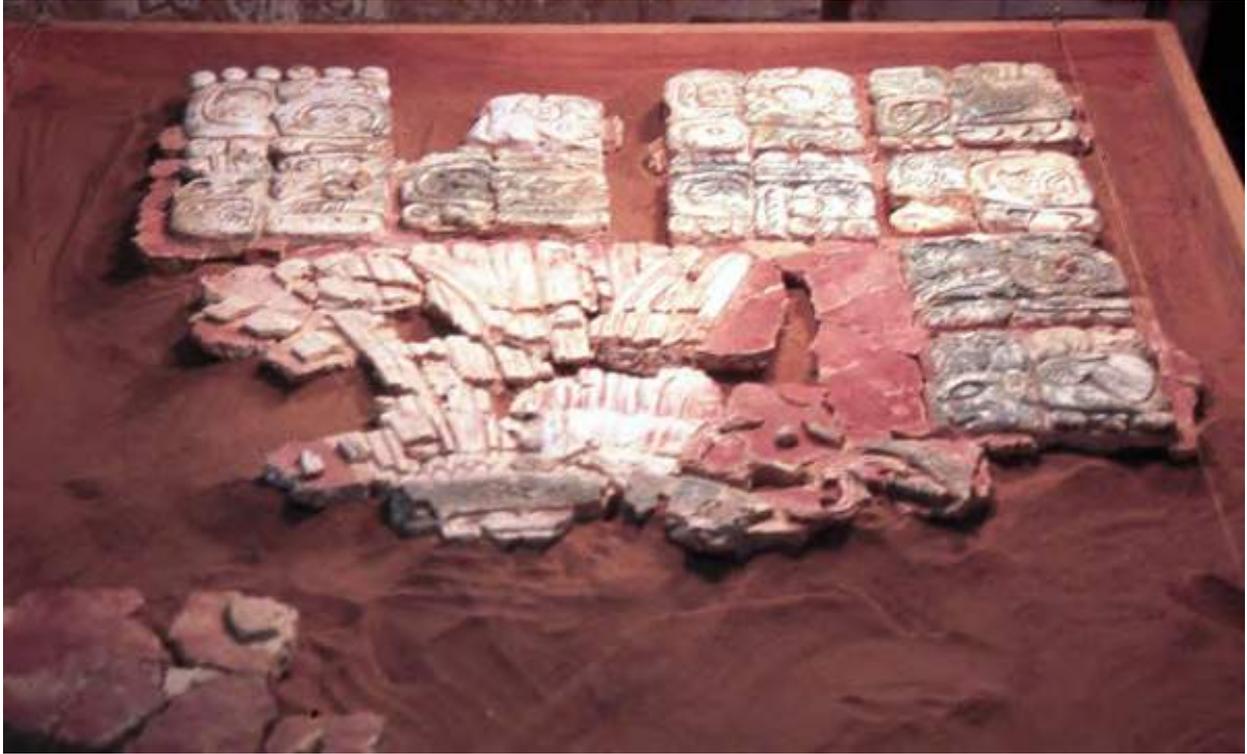
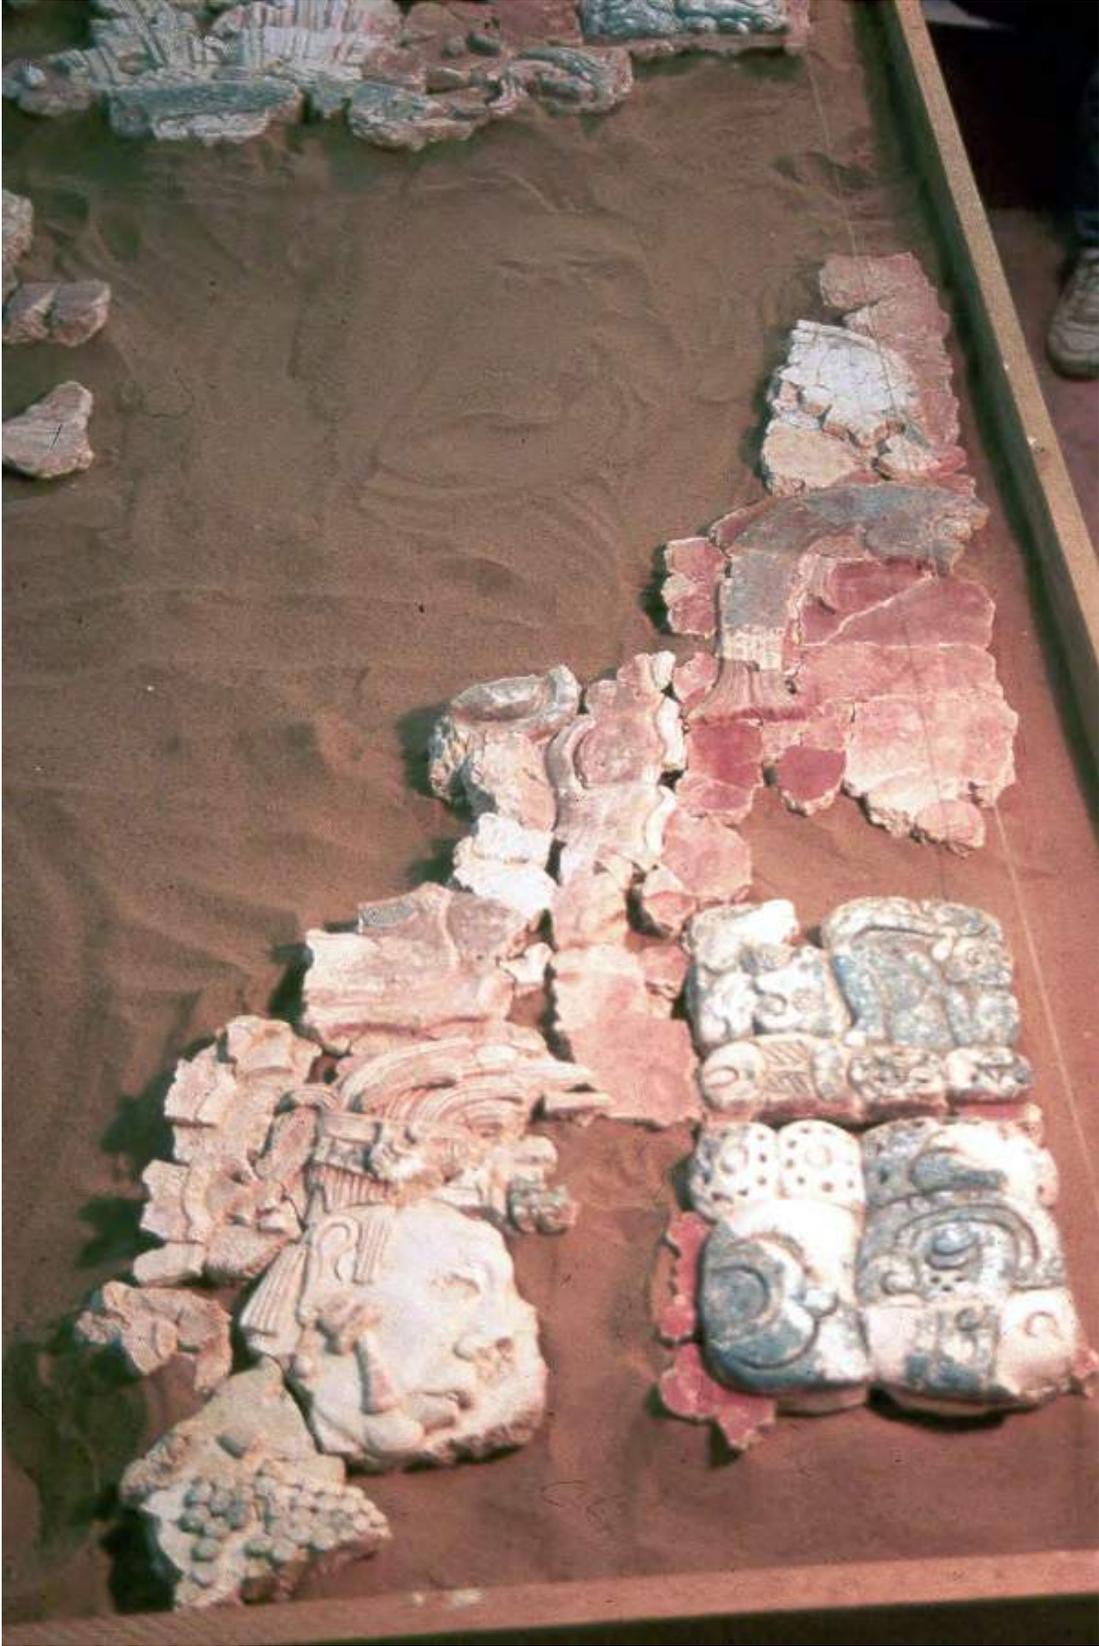
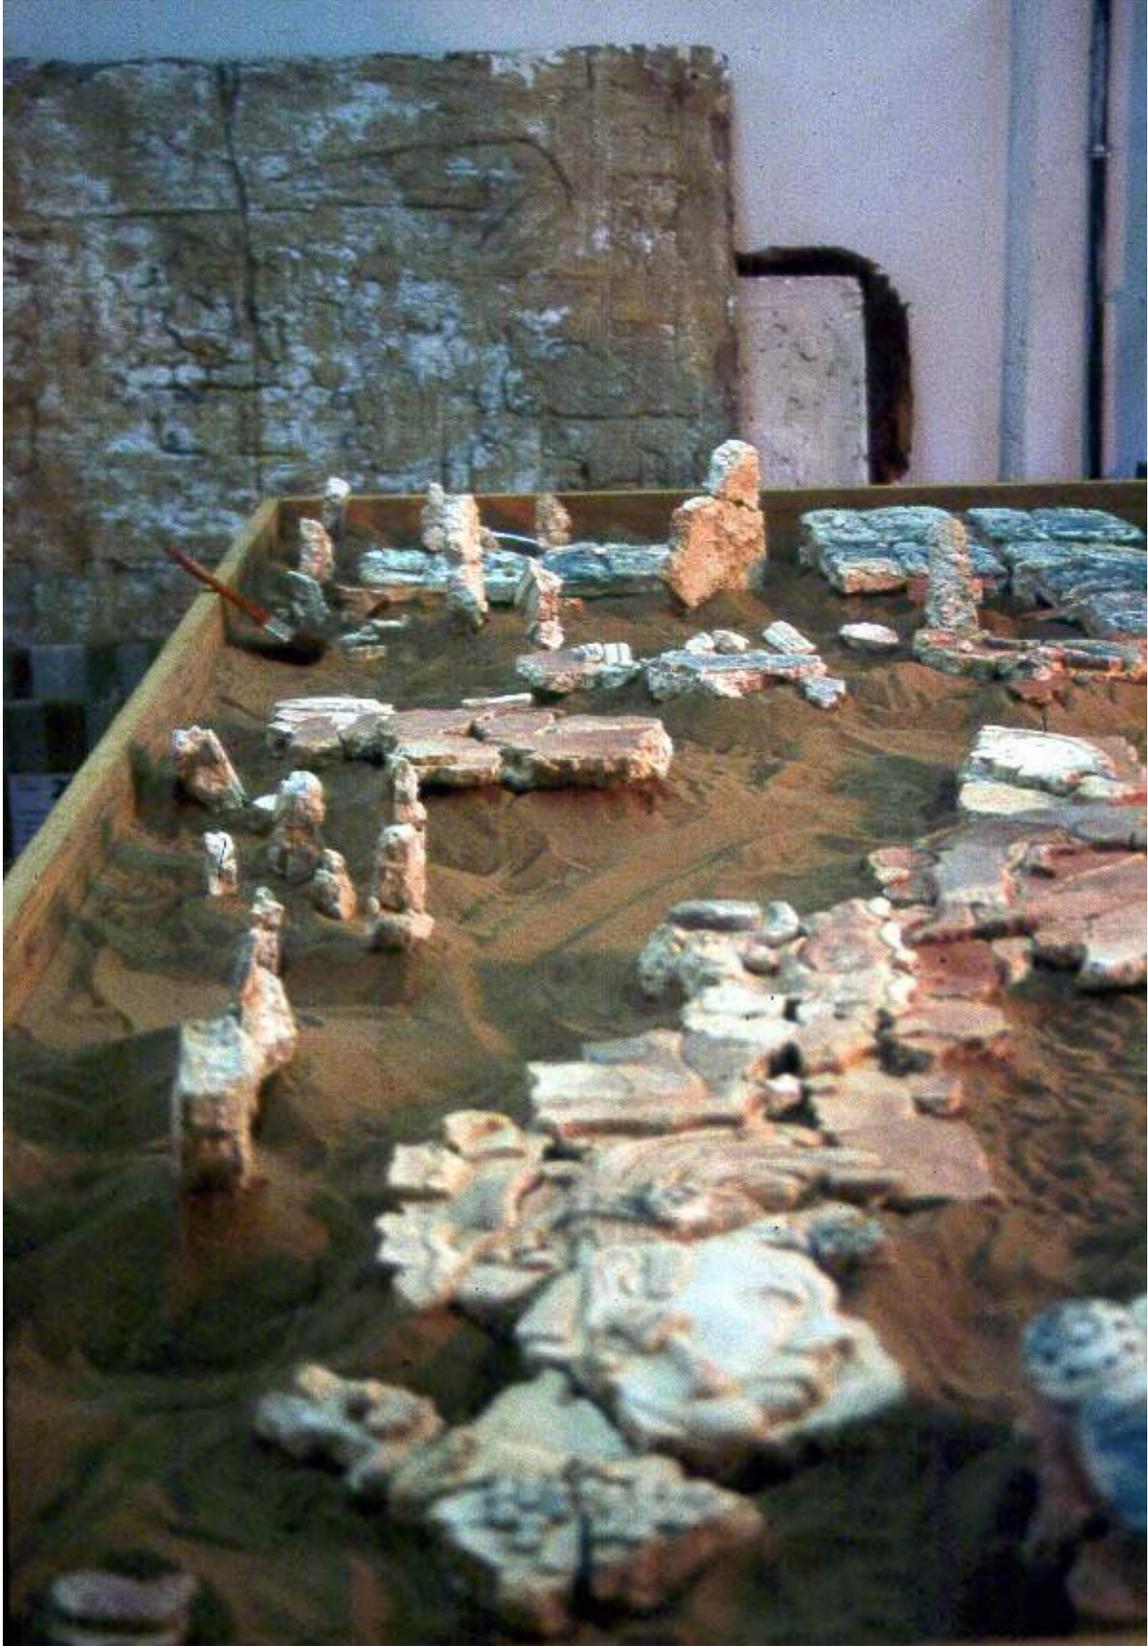
Photo 48. Assemblage of fragments forming blocks

2. Assembly of fragments in an attempt to form blocks (see [photo 48](#)).

As the joints of the stucco fragments began to be found, they were adhered with Mowithal B60H, with the aggregate of ceramic fiber to provide a greater resistance and they were later attached to the fragment detached from the pilaster (see [photo 49](#) and [photo 50](#)). The fragments were placed on the sand bed (see [photo 51](#)).

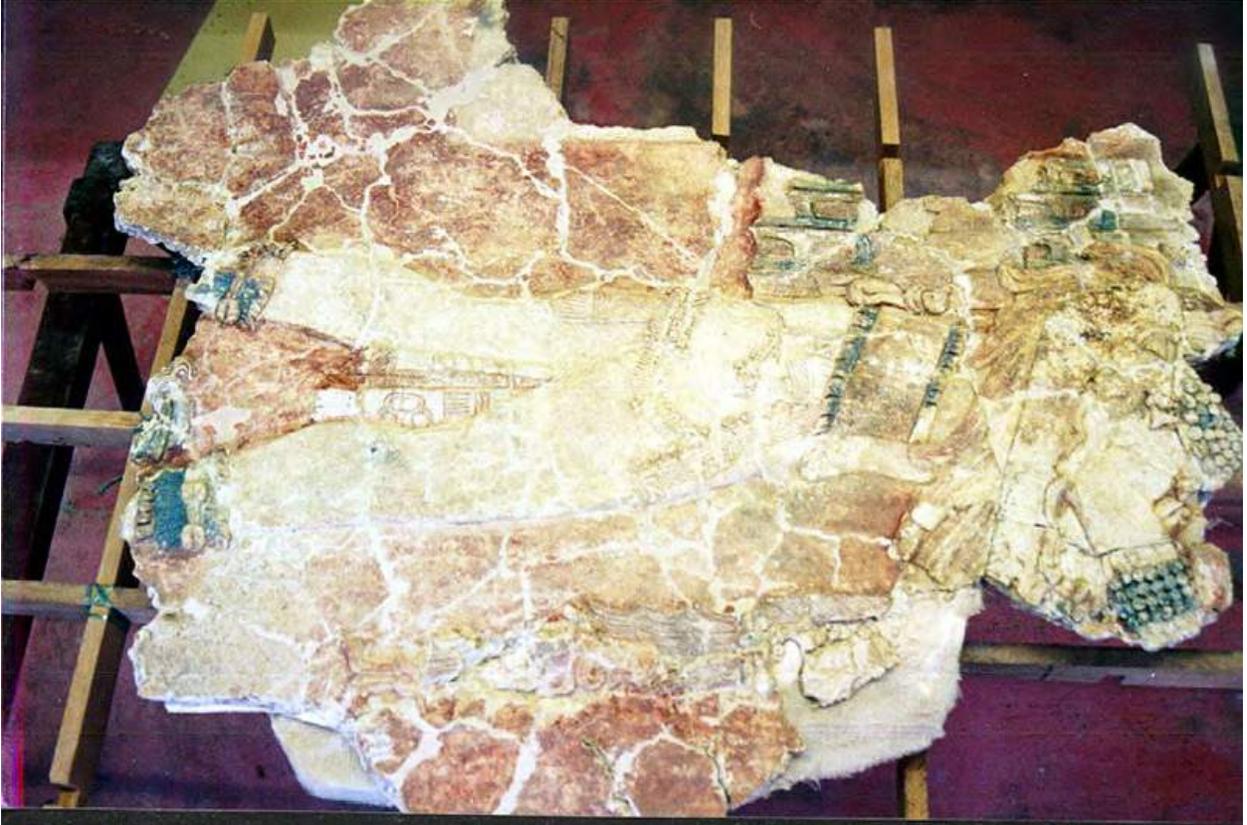
Photo 52. Wooden frame as a support

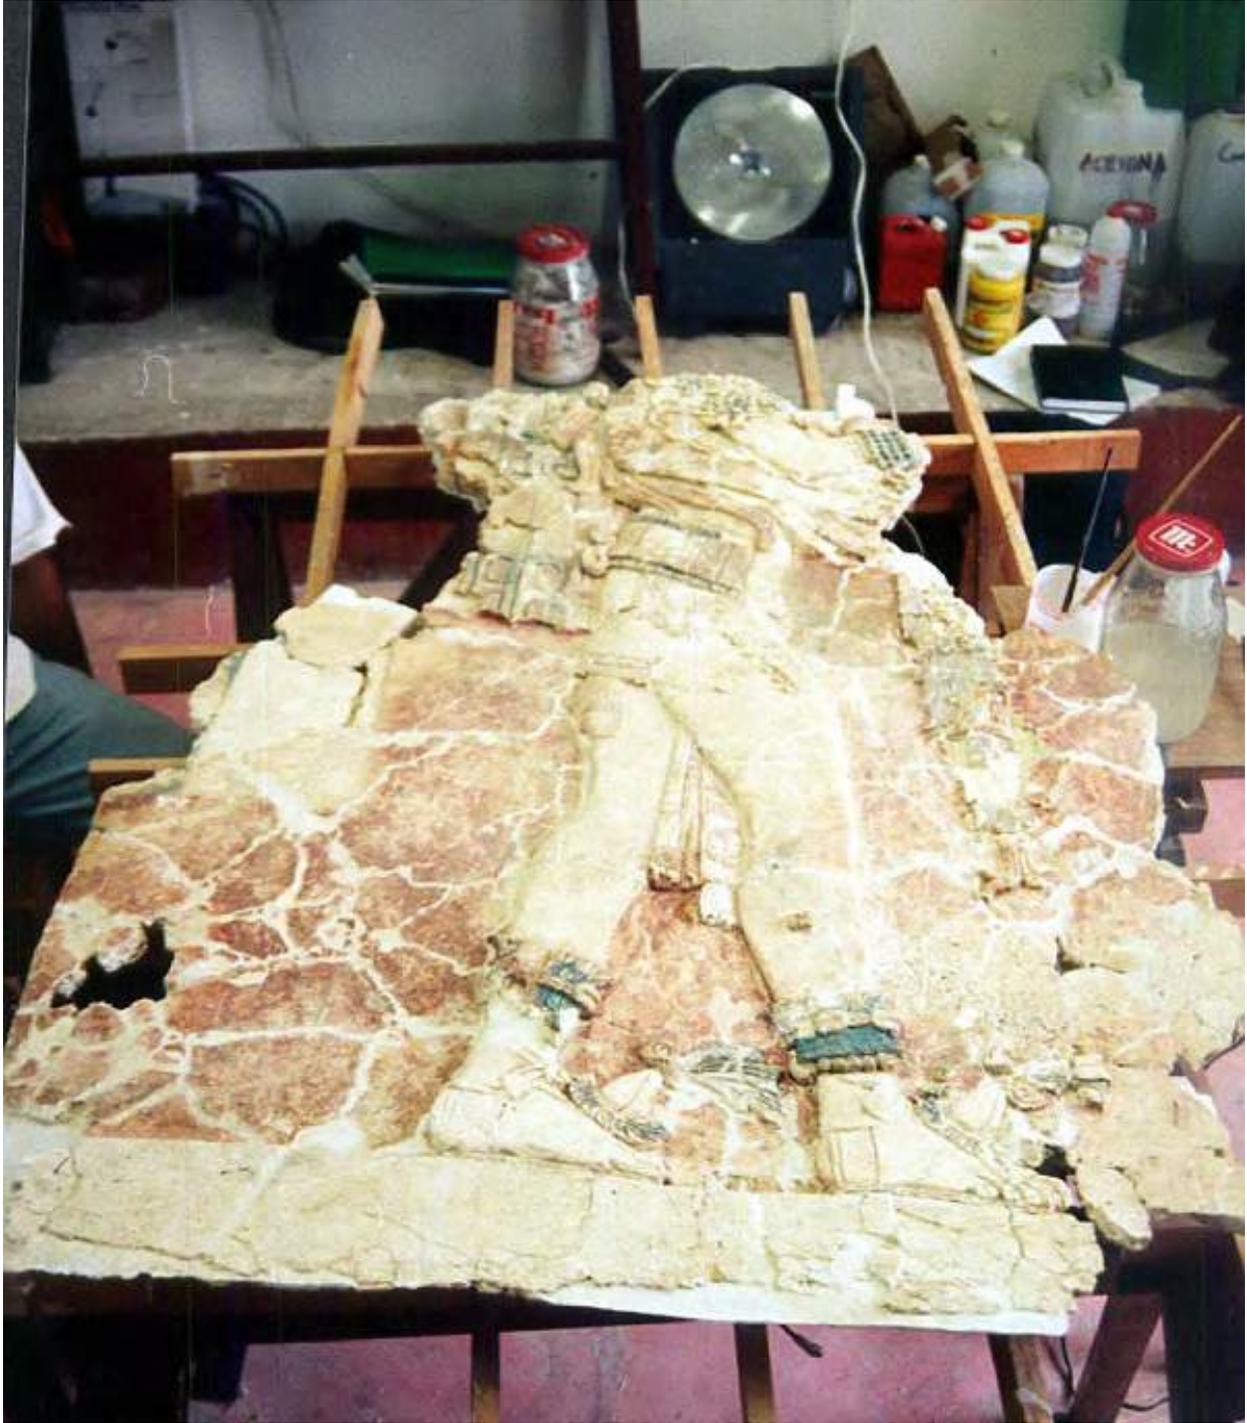
Photo 53. Joining of fragments on both sides

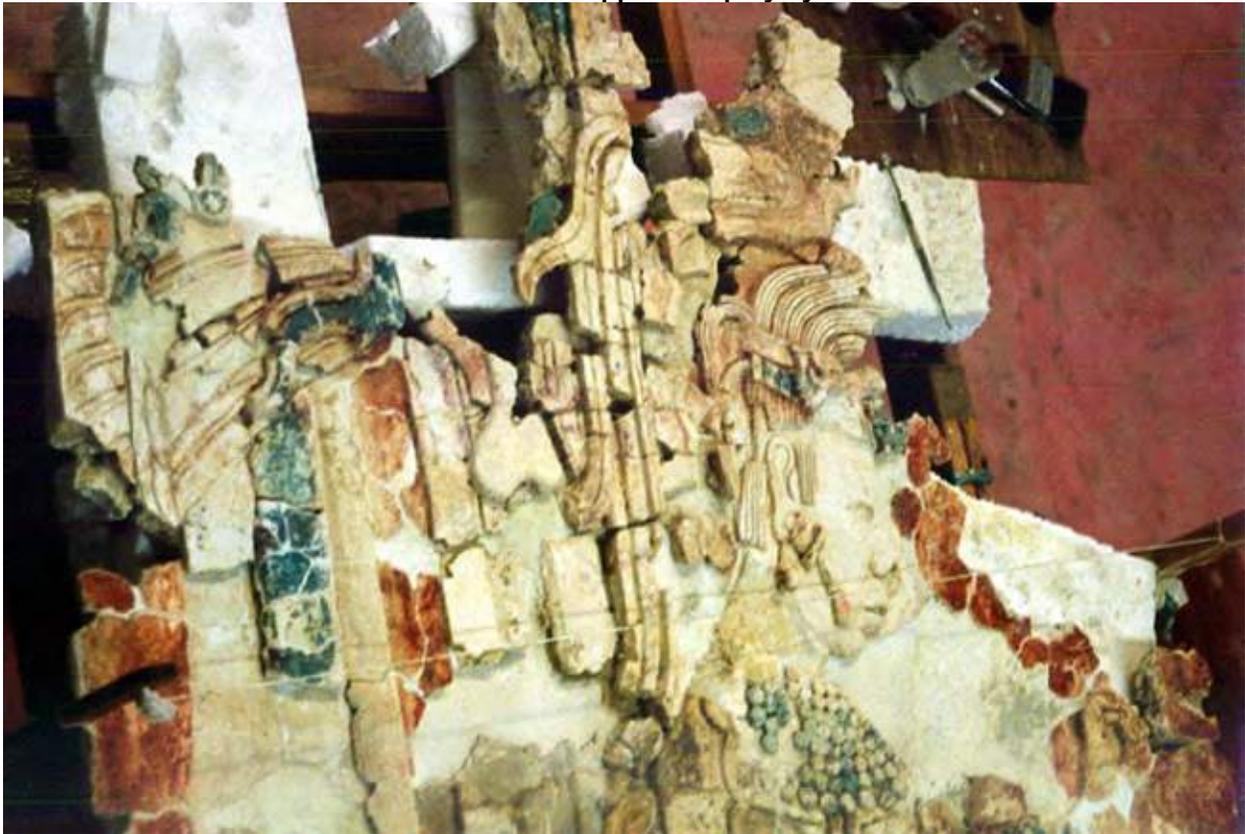
Photo 55. Joining of fragments

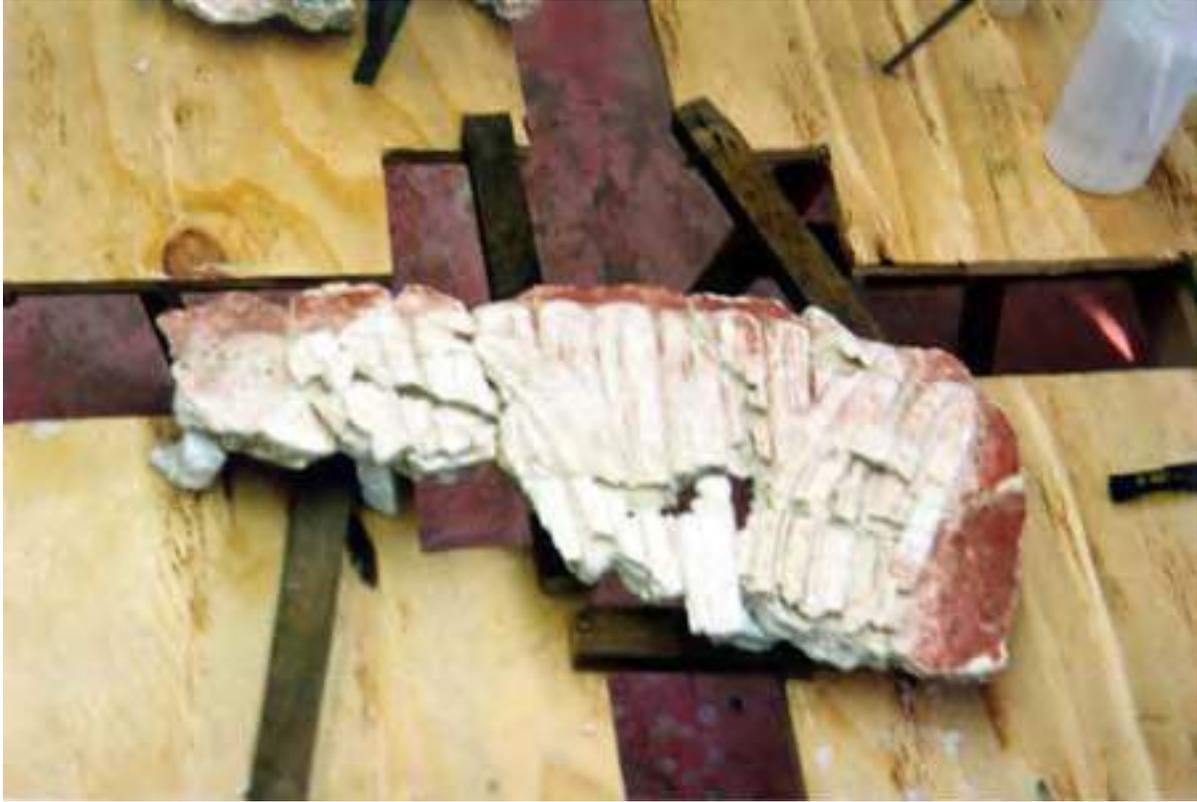
Photo 56. Joining of fragments

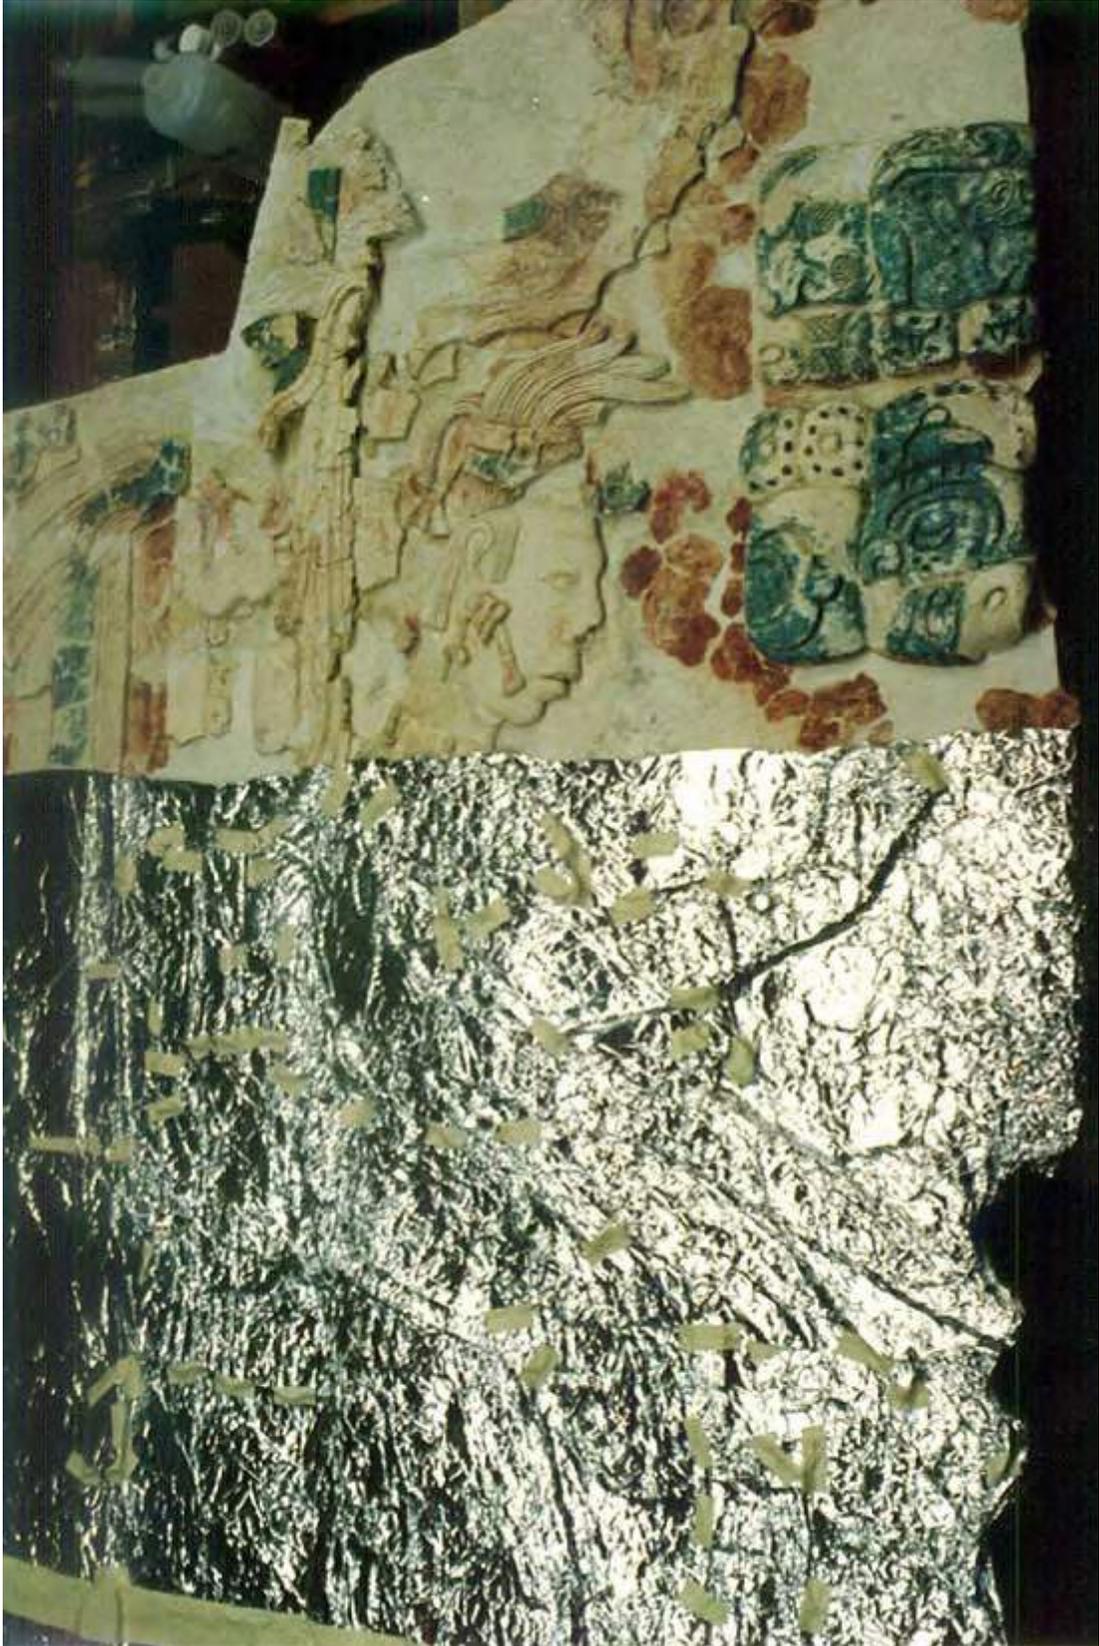
Photo 63. Protection covers with aluminum foil

With the purpose of preventing the resin that was to work as a provisional support from penetrating the stucco, a layer of aluminum foil was placed on the entire surface (see [photo 63](#)) to seal it, and we verified also that the paper had no perforations (see [photo 64](#)).

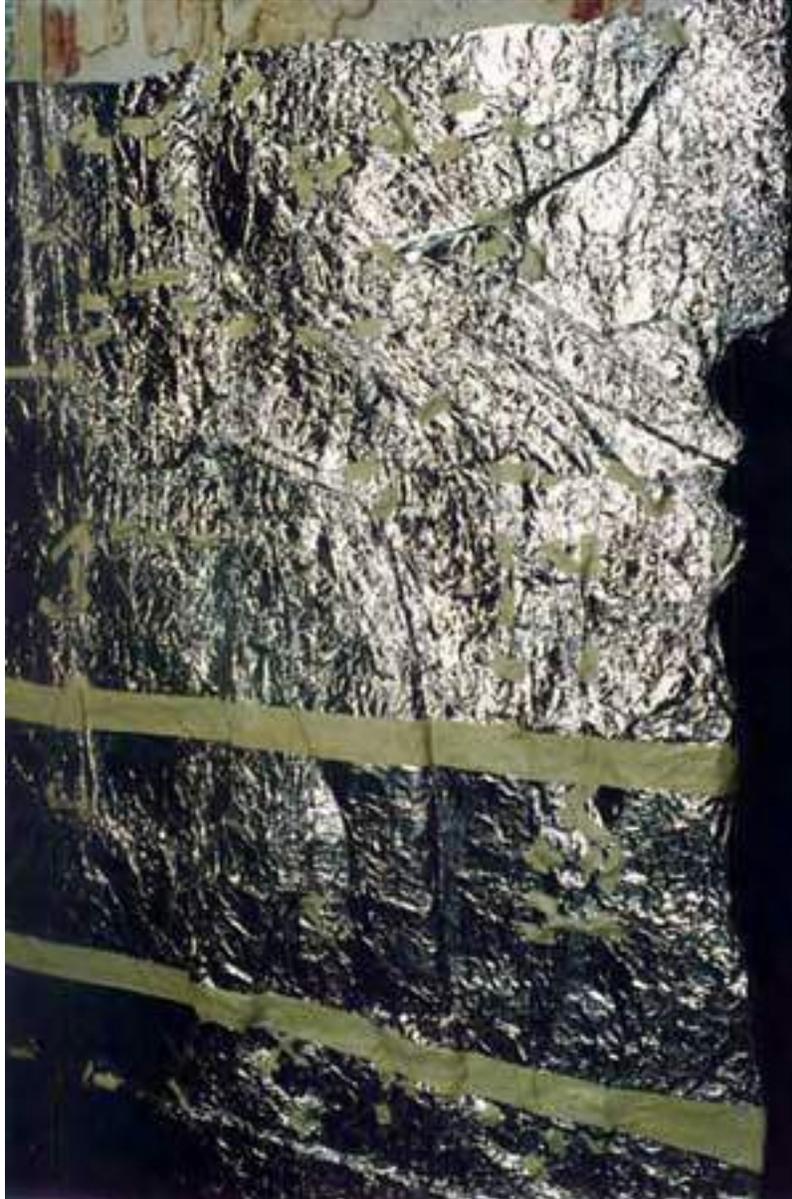
Photo 64. Protection covers with aluminum foil

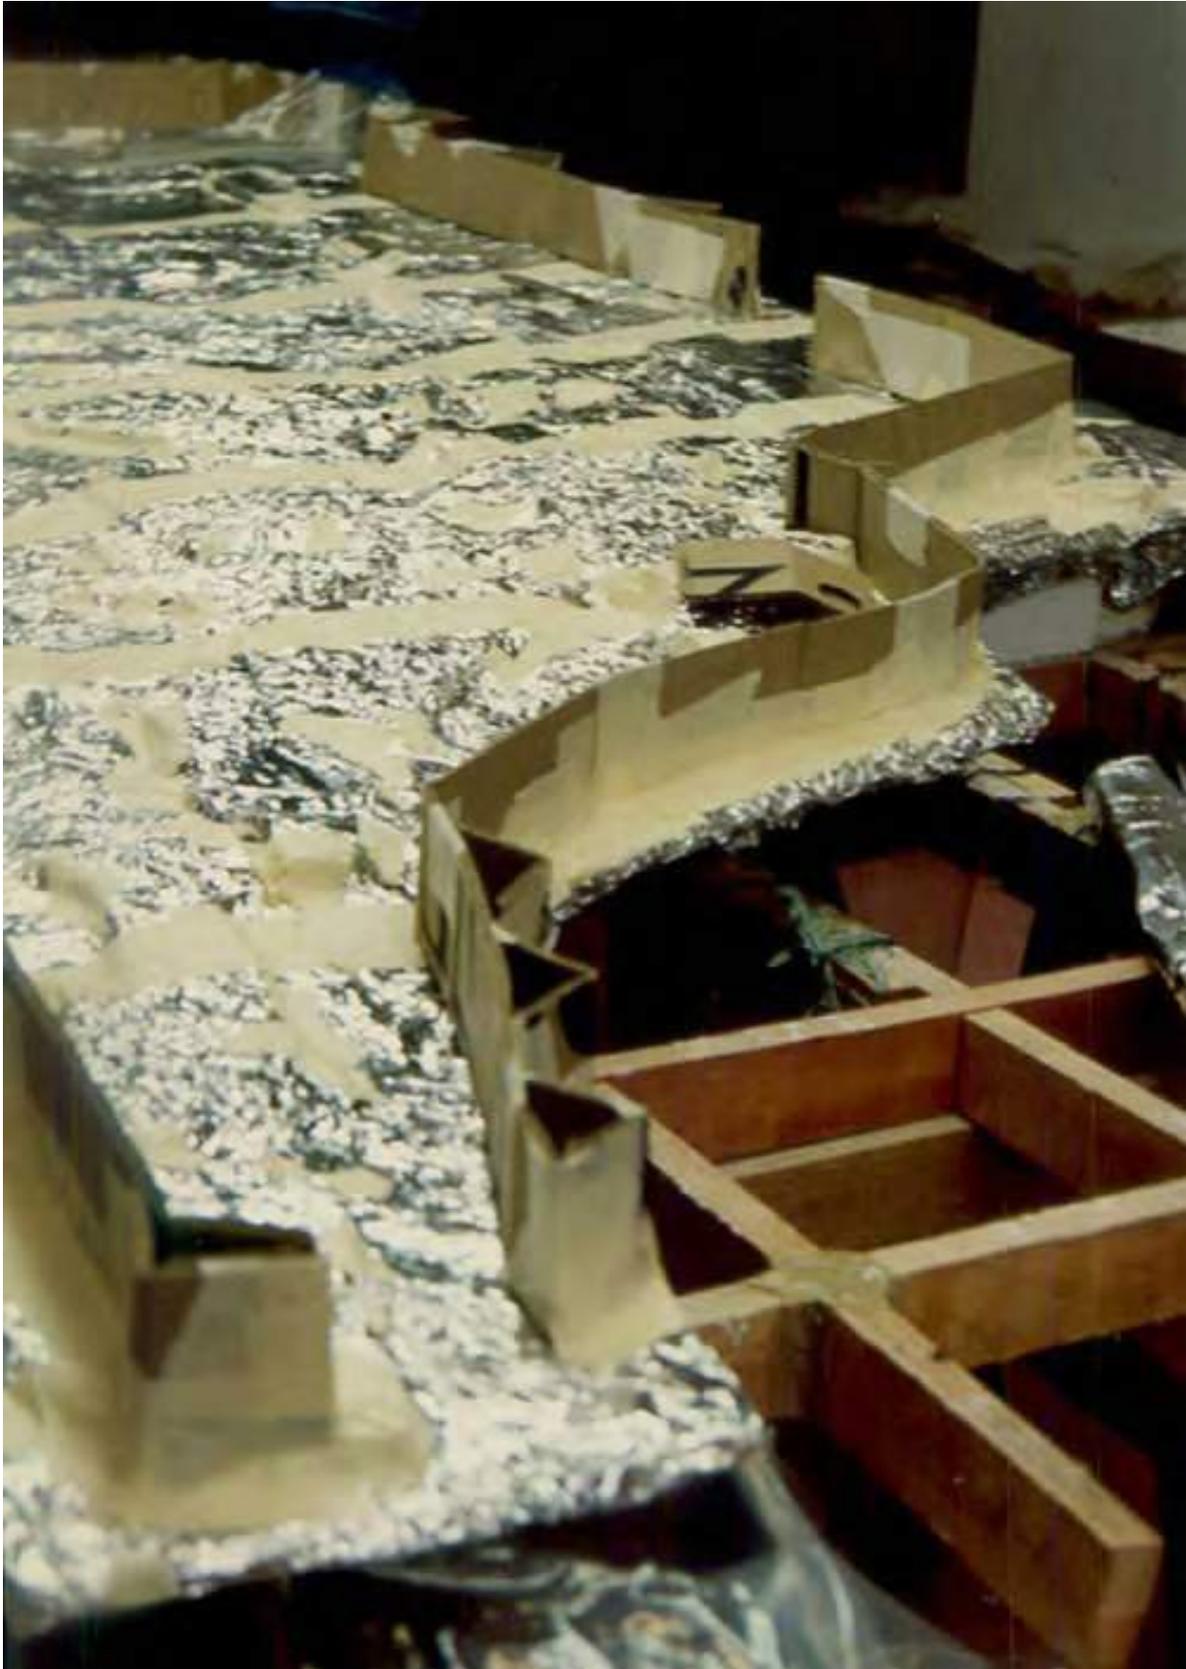
Photo 65. Partitions for retaining the polyurethane foam layer
