Stucco Relief from Structure XIX, Palenque

by: Marcia Valle Rangel and Juan Alfonso Cruz Becerril

Research Year: 1999

Site: Palenque, Group of the Cross

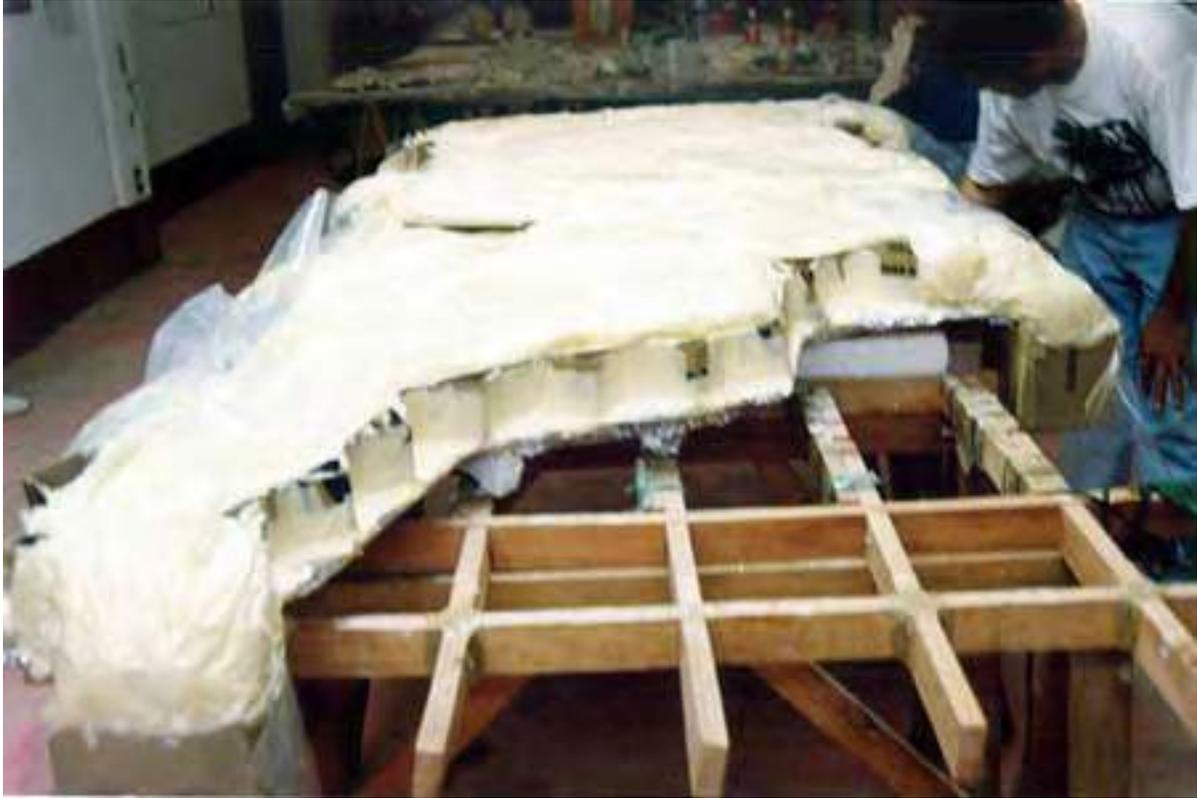
Photo 66. Polyurethane foam layer

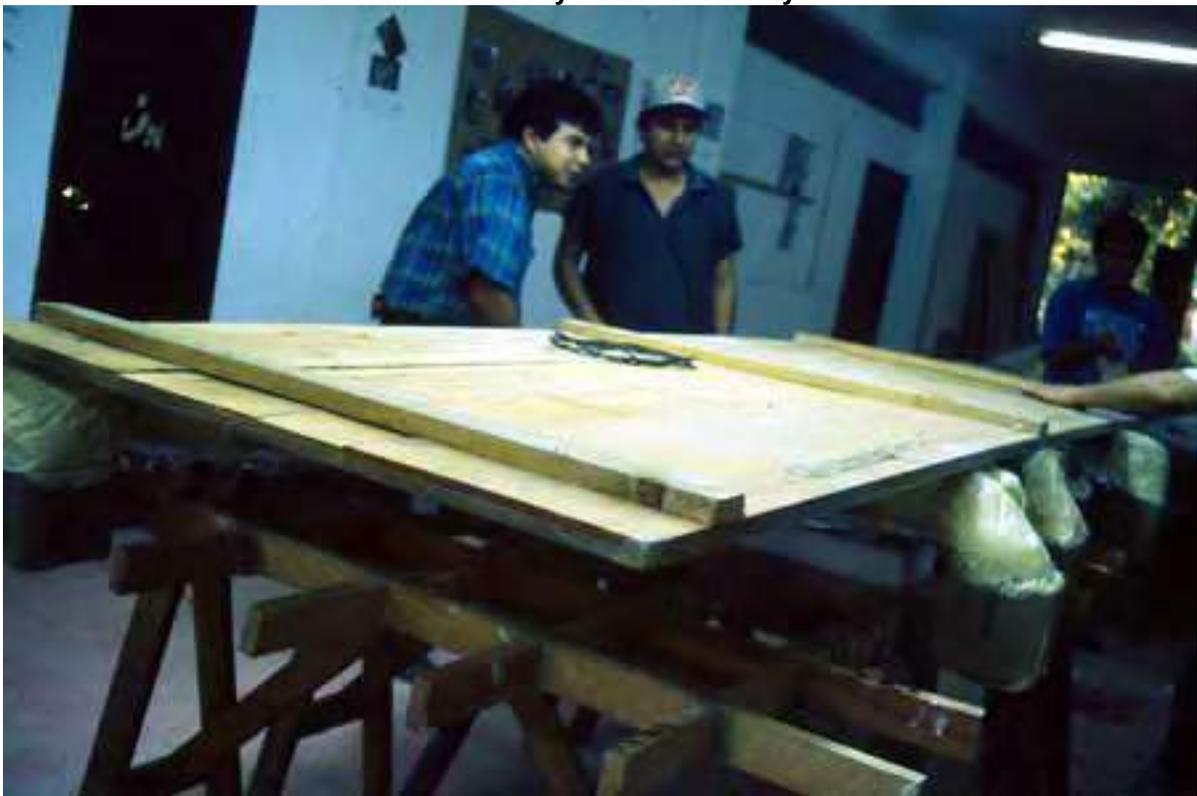
Photo 67. Placement of plank for turning over the stucco panel

On top of the polyurethane foam, a plank was positioned and tied up to the wooden frame, and then the entire stucco panel was turned over (see [photo 67](#)), enabling us to proceed with the necessary treatments on its back, to prepare the piece to receive its permanent support (see [photo 68](#)).

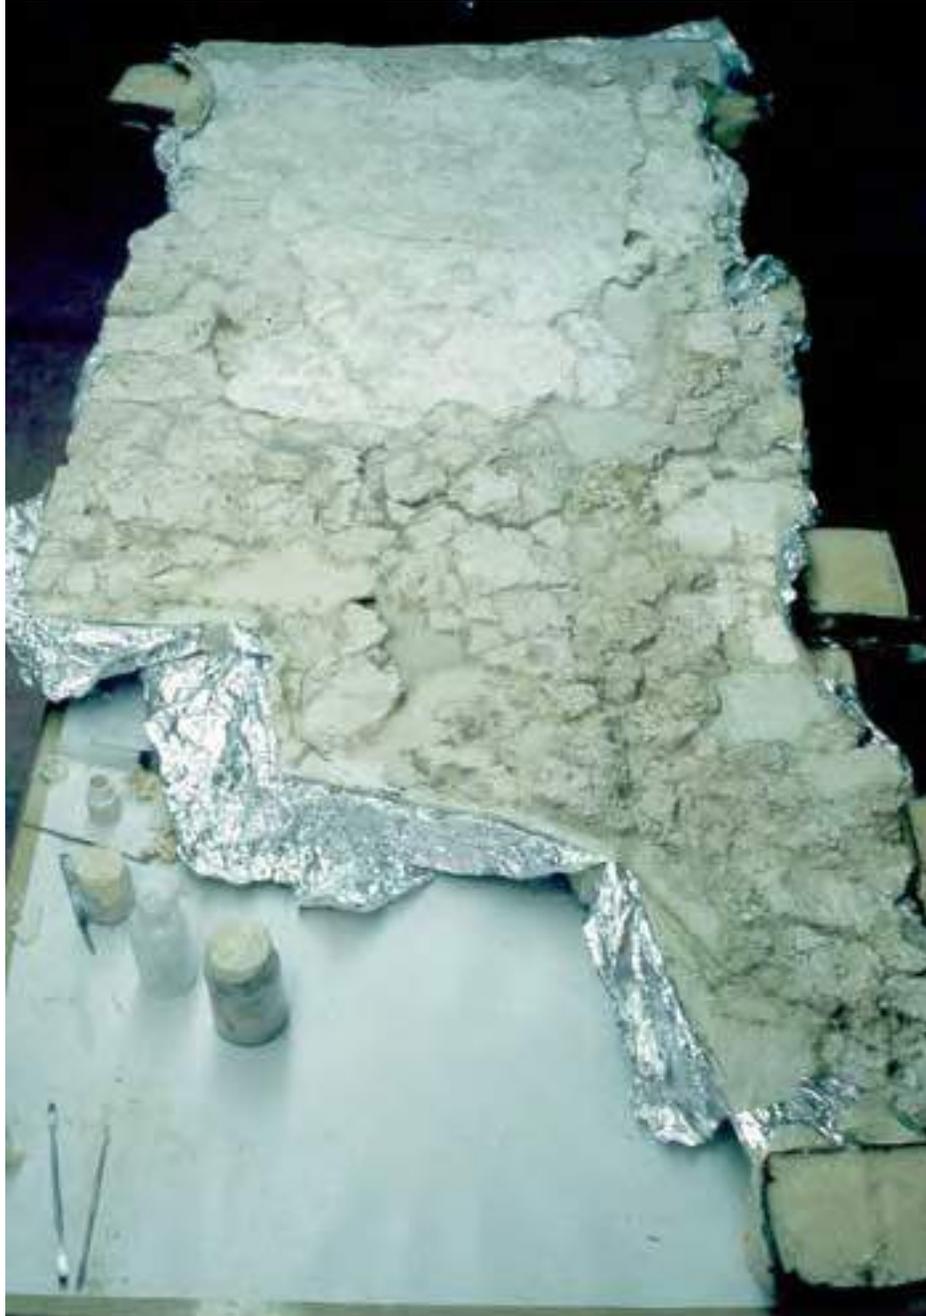
Photo 68. Reverse of panel. Prior to the repair process

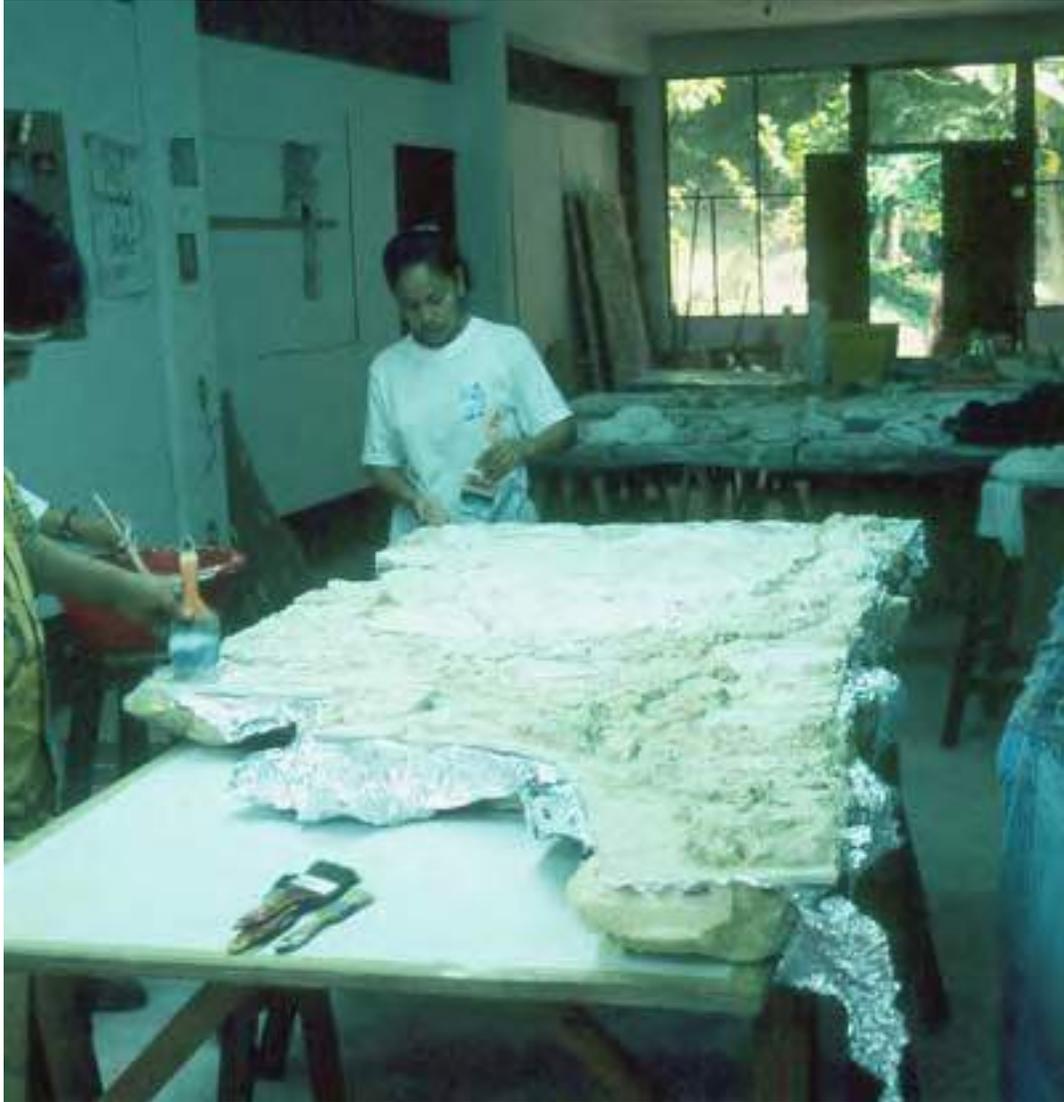
Photo 70. Application of the calcium caseinate layer

This layer was applied with a brush trying to fully cover every single space with this solution (see [photo 70](#)).

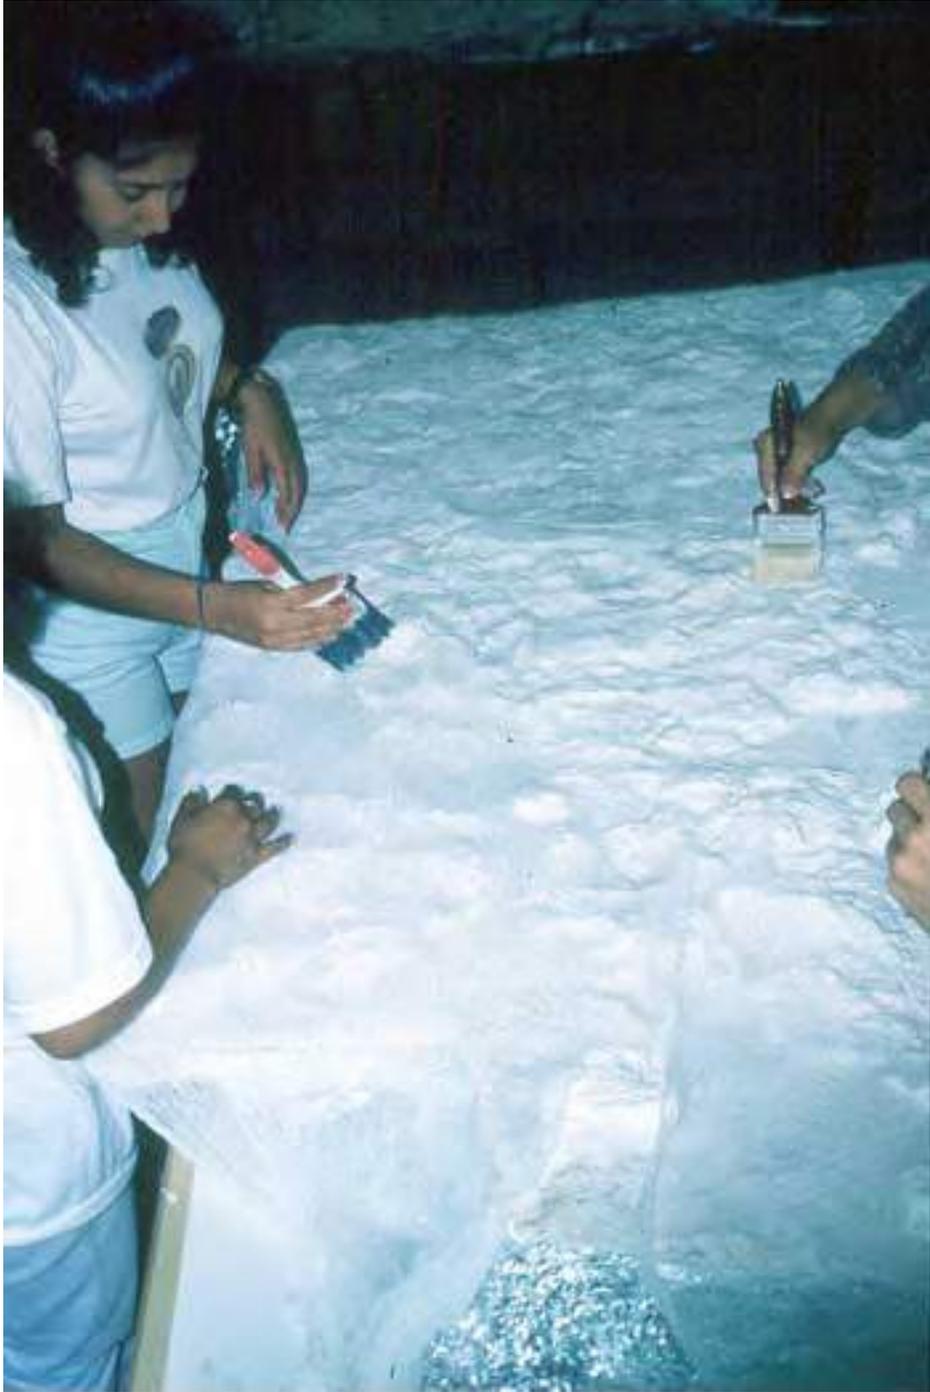
Photo 71. Application of the reversible layer

As an insulating and reversible layer, a cheesecloth cover was applied using calcium caseinate as adhesive agent, and subsequently an additional folded cover was applied using once more cheesecloth and calcium caseinate as an adhesive agent; both were applied with a brush (see [photo 71](#) and [photo 72](#)).

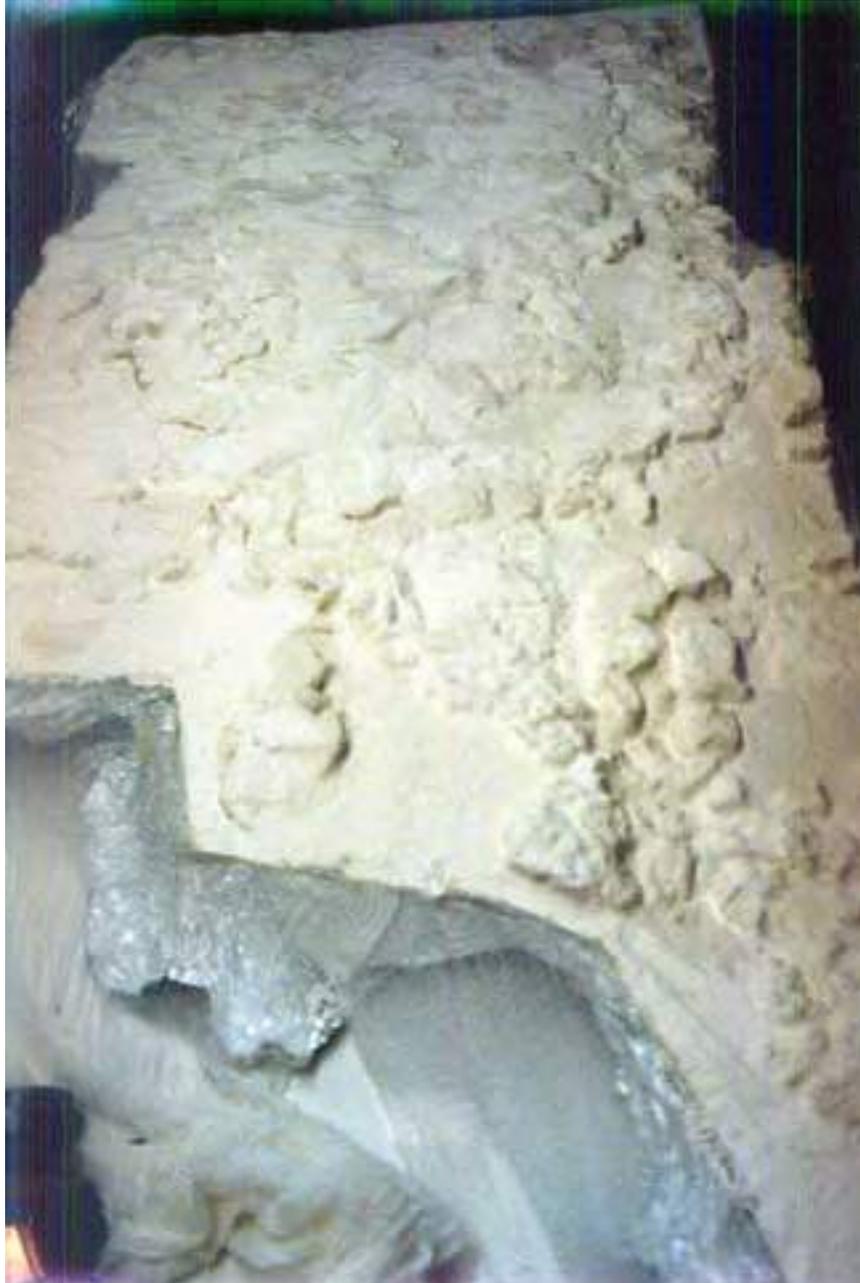
Photo 72. Insulating and reversible layer of cheesecloth and calcium caseinate

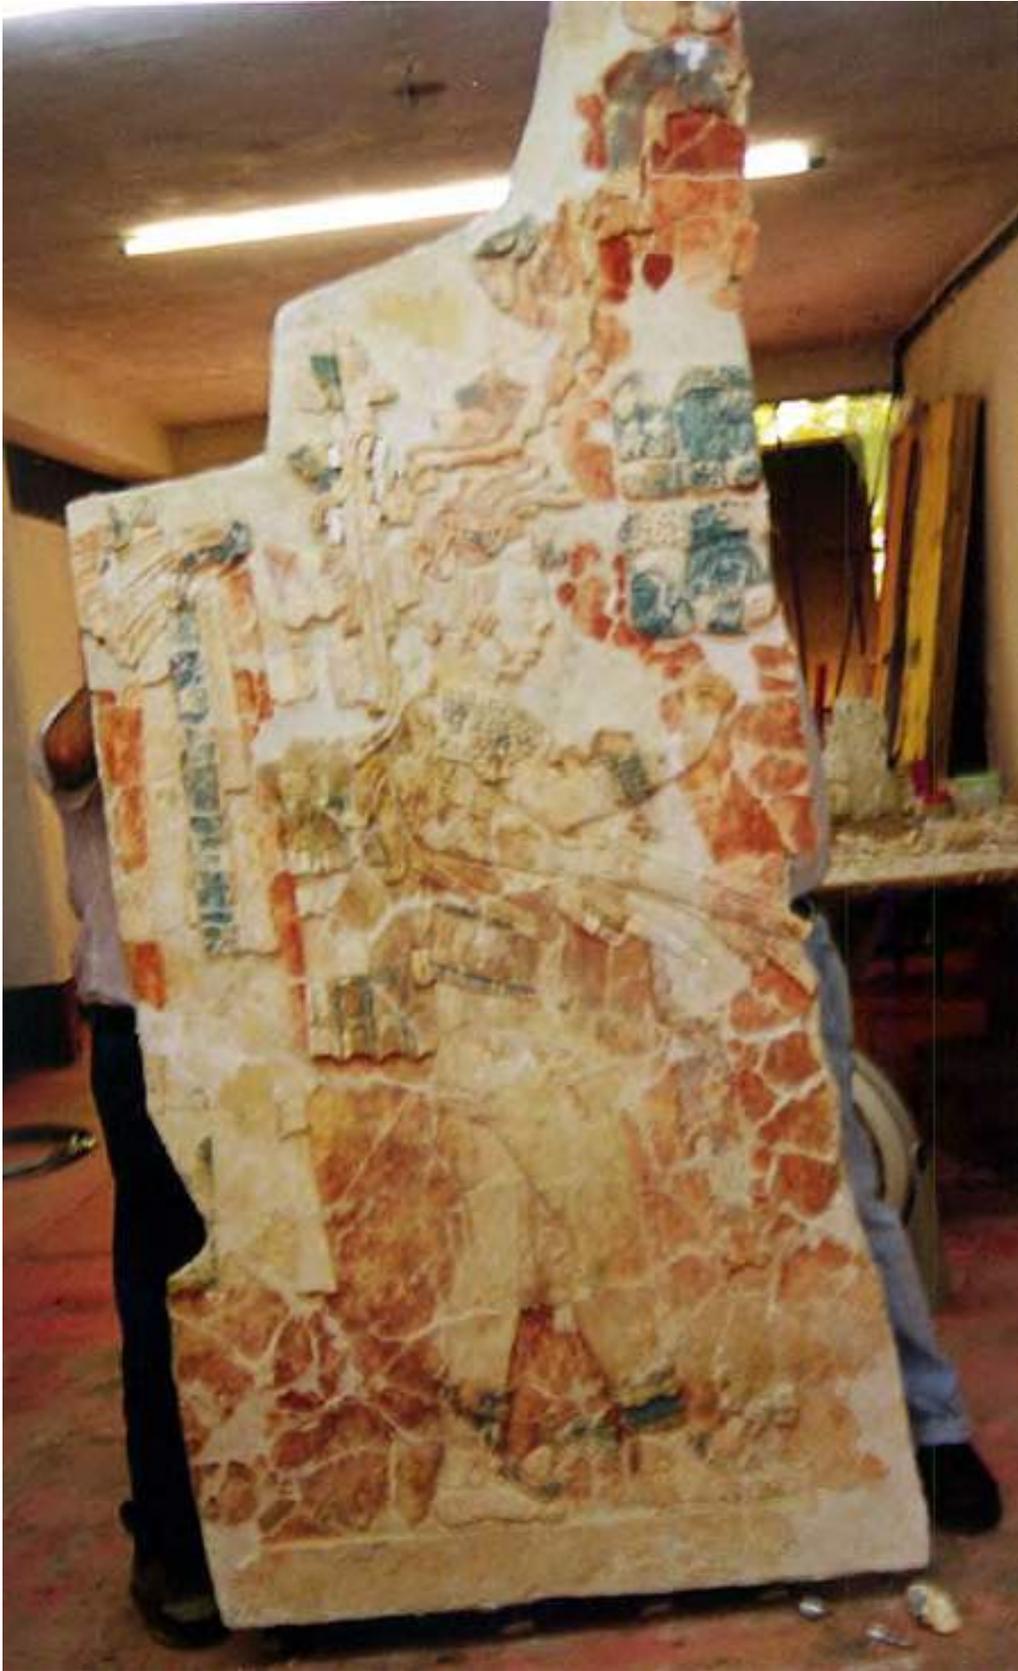
Photo 75. Pigment fixation

The pigment was fixed so that it wouldn't fade away with the passing of time, as a consequence of abrasion or friction of any sort (see [photo 75](#)).

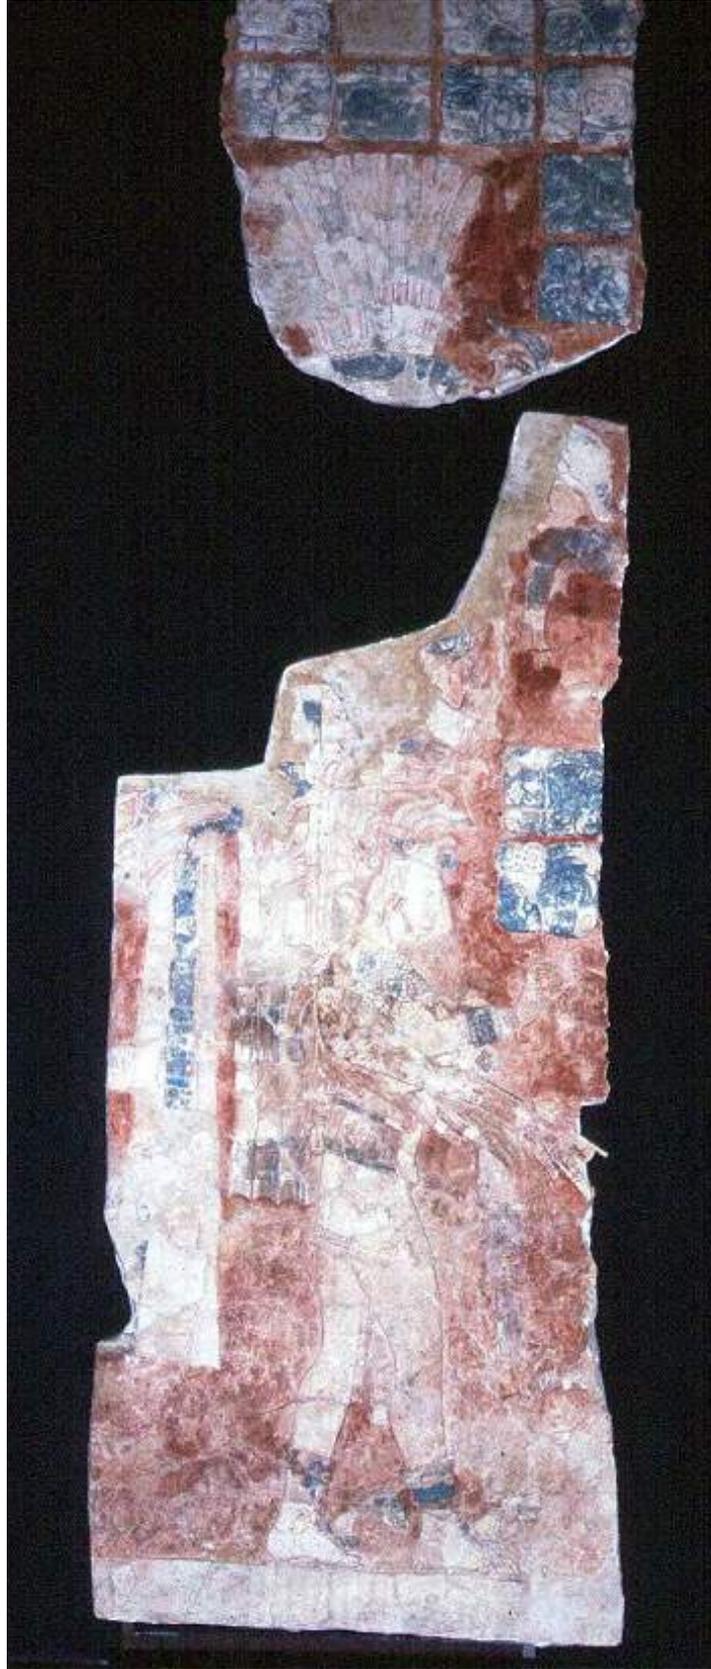
Photo 77. End of process
